State of Washington Department of Ecology

Cruise Ship Memorandum of Understanding, Cruise Operations in Washington State Inspection Report

Washington Gtate inspection Report											
Inspection Date		-			County Receiving					Ecology Inspector	
June 7, 2024					King	Marine Waters			Evan Dobrowski		
Entry Time 9:00AM		Phot	os Taken	Samp	les Taken	Inspection Announced		Disch	Discharges to: Surface Water		
Exit Time 11:30AM Yes No Ye					s ⊠ No ⊠ Yes □ No			☐ Grou	☐ Ground Water ☐ Dewater ☐ POTW		
Name and Location of Site Inspected: Additional Participants/Inspectors:											
	EBRITY EDGE	, Celebr	ity Cruises/	'Royal (Caribbean	Cruises Ltd.		Cody E	nnis, E	cology	
Pier								David F	uiimoto	Dort of Spottle	
	tle, Washingtor ite Representativ		me/Title/Pho	ne/e-ma	nil			David F	ијинотс	o, Port of Seattle	
	gios Efthymiou										
_	onsible Official(s	-						Other Fa	-		
	n Hanley, Mar	nager, E	:nvironme	ntal Re	egulatory	Compliance	e &			ide to John Hanley on	
	ainability al Caribbean (^ruicae	l td					May 23,			
,	o Caribbean V			3132				_	Flag - Malta IMO # 9812705

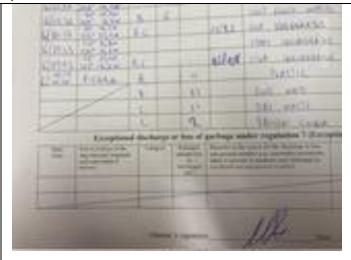
Photo # 3 Image: IMG_1674 Date: 6/7/2024

Description: Garbage Discharge log

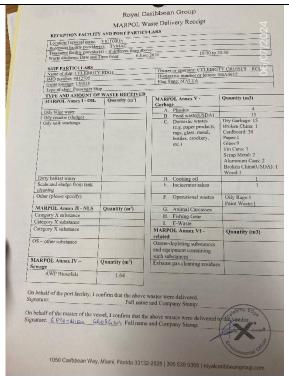
Photo # 5 Image: IMG_1676 Date: 6/7/2024

Description: Waste Delivery Receipt

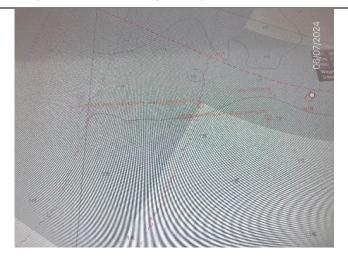
Photo # 7 Image: IMG_1678 Date: 6/7/2024

Taken by: Evan Dobrowski Description: Voyage map

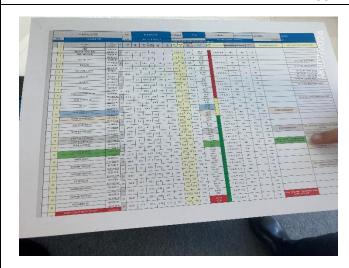
Photo # 8 Image: IMG_1679 Date: 6/7/2024

Taken by: Evan Dobrowski Description: Voyage map

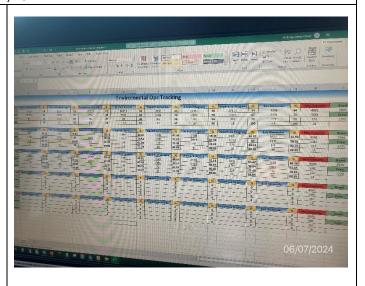
Photo # 11 Image: IMG_1682 Date: 6/7/2024

Description: Guest and Crew capacity logs

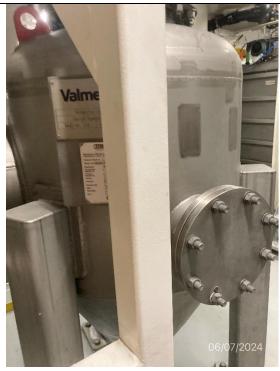
Photo # 41 Image: IMG_1712 Date: 6/7/2024

Description: Valmet Seawater Cyclone - Part of EGCS

system.

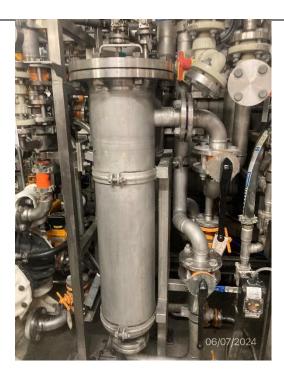
Photo # 42 Image: IMG_1713 Date: 6/7/2024

Description: Valmet Seawater Cyclone - Part of EGCS

system.

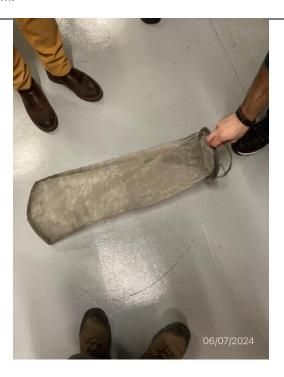
Photo # 43 Image: IMG_1714 Date: 6/7/2024

Taken by: Evan Dobrowski
Description: EGCS filter housing

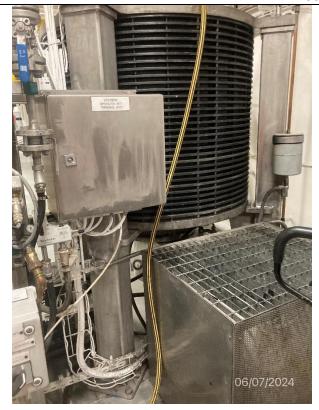
Photo # 44 Image: IMG_1715 Date: 6/7/2024

Taken by: Evan Dobrowski Description: EGCS bag filter

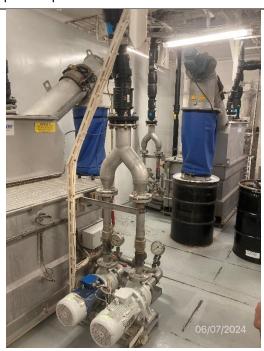
Description: Optifilter Aft Terminal box

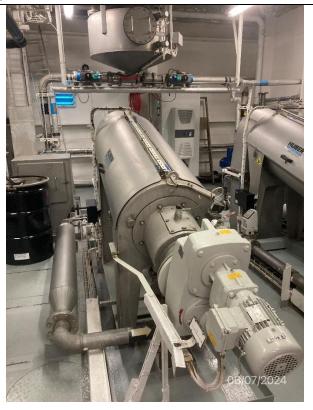
Photo # 47 Image: IMG_1718 Date: 6/7/2024

Description: Blackwater Screening units

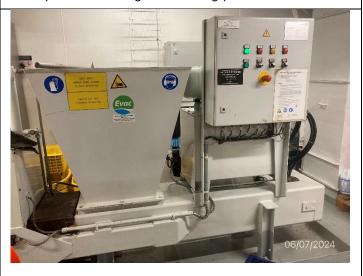
Photo # 51 Image: IMG_1722 Date: 6/7/2024

Description: Broken plates for recycling

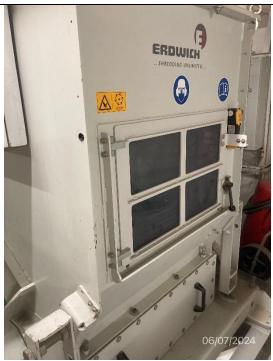
Photo # 52 Image: IMG_1723 Date: 6/7/2024

Taken by: Evan Dobrowski Description: Densifier

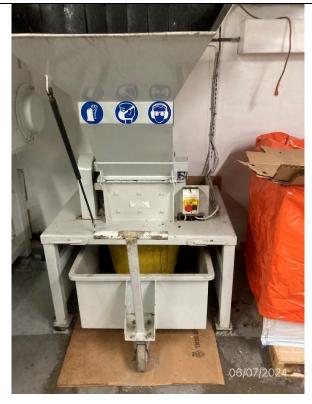
Photo # 53 Image: IMG_1724 Date: 6/7/2024

Taken by: Evan Dobrowski Description: Shredder

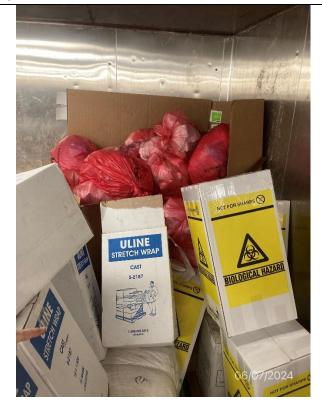
Photo # 57 Image: IMG_1728 Date: 6/7/2024

Taken by: Evan Dobrowski Description: Waste storage locker

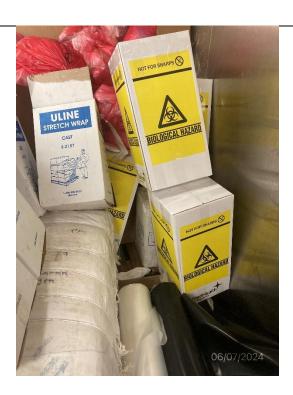
Photo # 58 Image: IMG_1729 Date: 6/7/2024

Taken by: Evan Dobrowski Description: Waste storage locker

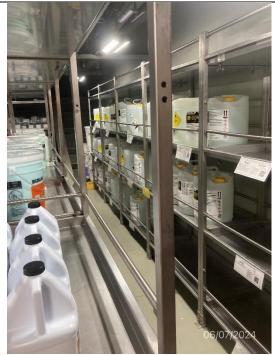
Photo # 59 Image: IMG_1730 Date: 6/7/2024

Taken by: Evan Dobrowski
Description: Waste storage locker

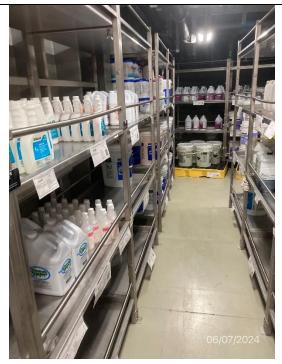
Photo # 60 Image: IMG_1731 Date: 6/7/2024

Description: Laundry Chemical Storage locker.

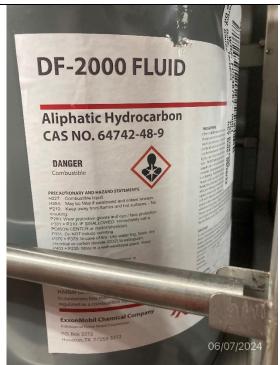
Photo # 61 Image: IMG_1732 Date: 6/7/2024

Description: Laundry Chemical Storage locker.

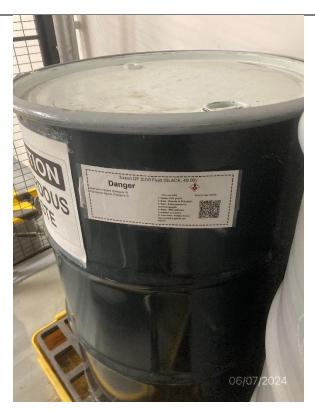
Photo # 62 Image: IMG_1733 Date: 6/7/2024

Description: Laundry chemical DF-2000

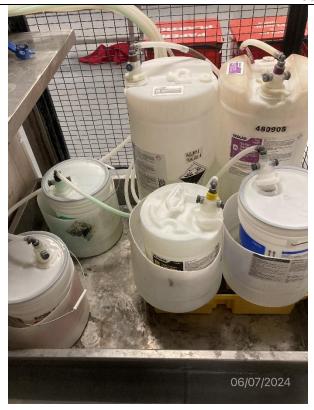
Photo # 64 Image: IMG_1735 Date: 6/7/2024

Description: Laundry chemical DF-2000

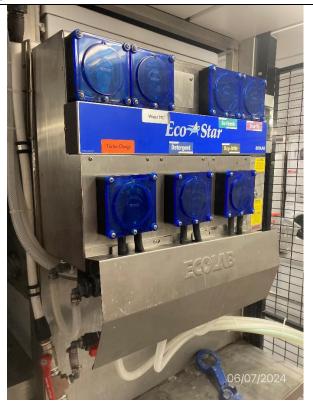
Photo # 67 Image: IMG_1738 Taken by: Evan Dobrowski Date: 6/7/2024

Description: Laundry chemicals in use.
