State of Washington Department of Ecology
Cruise Ship Memorandum of Understanding, Cruise Operations in Washington State Inspection Report

Inspection Date September 9, 2021	Permit Number NA	County King	Receiving Waters Marine Waters	Ecology Inspector Evan Dobrowski & Amy Jankowiak
Entry Time: 09:15	Photos Taken <input checked="" type="checkbox"/> Yes <input type="checkbox"/> No	Samples Taken <input type="checkbox"/> Yes <input checked="" type="checkbox"/> No	Inspection Announced <input checked="" type="checkbox"/> Yes <input type="checkbox"/> No	Discharges to: <input checked="" type="checkbox"/> Surface Water <input type="checkbox"/> Ground Water <input type="checkbox"/> Dewater <input type="checkbox"/> POTW
Exit Time: 11:25

Name and Location of Site Inspected: Silver Muse, SilverSea Cruises Pier 66 Seattle, Washington	Additional Participants/Inspectors: Igor Simovic, Staff Captain
---	---

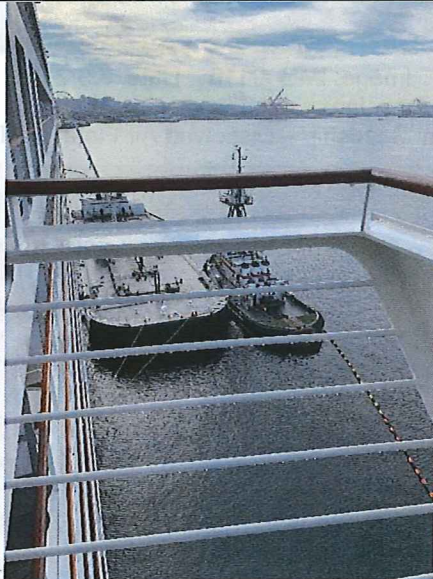
ECA fuel-sulfur compliance is achieved through the use of 0.1% sulfur content fuel (MGO) when in MOU waters, The SILVER MUSE does not have an Exhaust Gas Cleaning System. The vessel is also equipped for shore power, though shore power is not available at Pier 66 in Seattle. The vessel was bunkering fuel (photo #03) during the inspection.

Photo # 3 Image: IMG_0100
Date: 9/9/2021
Taken by: Amy Jankowiak
Description: Bridge – View of bunkering Fuel

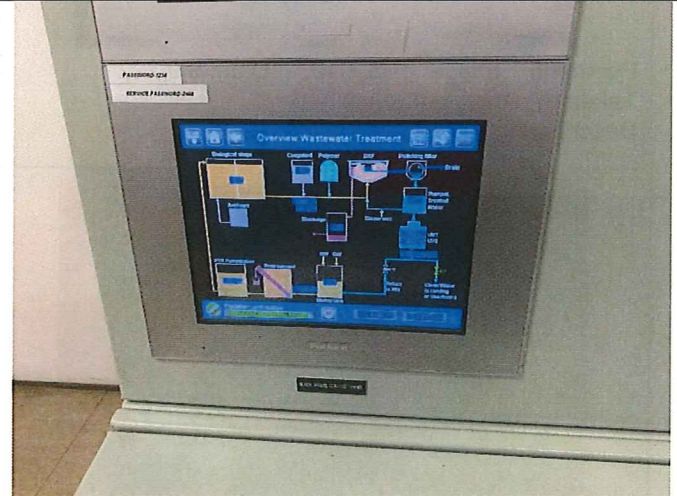
Blackwater and Graywater Scanship system (photo #04):

Black water moves by vacuum to the bio waste silo. From the silo, it goes to the drum screens which provide pre-screening. Blackwater liquid goes to the drum screens then enters the biosteps (bioreactor) (photo #14). Graywater is collected in mixing tanks and then mixes with blackwater at the biosteps. Solids from the pre-screen sent to the bioresidue tank. Gray water consists of sink, shower, galley water and laundry water. Anti-foamer is added to at the biological stage (photo #05). Biological treatment (biofilm on rotating plastic pieces with air added) occurs in the Biostep bioreactor.

Photo # 4 Image: IMG_0102
Date: 9/9/2021
Taken by: Amy Jankowiak
Description: Scanship Schematic

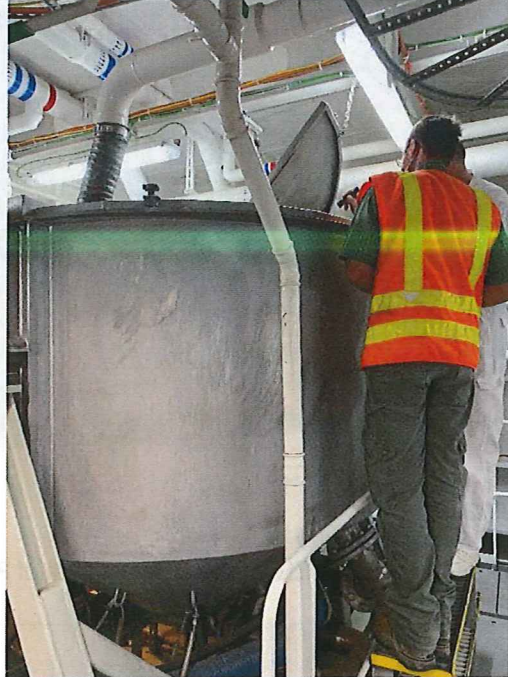
After the biostep, polymers and coagulants are added. Liquid then moves to the Dissolved Air Flotation (DAF) tanks (photo #06) for clarification. An air and water mixture is added to the bottom of the flotation tanks to keep turbulence at the bottom and to allow the solids to rise to the top, along with the help of the chemical addition. Skimmers on the top skim the solids into a sludge pocket which is then pumped to the bioresidue tank which is discharged outside of MOU

Photo # 6 Image: IMG_0110 Date: 9/9/2021
Taken by: Amy Jankowiak
Description: Scanship – Dissolved Air Flotation (DAF)

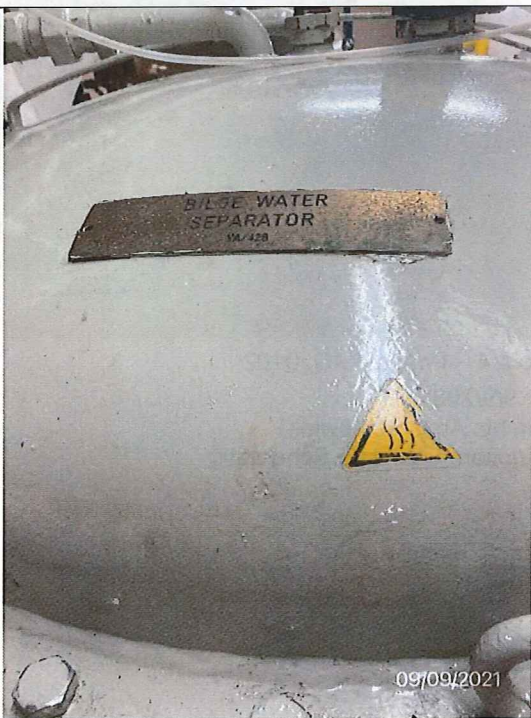
Oily bilge water is collected to the dirty bilge-settling tank and is treated with an oily water separator system (OWS) (photo #07 and #17). The oily bilge is treated to less than 15 parts per million (ppm) oil content. Prior to discharge, the clean bilge is sent through "white box" (photo #10) which can't be bypassed and doesn't allow discharges of greater than 15 ppm. The treated oily bilge water is then discharged outside of MOU related waters at a maximum of 15 ppm, and outside of MOU related waters. The Chief Engineer has the one key to the white box, and discharges of clean bilge and offloads of oily sludge are recorded in the Oil record Book. No bypasses or re-routing around the OWS or white box has been known to occur. While in MOU waters Oily Bilge water is not treated and instead collected and hauled to shore collection via MarVac and Stericycle.

Photo # 7 Image: IMG_0248 Date: 9/9/2021
Taken by: Evan Dobrowski
Description: Bilge – oily water separator (OWS)

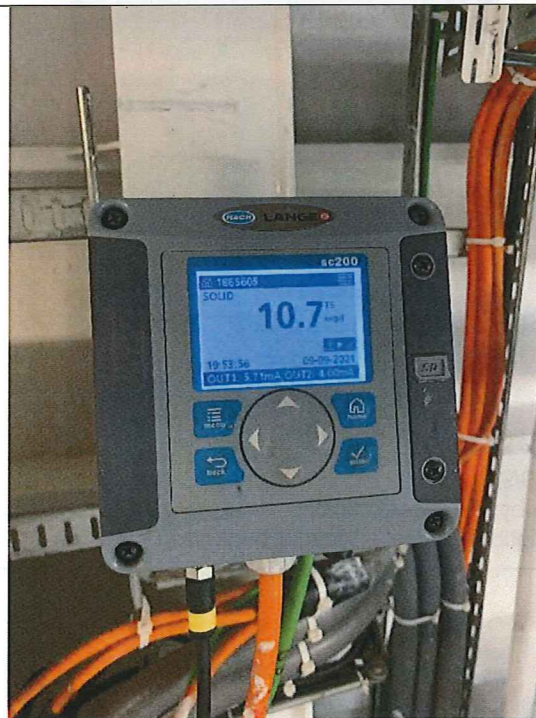
Total suspended solids (TSS) (equivalent to turbidity) is monitored continuously at UV disinfection (photo #08). At the time of the inspection, the TSS was 10.6 mg/l. If TSS exceeds 30 mg/l, the system automatically stops discharging and holds. PH is also monitored for adjustments. There are several monitors throughout the system that are used to access controls as well as in the ECR. The vessel conducts its own laboratory monitoring for process control, splits samples with a land-based lab for comparability. The vessel is approved to discharge continuously in Alaska, which has additional monitoring requirements.

Photo # 8 Image: IMG_0114 Date: 9/9/2021
Taken by: Amy Jankowiak
Description: Scanship – TSS reading

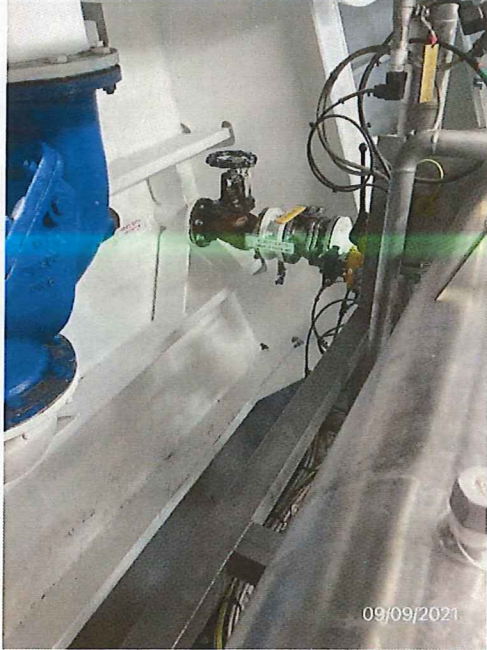
Flow then moves to ultraviolet (UV) light disinfection (photo #11). There are two large UV units, which work in sequence. The UV system is alarmed for bulb failure and intensity. Flow from the UV units either is discharged directly overboard via the discharge port (if in an area of allowed discharge)(photo #09) or is re-circulated to the mixing tanks.

Photo # 9 Image: IMG_0241 Date: 9/9/2021
Taken by: Evan Dobrowski
Description: Scanship – Overboard Discharge Port (Padlocked)

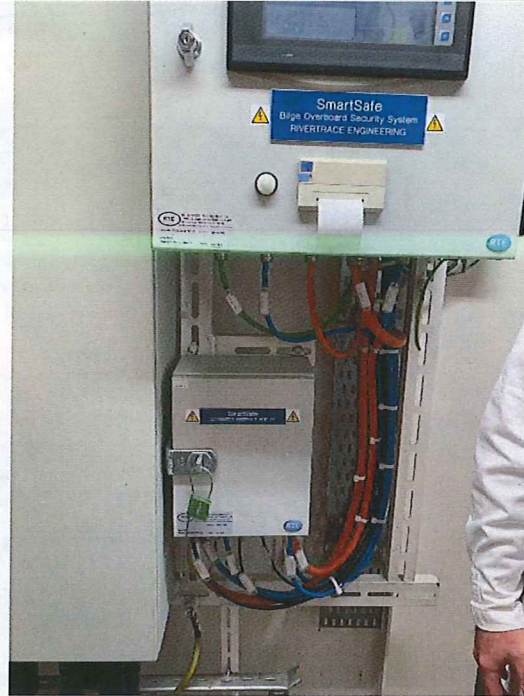
Photo # 10 Image: IMG_0127 Date: 9/9/2021
Taken by: Amy Jankowiak
Description: Bilge – White Box

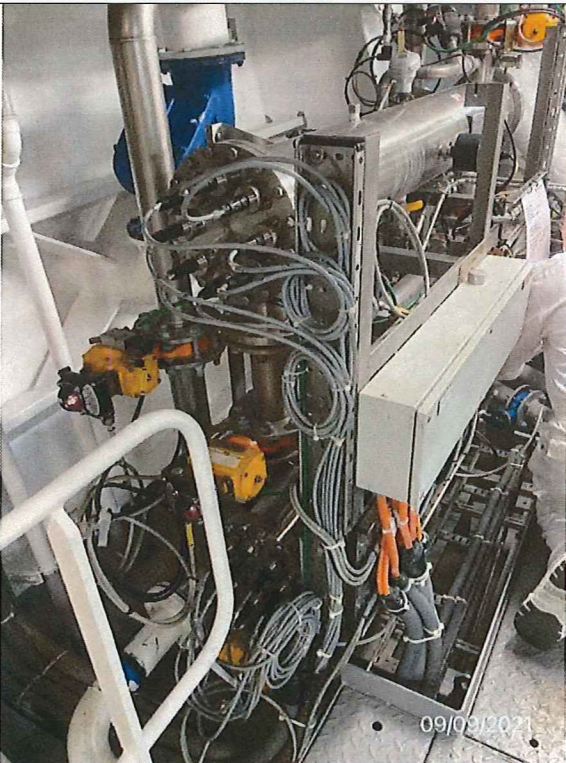
Photo # 11 Image: IMG_0240 Date: 9/9/2021
Taken by: Evan Dobrowski
Description: Scanship UV

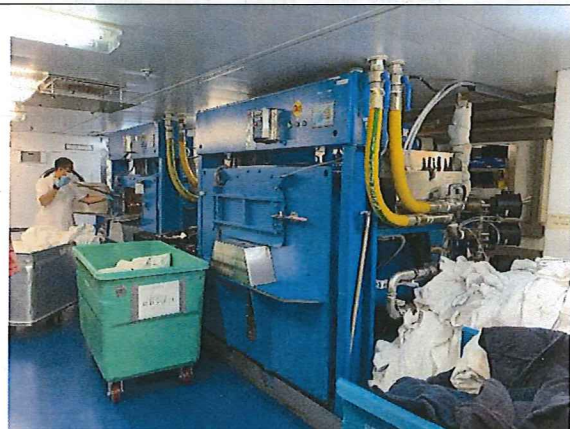
Dry cleaning is not done on board. Laundry (photo #12 and #28) water is sent to the Scanship treatment system and discharged outside of MOU related waters.

Photo # 12 Image: IMG_0119 Date: 9/9/2021
Taken by: Amy Jankowiak
Description: Laundry Room

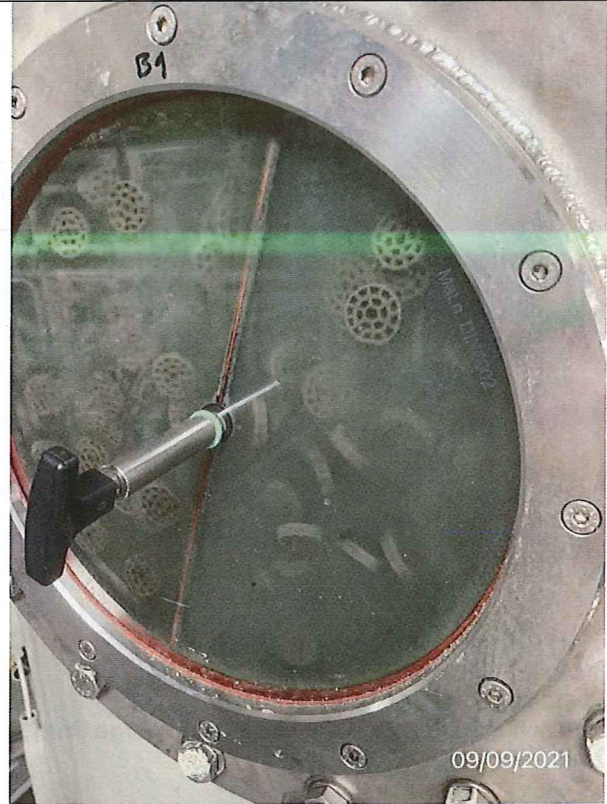
Photo # 14 Image: IMG_0223 Date: 9/9/2021
Taken by: Evan Dobrowski
Description: Scanship Biostep

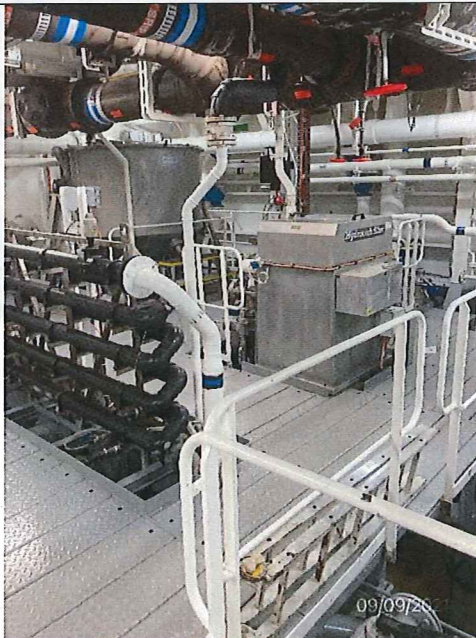
related waters and more than 12 miles. Liquid flow then moves to the polishing filters (photos #15 and #16) for ultrafiltration.

Photo # 15 Image: IMG_0071 Date: 9/9/2021
Taken by: Evan Dobrowski
Description: Scanship polishing filters

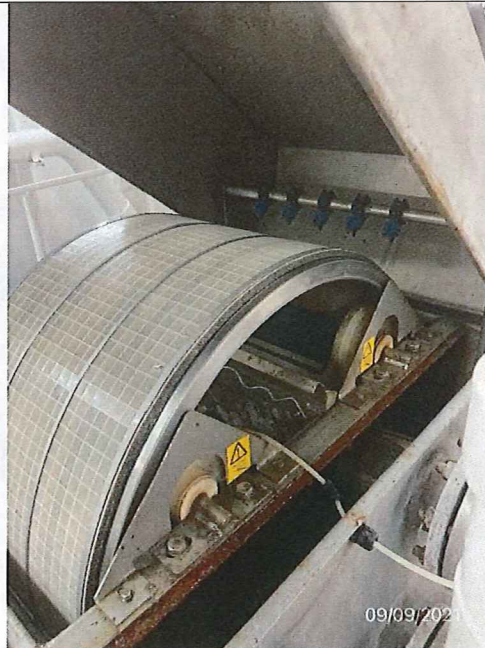
Photo # 16 Image: IMG_0233 Date: 9/9/2021
Taken by: Evan Dobrowski
Description: Scanship polishing filters - inside

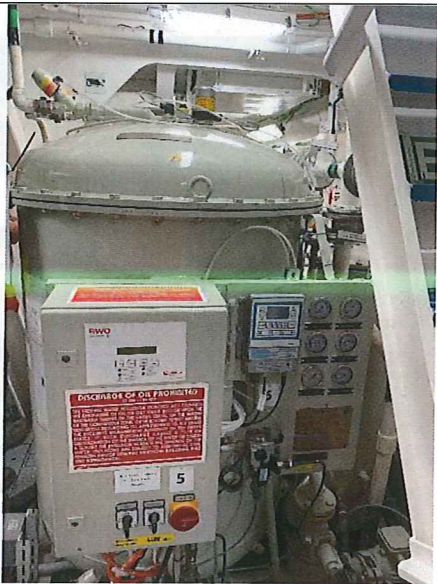
Photo # 17 Image: IMG_0123 Date: 9/9/2021
Taken by: Amy Jankowiak
Description: Bilge – Oil Water Separator

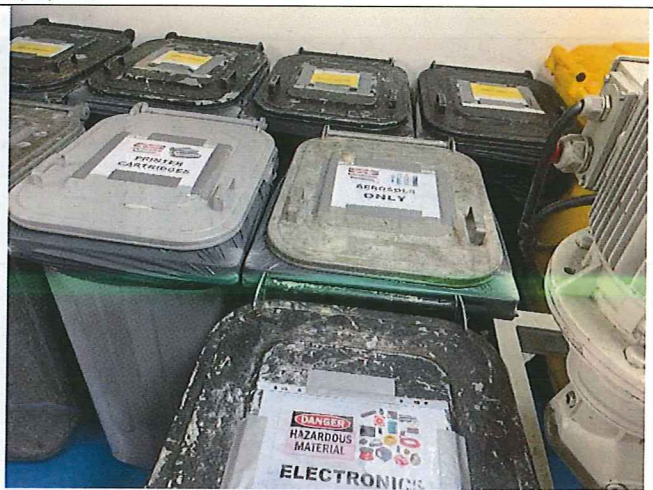
No photo waste is created onboard. X-rays are done digitally without any waste. Fluorescent bulbs are boxes and offloaded, not crushed on board. Hazardous waste materials are stored separately (photo #18) and offloaded. Solid waste (garbage, recyclables (photo #20), etc) is collected, sorted (photo #19), and either reused, recycled, incinerated (photo #22) or off-loaded to shore as appropriate. Waste minimization efforts are done by tracking, material usage

Photo # 18 Image: IMG_0130 Date: 9/9/2021
Taken by: Amy Jankowiak
Description: Garbage Room – Sorted Hazardous Wastes

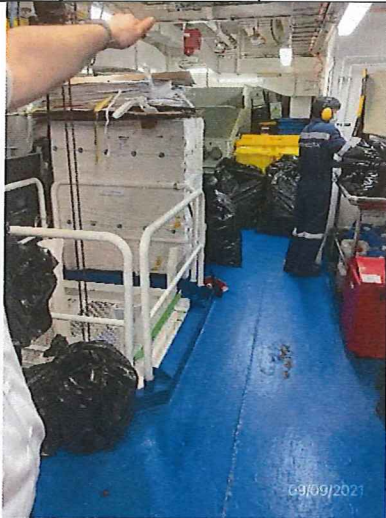
Photo # 19 Image: IMG_0256 Date: 9/9/2021
Taken by: Evan Dobrowski
Description: Garbage Room (GR)

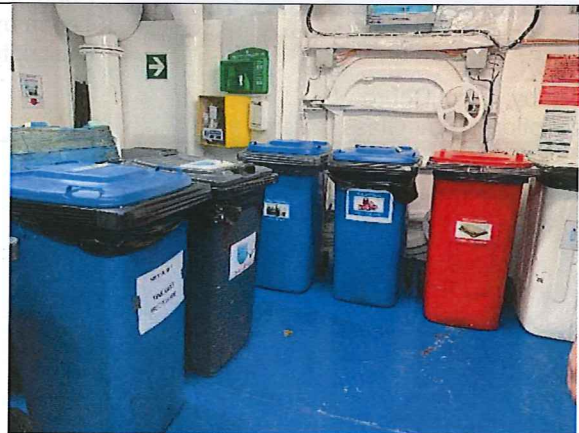
Photo # 20 Image: IMG_0129 Date: 9/9/2021
Taken by: Amy Jankowiak
Description: GR – Garbage/Recycling Sorted

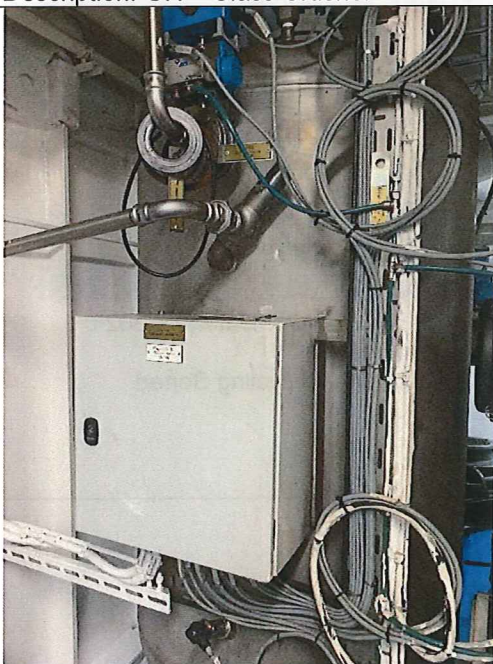
Food waste is sorted at the source (photo #26) in galleys with a screen prior to the pulper (photo #25). Food is pulped to less than 25 nm and is sent vacuum (photo #23) to the food tank (photo #25) and discharged outside of MOU related waters. Galleys use Ecolab phosphate free and non-toxic detergents and degreasers. Food waste discharges are logged in the Garbage Record Book.

Photo # 23 Image: IMG_0132 Date: 9/9/2021
 Taken by: Amy Jankowiak
 Description: Food Waste Vacuum

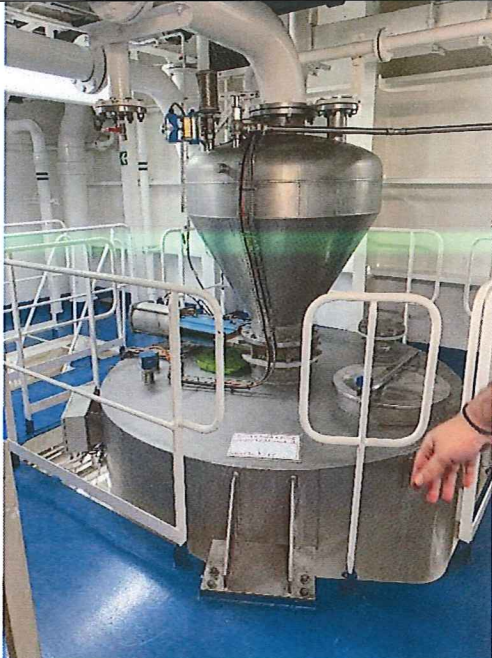
Photo # 25 Image: IMG_0133 Date: 9/9/2021
Taken by: Amy Jankowiak
Description: Food Waste Collection tank

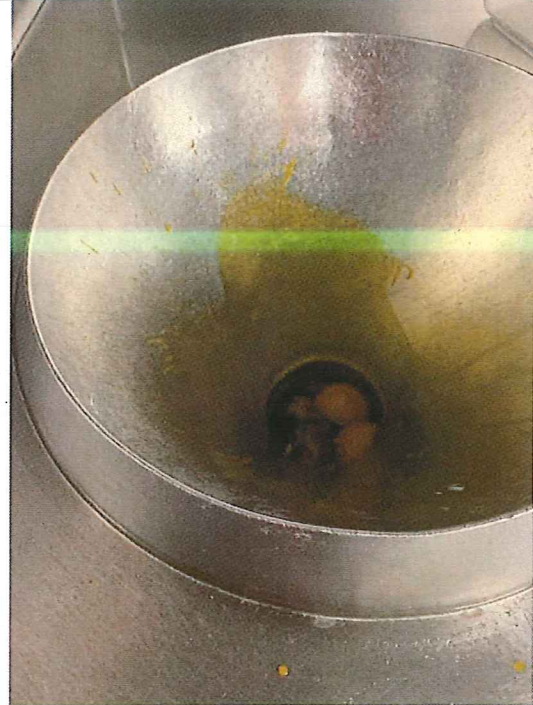
Photo # 26 Image: IMG_0137 Date: 9/9/2021
Taken by: Amy Jankowiak
Description: Galley – Pulper screen

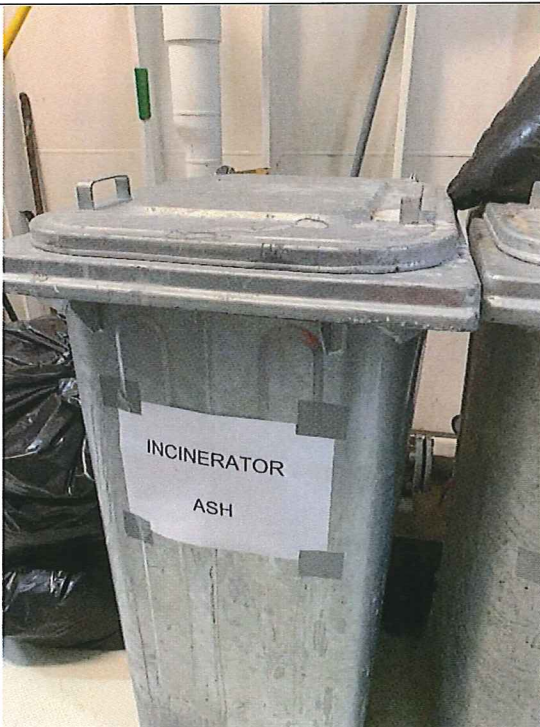
analysis, and minimizing materials such as single-use plastics. Solid and hazardous waste is offloaded in Seattle during this route this season using Stericycle and Waste Management. Hazardous waste offload records were reviewed. The incinerator is used primarily for cardboard that can't be recycled and some soft plastics. Incinerator ash (photo #27) is offloaded after testing as non-hazardous waste.

Photo # 27 Image: IMG_0136 Date: 9/9/2021
Taken by: Amy Jankowiak
Description: Garbage Room – Incinerator Ash

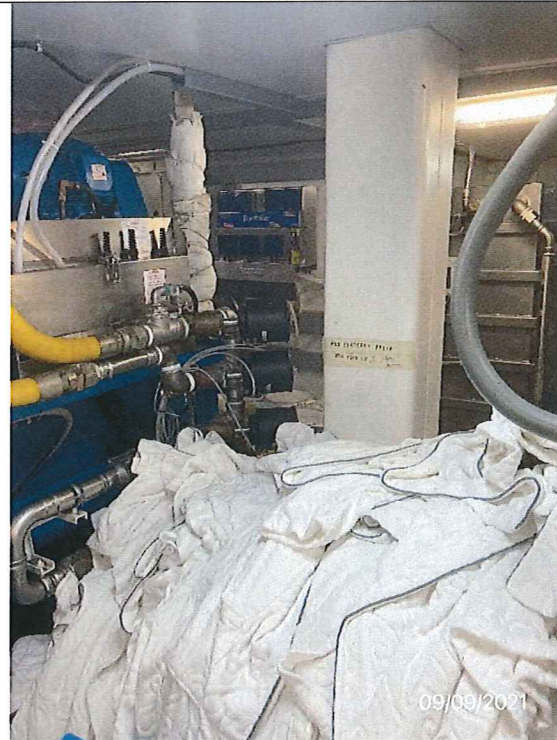
Photo # 28 Image: IMG_0242 Date: 9/9/2021
Taken by: Evan Dobrowski
Description: Laundry – Chem storage
