State of Washington Department of Ecology  
**Cruise Ship Memorandum of Understanding, Cruise Operations in Washington State Inspection Report**

Evan Dobrowski, Washington State Department of Ecology (Ecology) Northwest Regional Office, Water Quality Program (NWRO-WQ) conducted the inspection of the Princess Cruise Lines, MAJESTIC PRINCESS on July 14, 2024. The main contact on board the MAJESTIC PRINCESS was Constantin Samoila, Environmental Officer (EO) for the vessel; Alessandro Costaguola, Staff Chief Engineer also accompanied us for part of the inspection. Jessica Kasmari, Ecology Water Quality Program also joined us for the inspection. Prior notification of the visit was given on June 27, 2024, for security protocol. The purpose of the inspection was to evaluate compliance with the *Memorandum of Understanding Cruise Operations in Washington State* (MOU), as amended. The MAJESTIC PRINCESS is not approved to discharge wastewater in MOU waters.

**PHOTO ADDENDUM – MAJESTIC PRINCESS  
PRINCESS CRUISE LINES JULY 14, 2024**

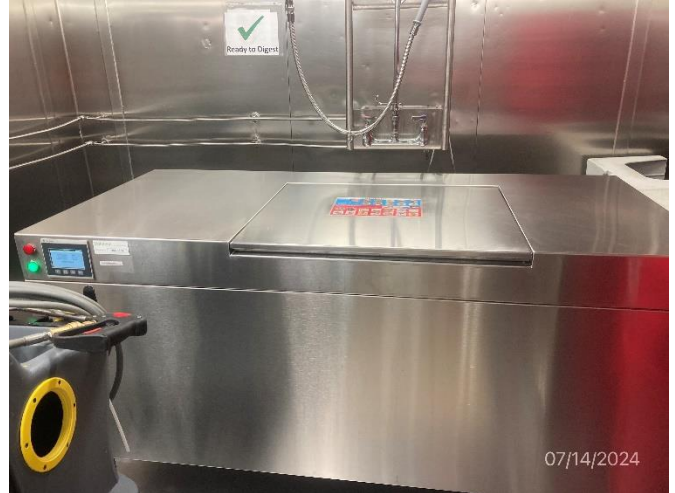
Photo # 2 Image: IMG\_1798 Date: 7/14/2024  
Taken by: Evan Dobrowski  
Description: Photo of Bi Hi-Tech Digester

Food waste is sorted by hand and sent from the galleys to ten biodigesters if soft food all liquids go to the food waste holding tanks. If hard food, it goes to the bio-grinders and then to the incinerator or offloaded to shore. A grease separator collects grease from the galleys and is combined with used cooking oil for onshore recycling in Victoria. Food waste discharges are logged in the NAPA system.

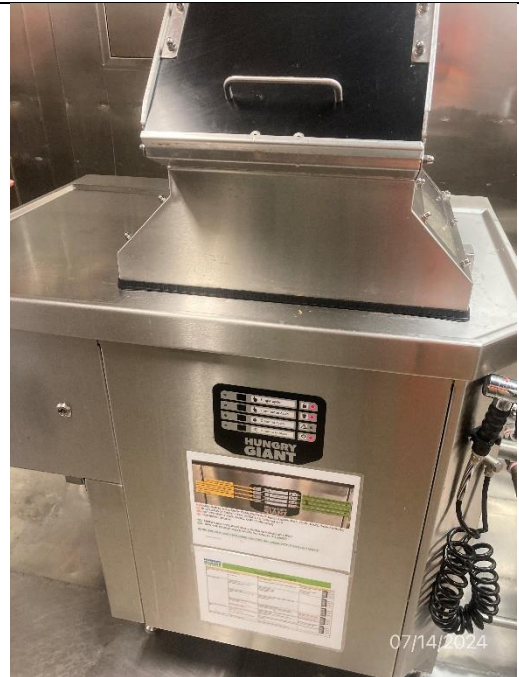
Photo # 4 Image: IMG\_1802 Date: 7/14/2024  
Taken by: Evan Dobrowski  
Description: Photo of Hungry Giant organics recycling unit.

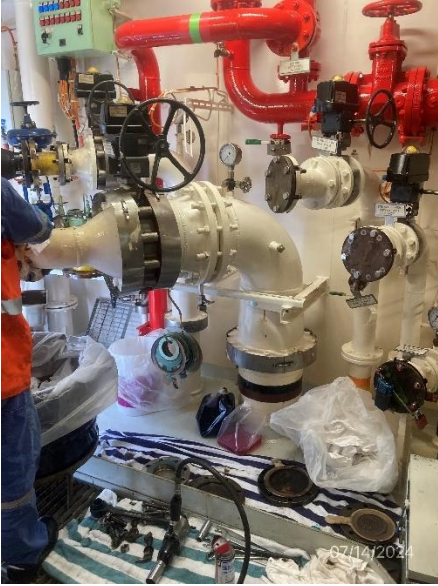
Photo # 5 Image: IMG\_1803 Date: 7/14/2024  
Taken by: Evan Dobrowski  
Description: Photo of fuel transfer room.

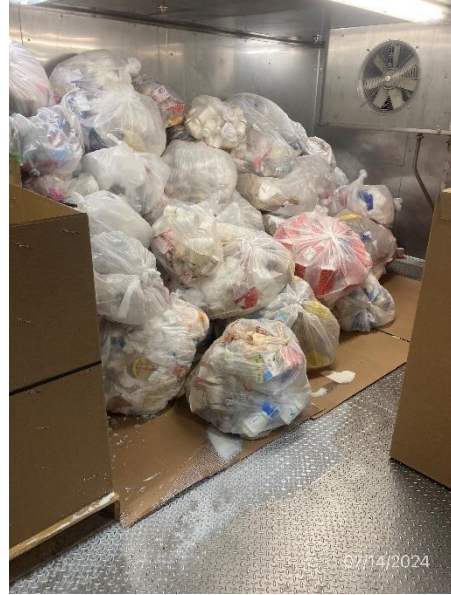
Photo # 6 Image: IMG\_1807 Date: 7/14/2024  
Taken by: Evan Dobrowski  
Description: Photo of sorting room trash holding area.

Solid waste (garbage, recyclables, etc) is collected, sorted, and either reused, recycled, incinerated or off-loaded to shore in Victoria on this route as appropriate.

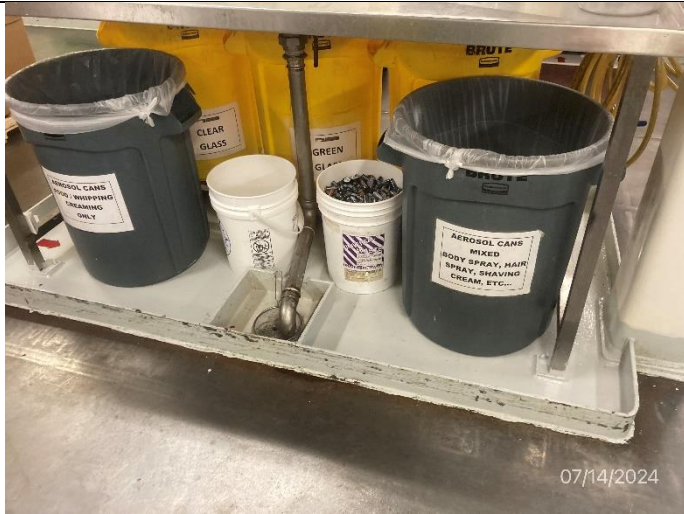
Photo # 7 Image: IMG\_1808 Date: 7/14/2024  
Taken by: Evan Dobrowski  
Description: Photo of sorting room battery and aerosol can storage.

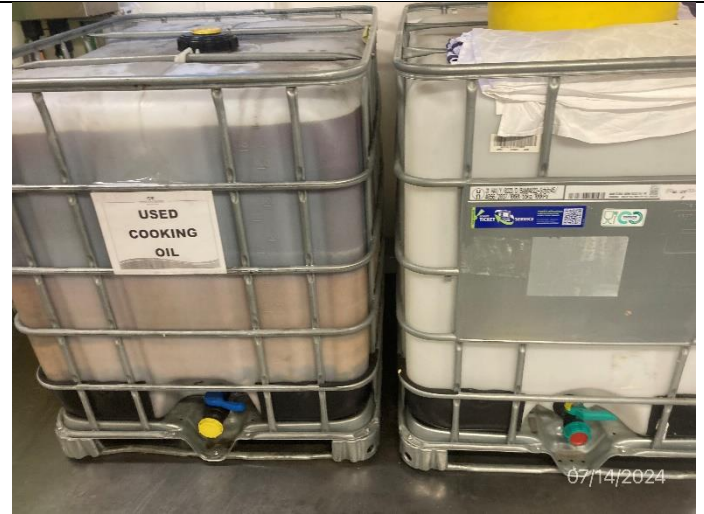
Photo # 8 Image: IMG\_1809 Date: 7/14/2024  
Taken by: Evan Dobrowski  
Description: Photo of used cooking oil storage.

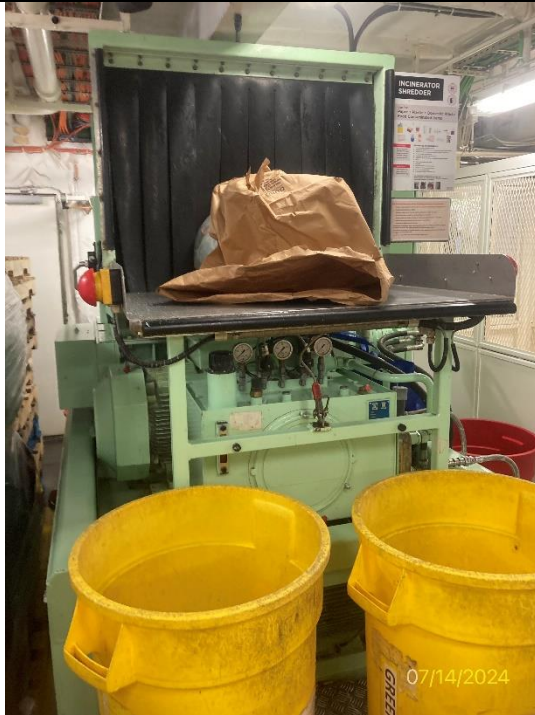
Photo # 11 Image: IMG\_1813 Date: 7/14/2024  
Taken by: Evan Dobrowski  
Description: Photo of incinerator shoot inside garbage sorting room.

Hazardous waste is not offloaded in Seattle, only in Victoria on this route. Incinerators are not used in port, only underway.

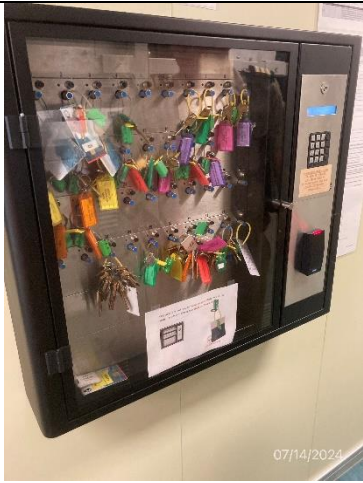
Photo # 13 Image: IMG\_1822 Date: 7/14/2024  
Taken by: Evan Dobrowski  
Description: Photo of keylock system.

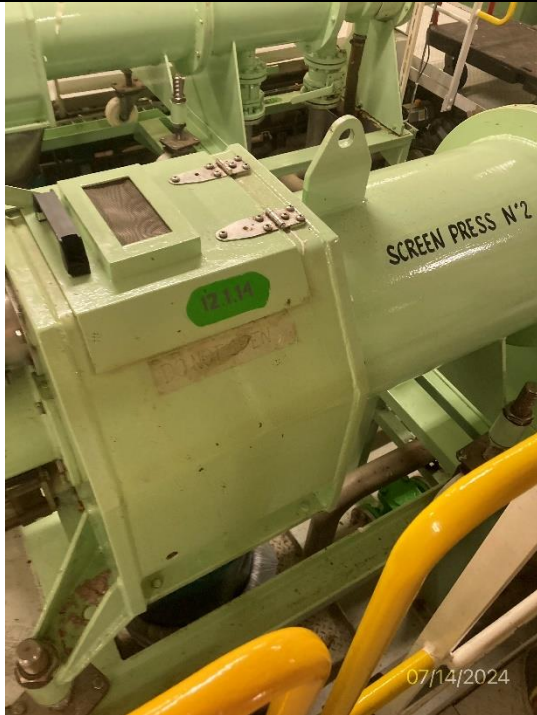
Photo # 15 Image: IMG\_1824 Date: 7/14/2024  
Taken by: Evan Dobrowski  
Description: Photo of Wartsila MBR system Screen Press.

There are two MBR's on the vessel and the system is designed to treat both black and grey water; but can be used in several methods to segregate black and grey water. The first step is a prescreening press which filters out coarse solids for both black and grey water. The second step is an aerated blackwater/greywater holding tank which feed to the MBR 1<sup>st</sup> stage of antifoam dosing and mixing. After this is the biological processing followed by a two stage MBR fine filtration process. Black water, which includes toilet waste, and infirmity drains moves by vacuum to Evac collection tanks. From the collection tanks, it goes to the screener. Solids are sent to the biowaste tank, then to the incinerator and liquid moves to a tank and is then pumped through the system. Gray water consists of sink, shower, galley water, laundry water and potentially pool water and is collected in one of two mixing tanks. From the mixing tanks, the liquid moves to the 5-step MBR for treatment. A defoamer can be used to control foam prior to the MBR treatment. Grease from the galleys is collected to prevent it from entering and interfering with the Wartsila MBR AWP.

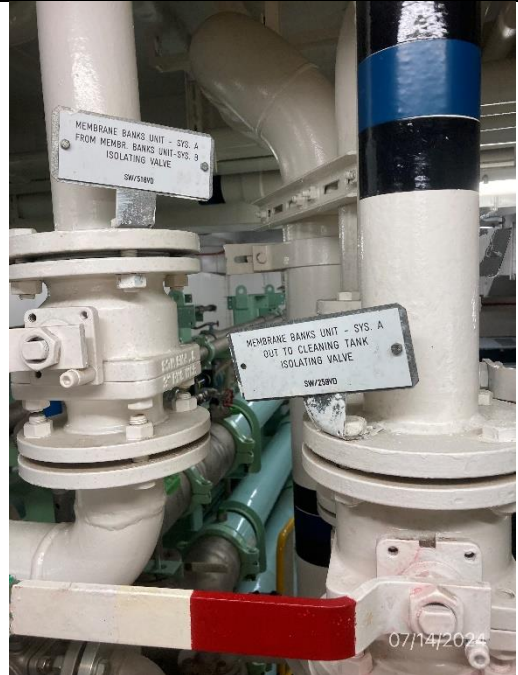
Photo # 16 Image: IMG\_1828 Date: 7/14/2024  
Taken by: Evan Dobrowski  
Description: Photo of Wartsila MBR isolation valves.

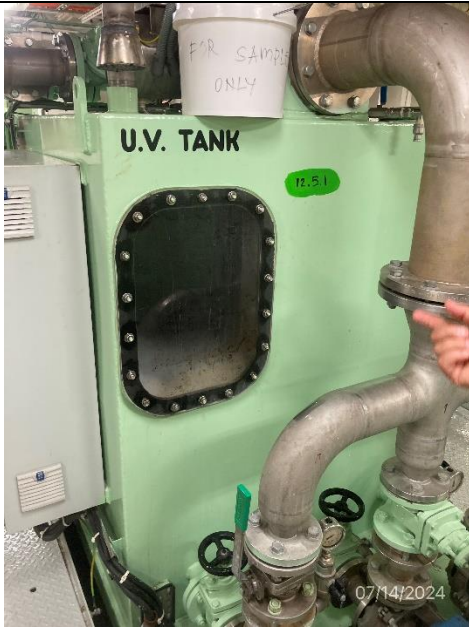
Photo # 17 Image: IMG\_1833 Date: 7/14/2024  
Taken by: Evan Dobrowski  
Description: Photo showing UV tank for MBR system.

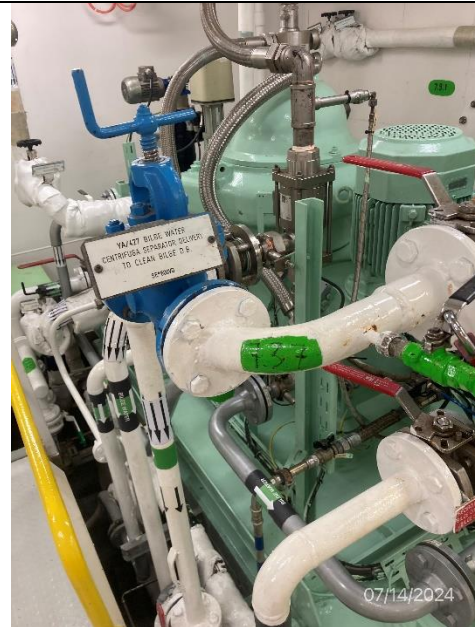
Photo # 18 Image: IMG\_1838 Date: 7/14/2024  
Taken by: Evan Dobrowski  
Description: Photo showing bilge water centrifugal separator.

Oily bilge water is treated with one centrifugal oily water separators (OWS). This includes pumping oily bilge water to a settling tank, then onto processing in the OWS. From there the clean bilge goes to the Clean Bilge Tank and is then discharged if in an area approved – outside of MOU related waters. A white box is used to only allow discharges at less than 5 ppm oil content

maximum. Any treated bilge that does not meet that level is sent by y-valve to the dirty bilge tank and onto the dirty bilge settling tank for re-processing. The discharge protocol is to discharge treated oily bilge at less than 5 ppm outside of MOU related waters, at sea. The EO confirmed that he is not aware of any rerouting of oily bilge and that any staff can report concerns. Reports can be made through the staff/line or through the IMO whistleblower reporting. The OWS were off and recirculating during the inspection and not discharging.

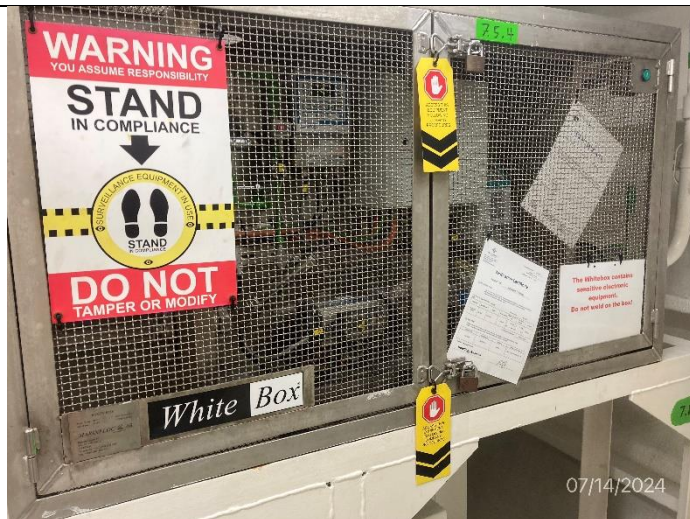
Photo # 19 Image: IMG\_1841 Date: 7/14/2024  
Taken by: Evan Dobrowski  
Description: Photo showing double locked marinfloc white box system.

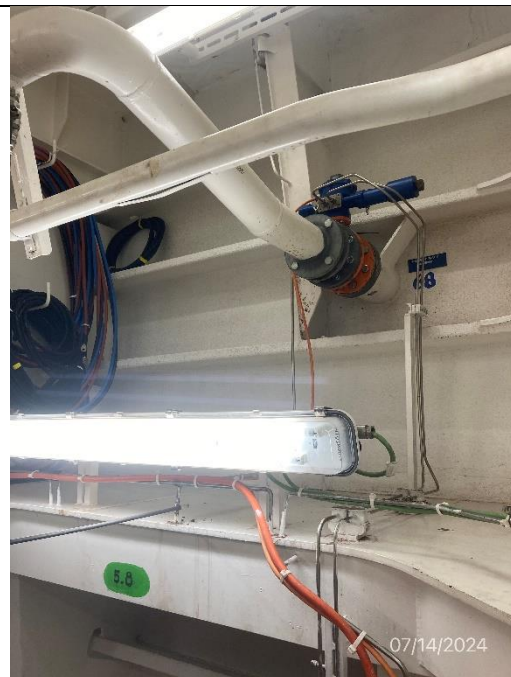
Photo # 20 Image: IMG\_1844 Date: 7/14/2024  
Taken by: Evan Dobrowski  
Description: Photo showing overboard discharge with electronic locking system.

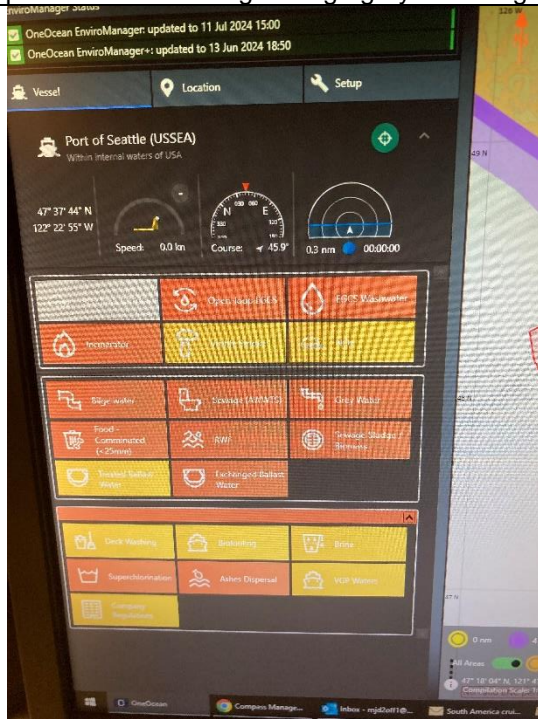
Photo # 23 Image: IMG\_1850 Date: 7/14/2024  
Taken by: Evan Dobrowski  
Description: Photo showing OneOcean EnviroManager data.
