PSI Cleanup Sites – Port Gardner

Sound Living Conference
October 25, 2014

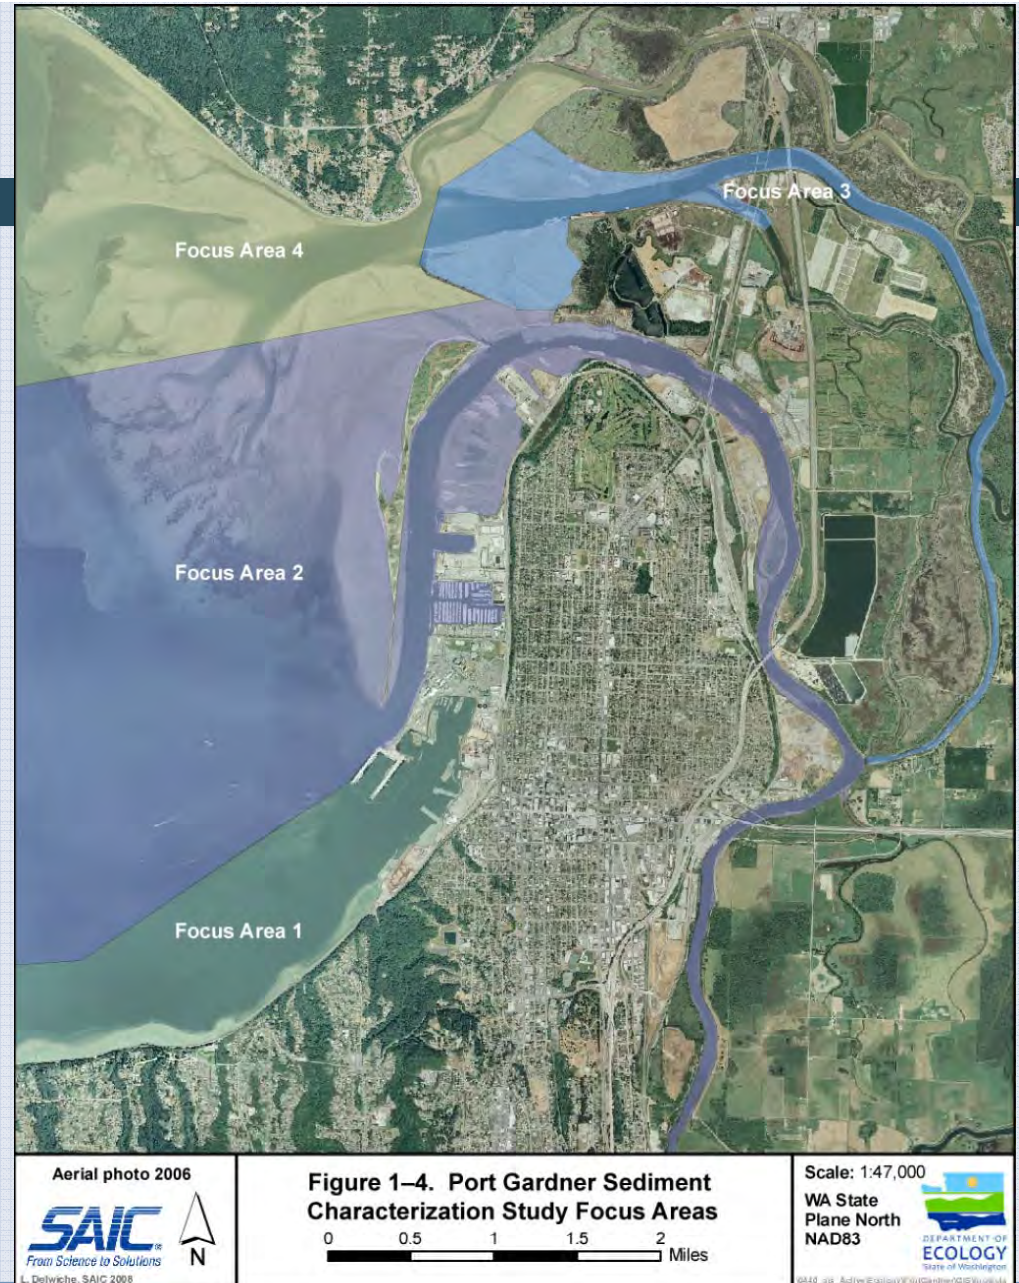
2008 Baywide Study

- ❑ 82 sampling locations
- ❑ General condition of the sediments
- ❑ Distribution of wood waste

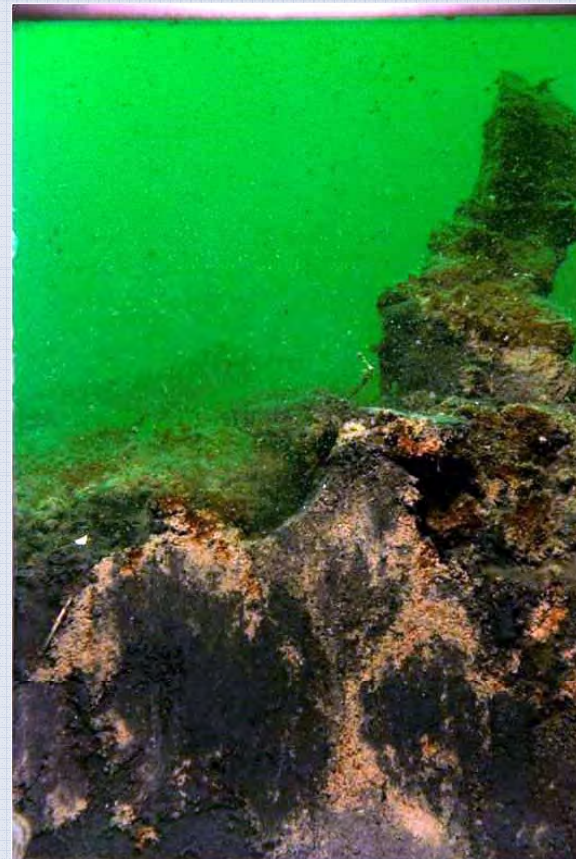
Wood Waste – Anoxic Conditions – East Waterway

- ❑ **East Waterway/Mill A sediments are the most impacted**
 - Biological toxicity and chemical exceedances
 - Higher levels of Dioxins/Furans
 - Highest wood debris accumulations
- ❑ **Maulsby Mudflats and Sloughs**
 - Biological toxicity
 - Lower levels of Dioxin/Furans
- ❑ **Tissue**
 - **Metals** – Arsenic, copper, and zinc had the highest concentrations
 - **PCBs** – Non-detect in the tissue meat; detected in the fatty material (i.e., hepatopancreas)
 - **Dioxins/Furans** – Detected in the tissue meat; high concentrations in the fatty material
- ❑ **Department of Health** completed a health consult

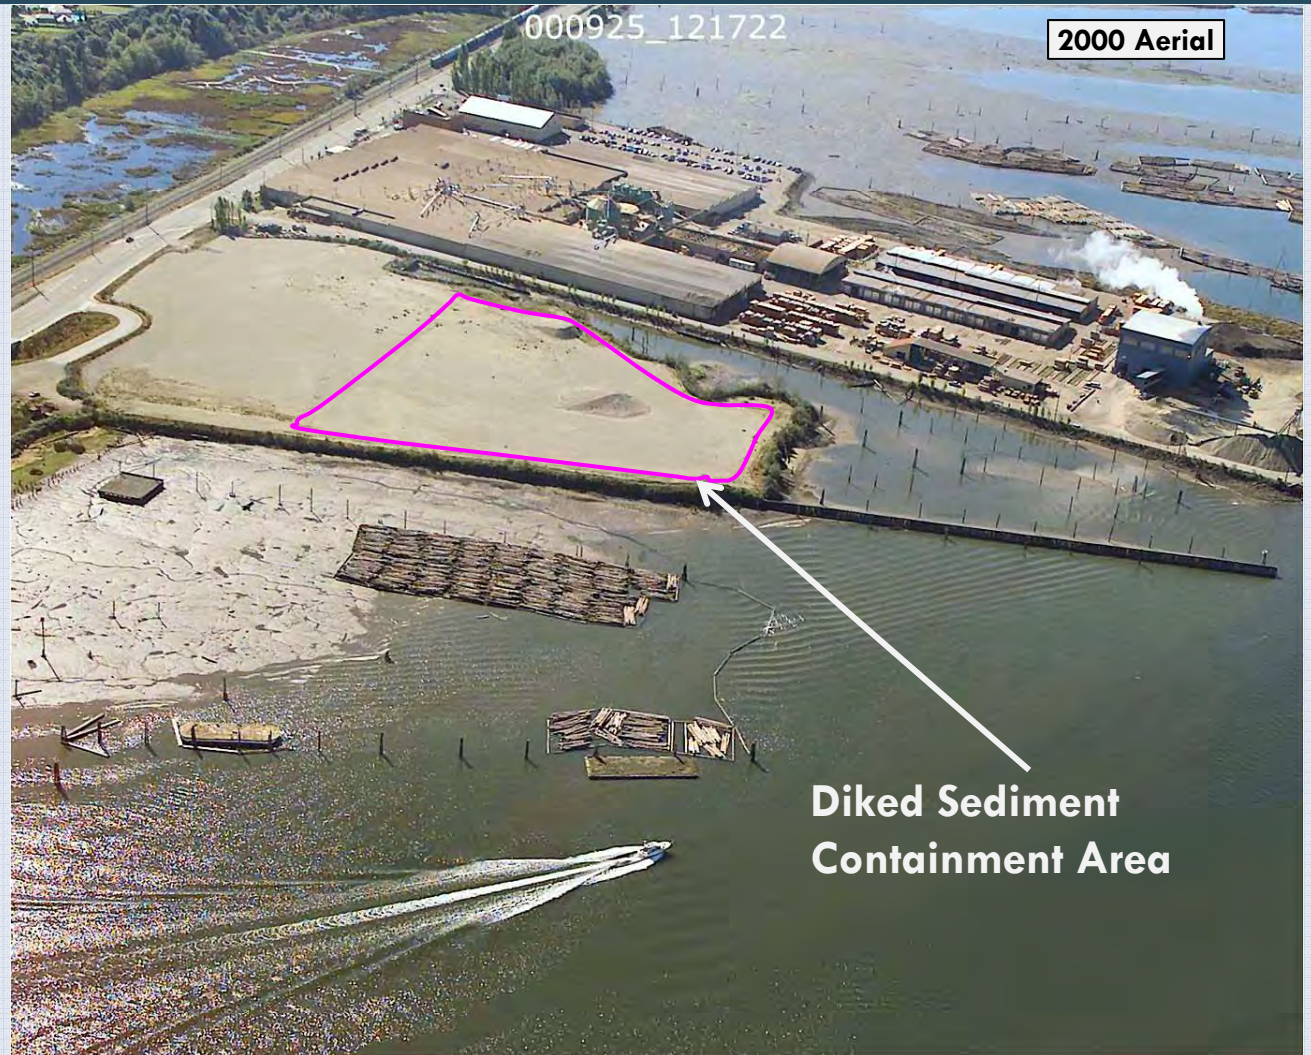
**Wood Waste
Removal Area**

- PCB Removal – 10 cu yds
- Wood Waste Removal – 140,000 cu yds
- Pile Removal – 8,000 cu yds

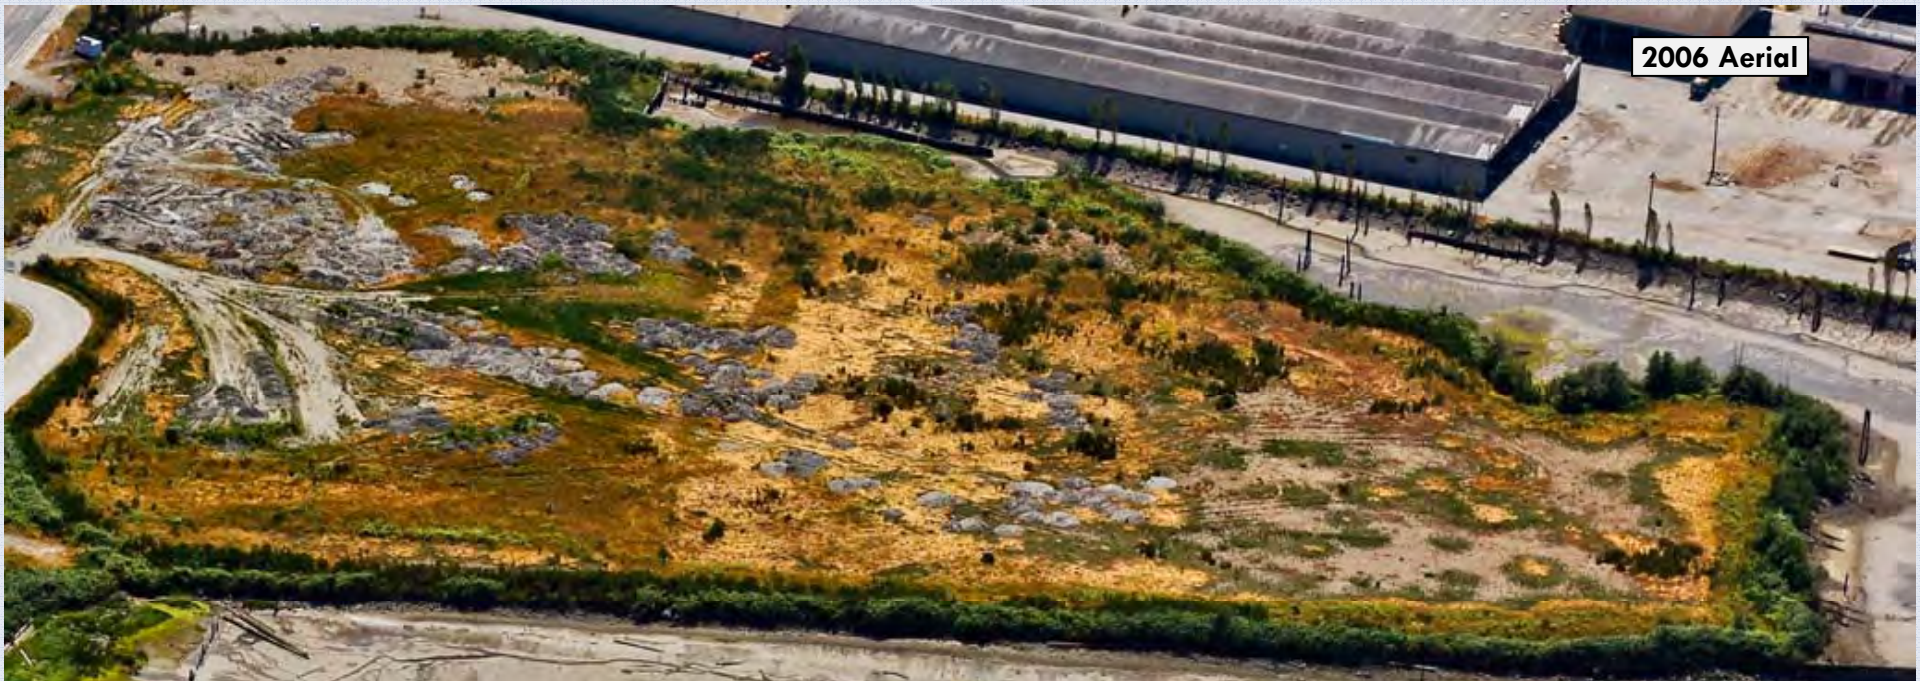
Upland Soil Stockpiles

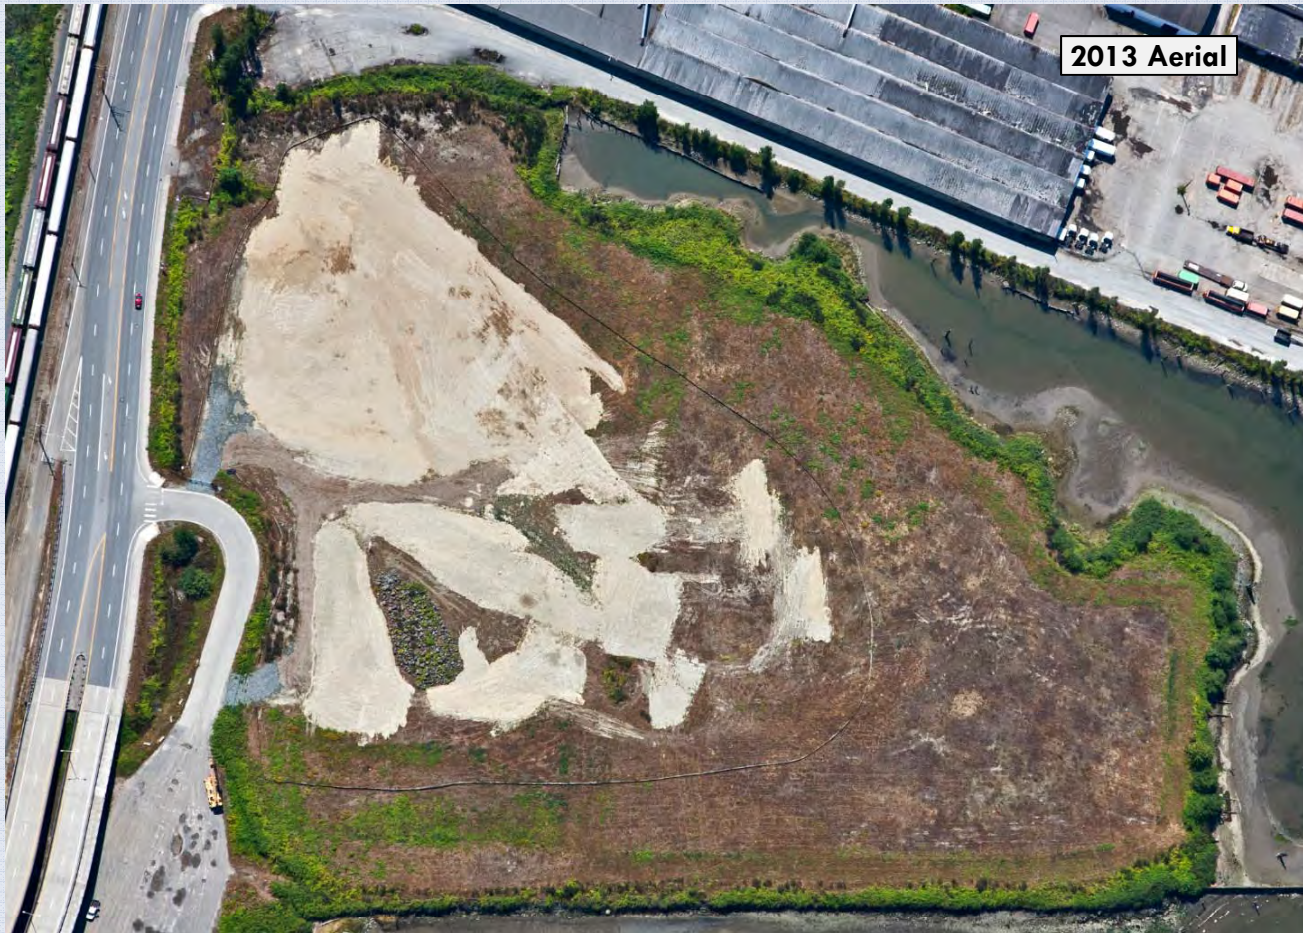
Contaminated Pile Removal

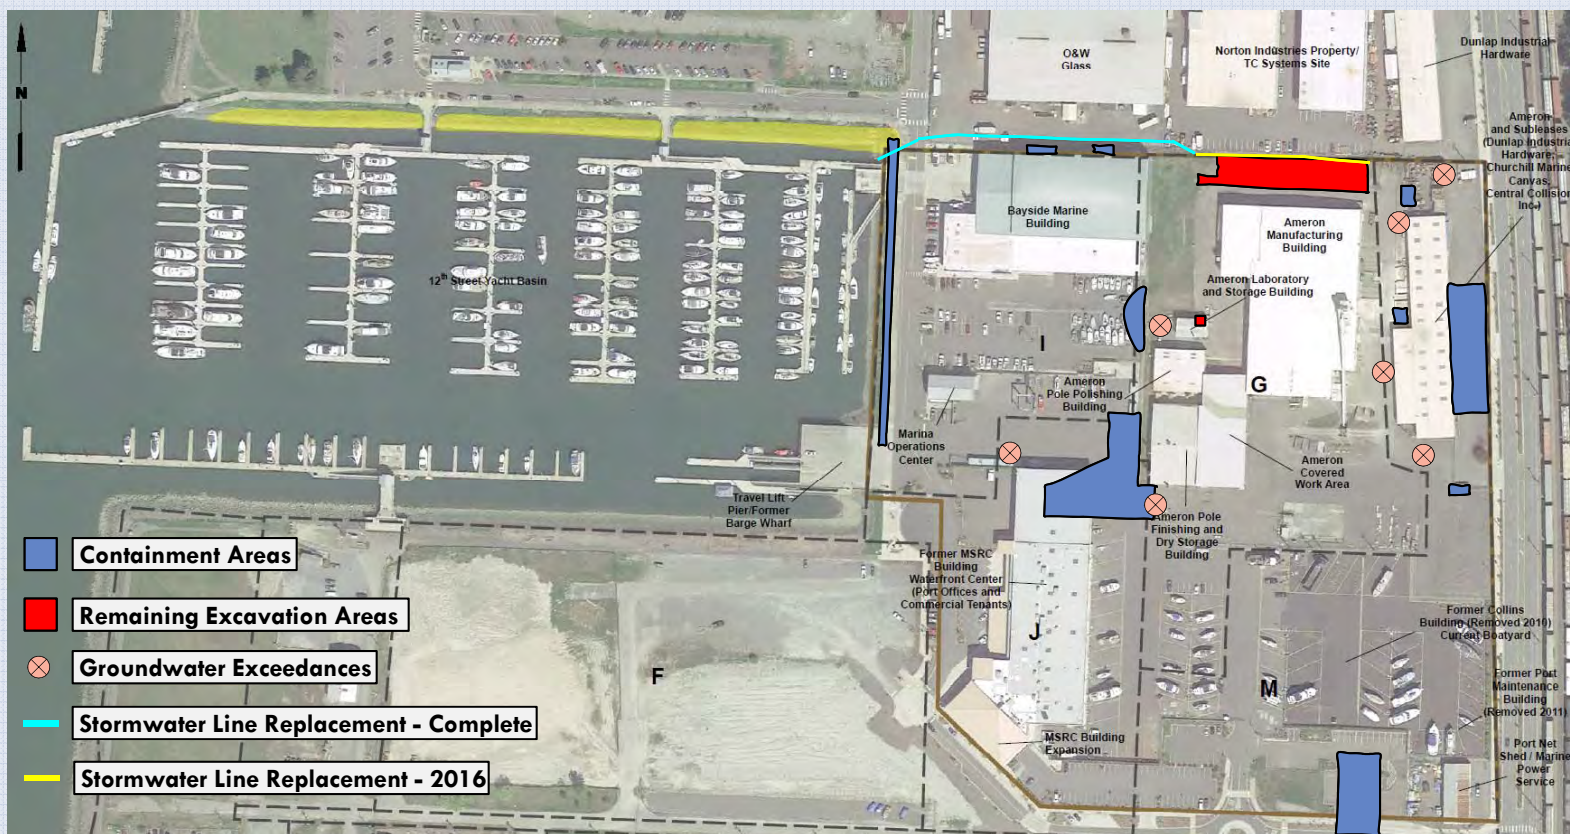
Cleanup Action Areas

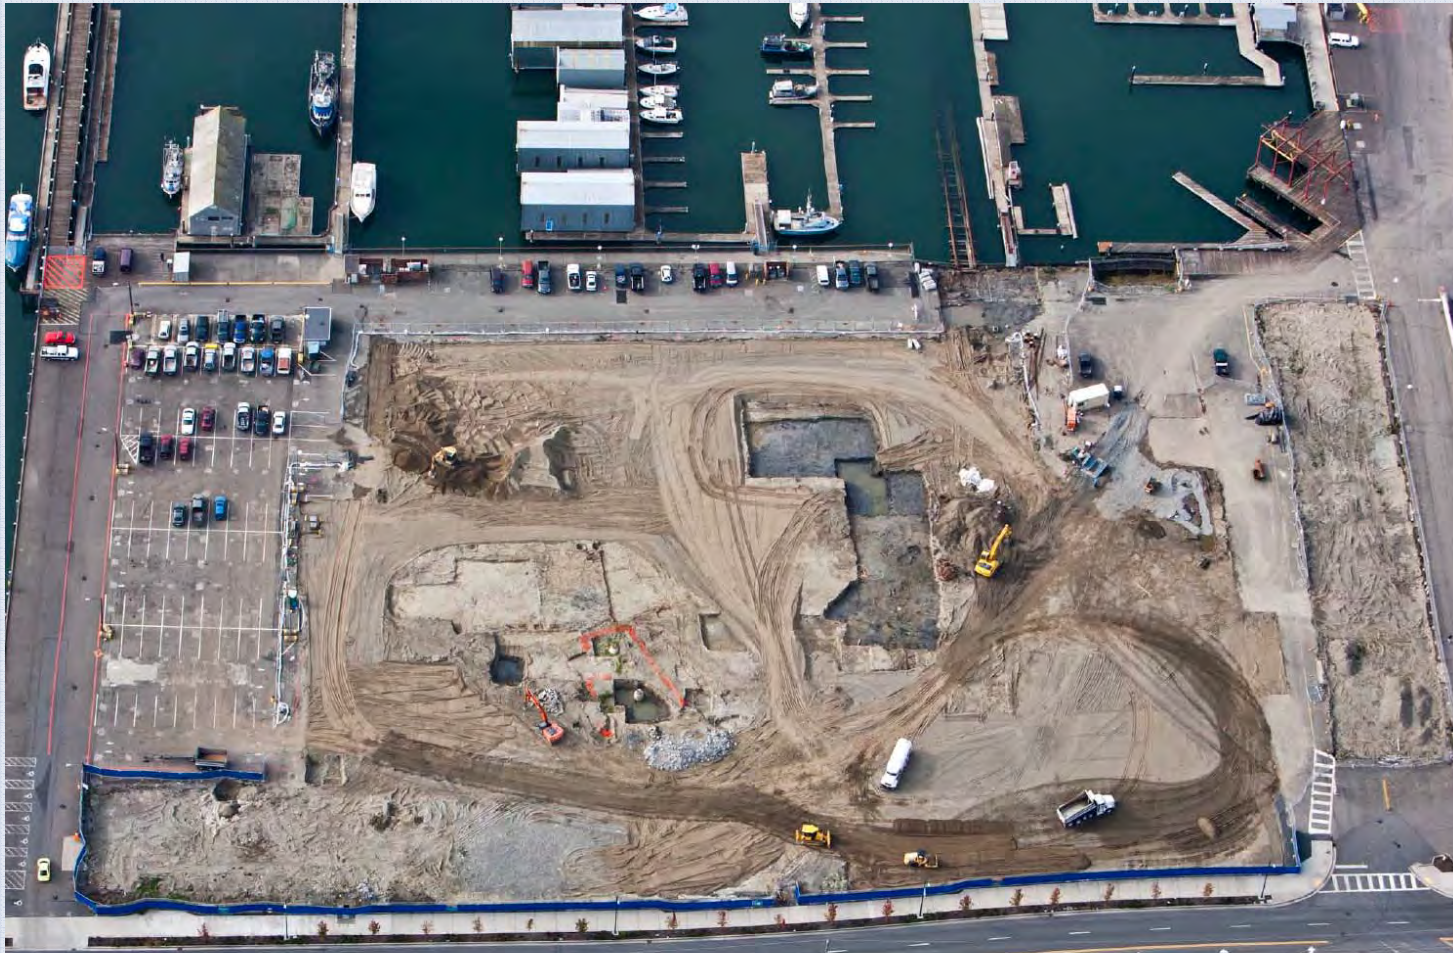
Upland Cleanup – November 2013

- Excavation – 15,000 cu yds
- Cleanout Stormwater System
- Monitor Groundwater

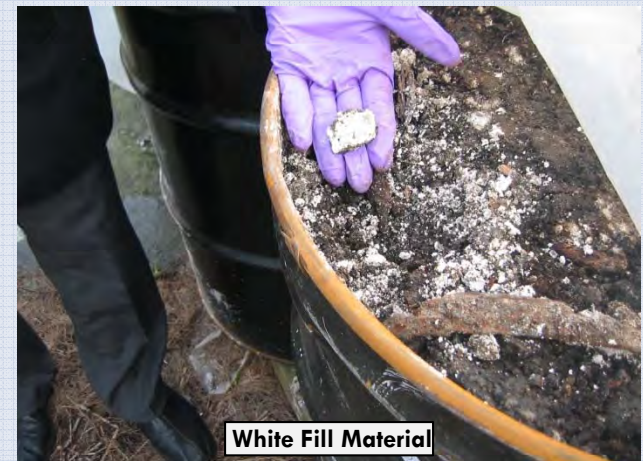
Leak from compressor shed

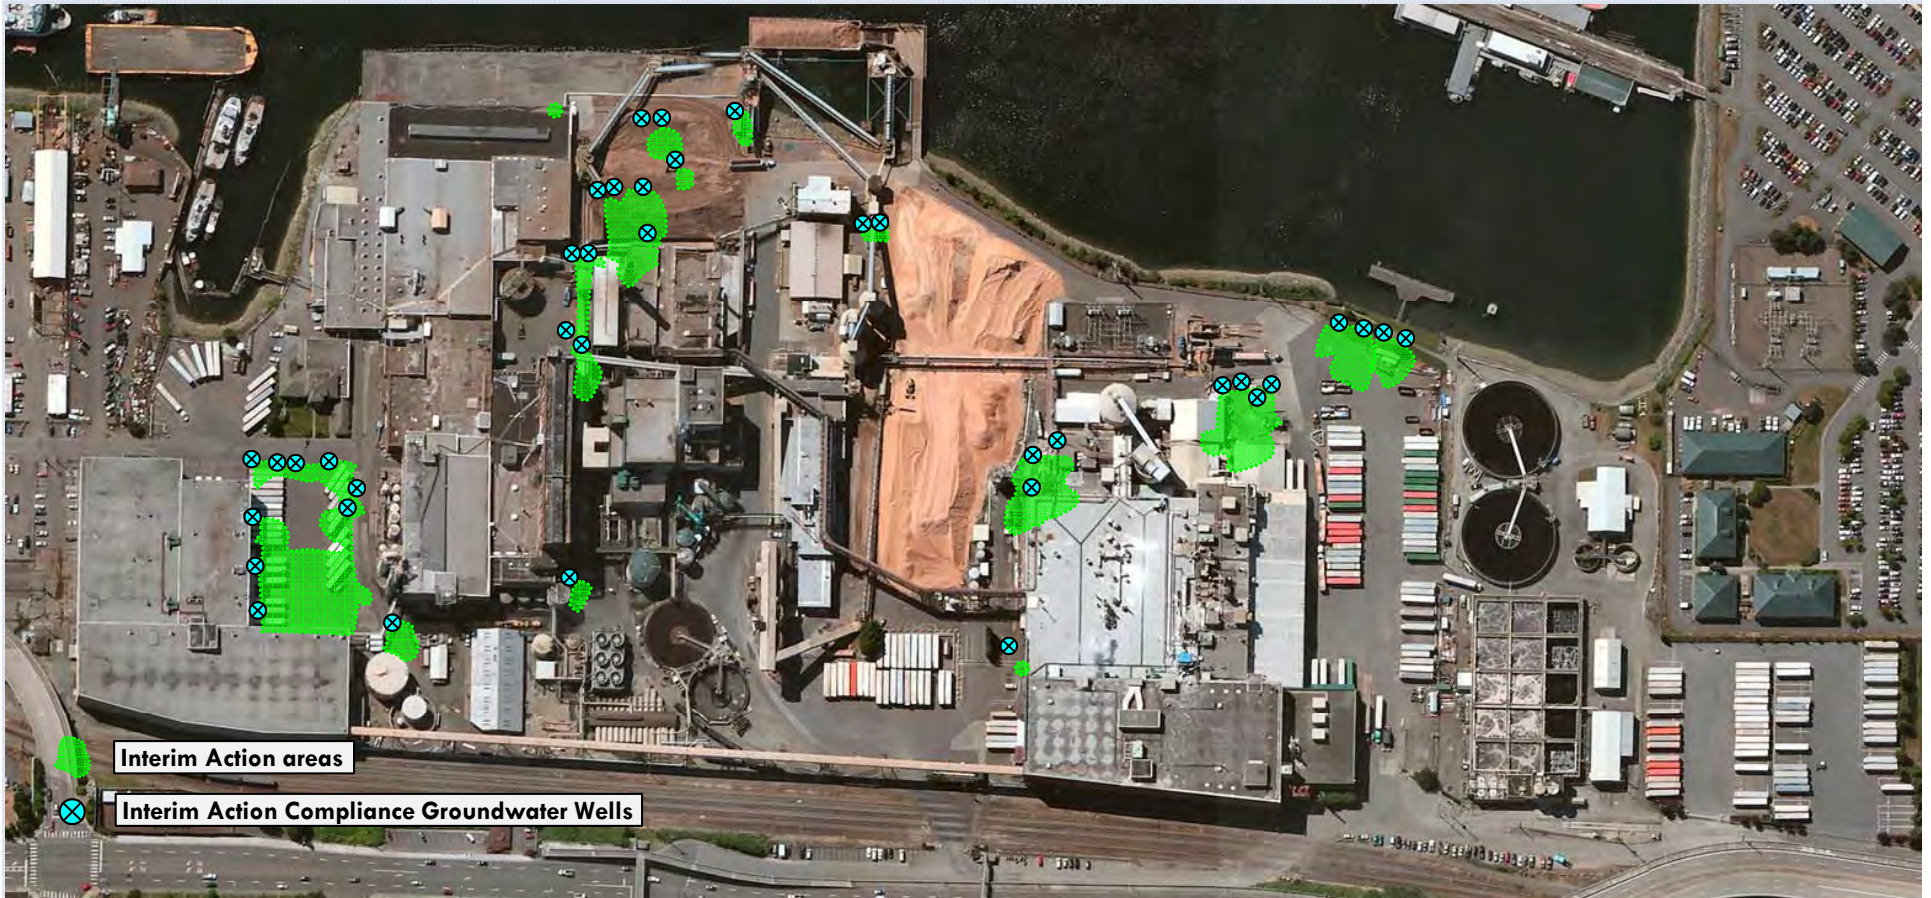
Upland Interim Action Areas

- Facility Closed (2012) – Removed all dangerous waste
- Interim Cleanups
 - 38,000 cu yds of contaminated soil removed
 - 5.6 million gallons – Groundwater removed for treatment

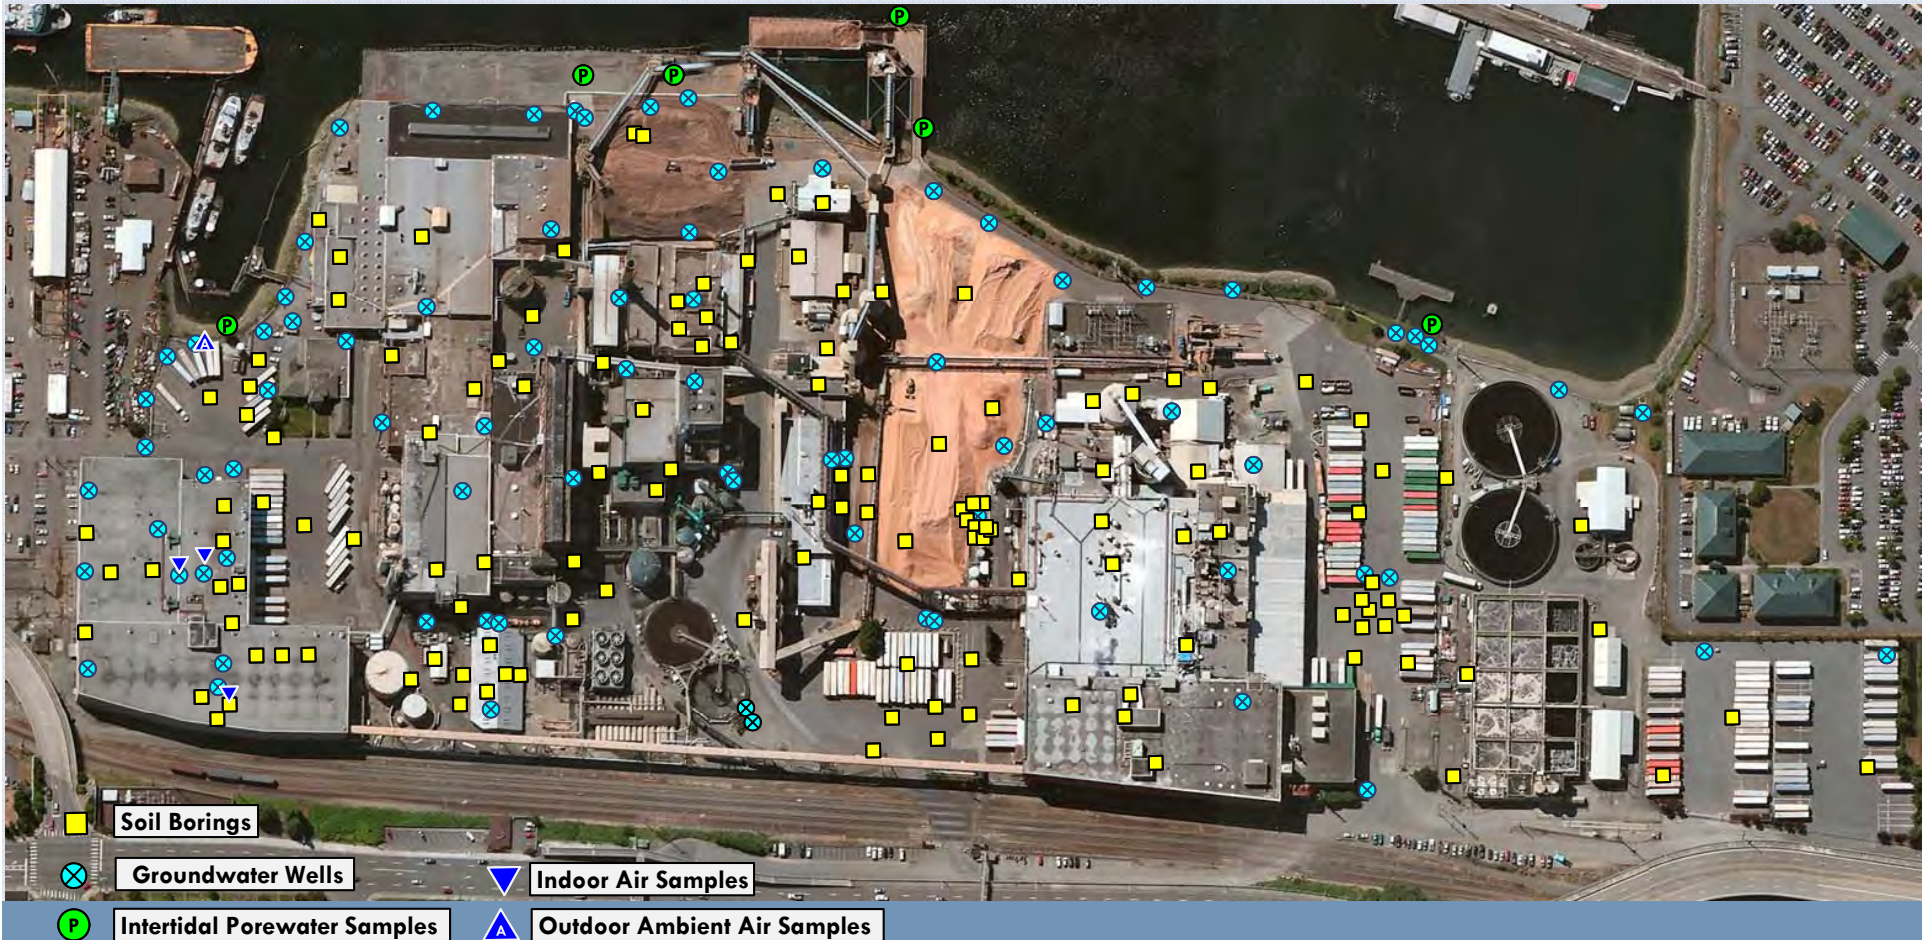
RI/FS Sampling

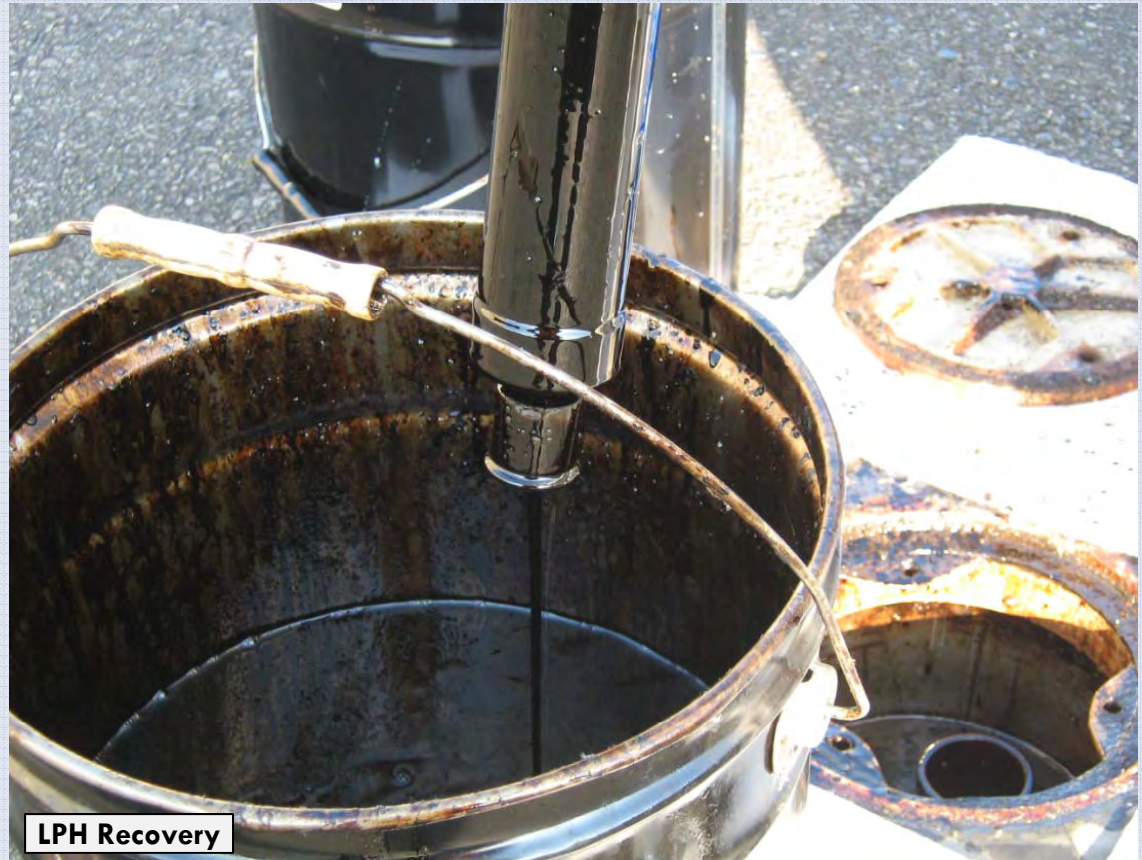
Petroleum Seep

Former City Dump

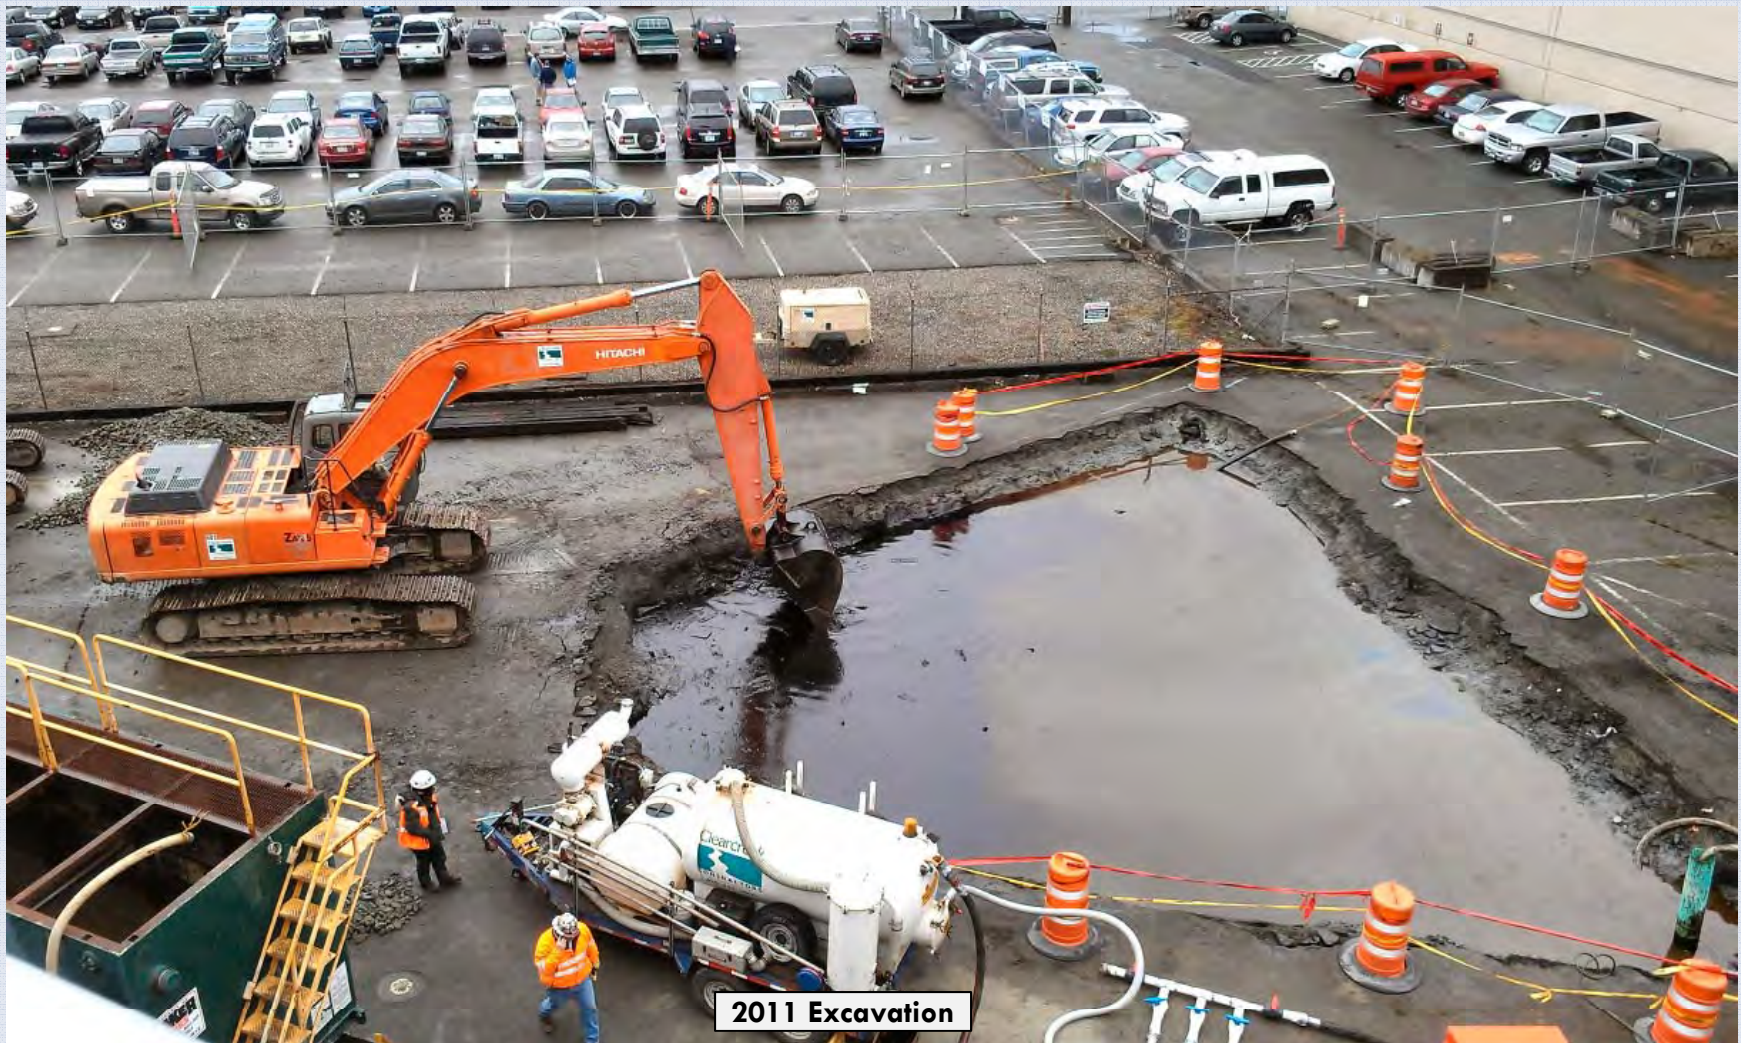
LPH Recovery
