State of Washington Department of Ecology
Cruise Ship Memorandum of Understanding, Cruise Operations in Washington State Inspection Report

Name and Location of Site Inspected: QUEEN ELIZABETH, Cunard Lines Carnival Cruise Lines Pier 91, Seattle, Washington	Additional Participants/Inspectors: Megan Junod, Ecology
On-Site Representative(s): Name/Title/Phone/e-mail Rob McCulloch, Environmental Officer qeenv@cunard.co.uk	
Responsible Official(s): Name/Title/Address/Phone/e-mail David Smith, Sr. Manager, Environmental – Carnival UK P&O Cruise Lines e: David.Smith@pocruises.com	Other Facility Data: Notification made to David Smith and John Haeflinger on July 28, 2025 Flag: Bermuda

**PHOTO ADDENDUM – QUEEN ELIZABETH
CUNARD LINES AUGUST 11, 2025**

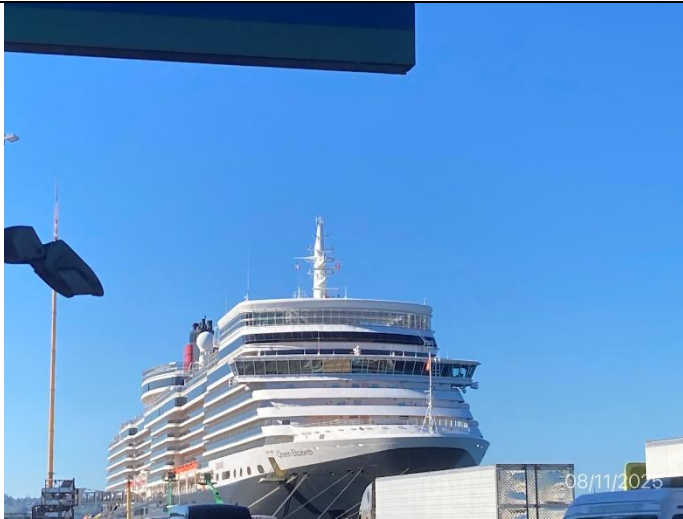
Photo # 1 Image: IMG_2933 Date: 8/11/2025
Taken by: Evan Dobrowski
Description: Photo of M/V QUEEN ELIZABETH

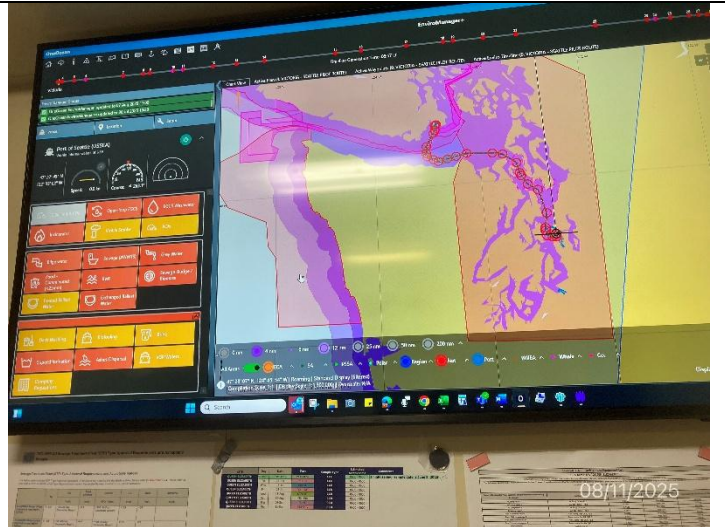
The discharge protocols start with a voyage plans for each itinerary prior to that route. A matrix is developed for each route upon a detailed review of locations for allowed discharges, holding ability of the various waste streams, and other requirements. The voyage plan for the Seattle/Alaska route details no discharges in MOU related waters. Discharges are stopped at about 13 miles prior to MOU related waters. This vessel stops in Victoria prior to Seattle. Discharges are resumed 13 miles out of MOU related waters or per Canadian requirements. Maps show the area of stopped discharge prior to entering the OCNMS and Strait of Juan de Fuca.

Photo # 2 Image: IMG_2936 Date: 8/11/2025
Taken by: Evan Dobrowski
Description: Photo of OneOcean software documenting environmental requirements within planned route from Victoria to Seattle.

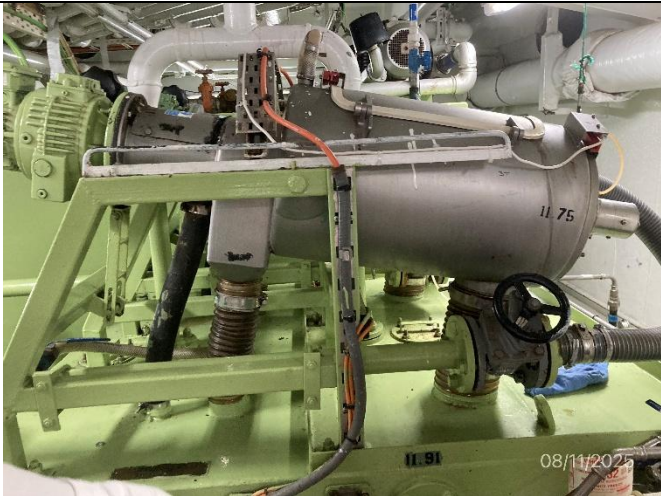
There is two AWP on the vessel one for blackwater and one for greywater treatment. Black water, which includes toilet waste, and infirmary drains moves by vacuum to one of five Evac collection tanks. From the collection tanks, it goes to the screener. Solids are sent to the biowaste tank, then to the incinerator and liquid moves to a tank and is then pumped to the biostep to permeate, and finally overboard when allowed. Gray water consists of sink, shower, galley water, laundry water and potentially pool water and is collected in one of two mixing tanks. From the mixing tanks, the liquid moves to the 5-step biostep for biological treatment.

Photo # 5 Image: IMG_2943 Date: 8/11/2025
Taken by: Evan Dobrowski
Description: Photo of waste water treatment system screen press component.

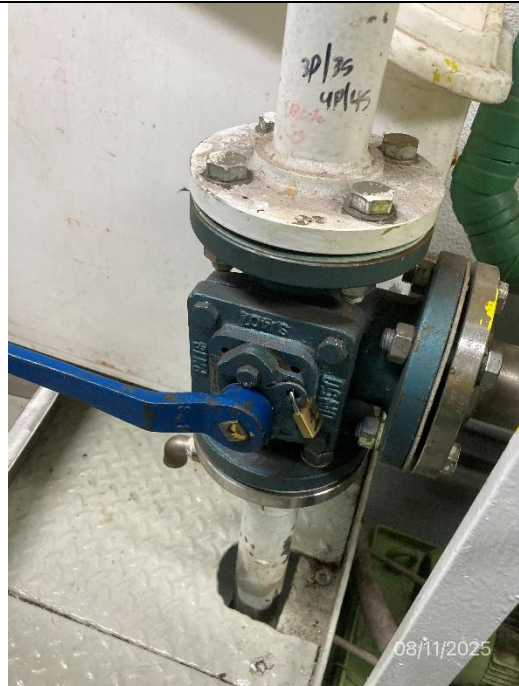
Photo # 6 Image: IMG_2945 Date: 8/11/2025
Taken by: Evan Dobrowski
Description: Photo of blackwater MBR discharge valve with padlock.

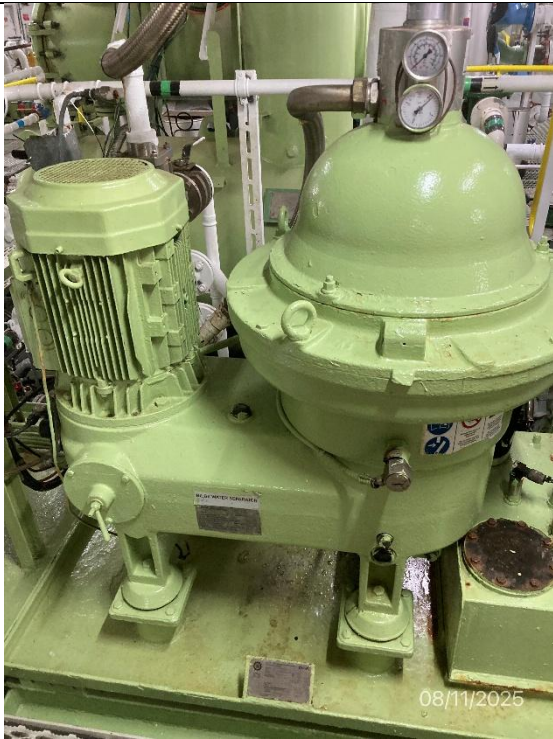
Oily bilge water is treated with centrifugal oily water separators (OWS). This includes pumping oily bilge water to a settling tank, then onto processing in the OWS. From there the clean bilge goes to the Clean Bilge Tank and is then discharged if in an area approved – outside of MOU related waters. A white box is used to only allow discharges at less than 5 ppm oil content maximum. Any treated bilge that does not meet that level is sent by y-valve to the dirty bilge tank and onto the dirty bilge settling tank for re-processing. The discharge protocol is to discharge treated oily bilge at less than 5 ppm outside of MOU related waters, at sea. The EO confirmed that they are not aware of any rerouting of oily bilge and that any staff can report concerns. Reports can be made through the staff/line or through the IMO whistleblower reporting. The OWS were off and recirculating during the inspection and not discharging.

Photo # 7 Image: IMG_2951 Date: 8/11/2025
Taken by: Evan Dobrowski
Description: Photo of bilge water separator.

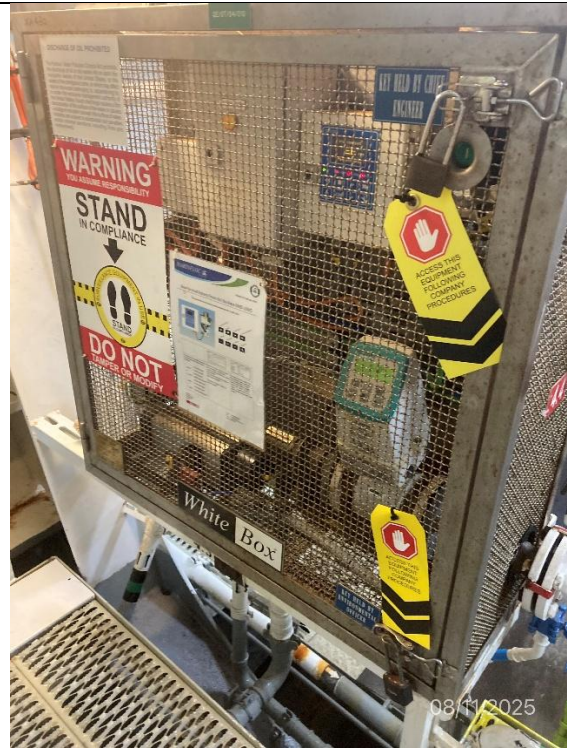
Photo # 8 Image: IMG_2811 Date: 8/11/2025
Taken by: Evan Dobrowski
Description: Photo of White box with padlocks.

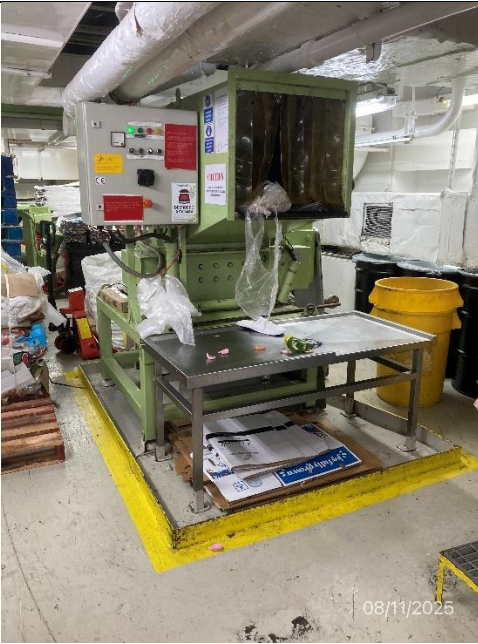
Solid waste (garbage, recyclables, etc) is collected, sorted, and either reused, recycled, incinerated or off-loaded to shore in Victoria on this route as appropriate.

Photo # 9 Image: IMG_2956 Date: 8/11/2025
Taken by: Evan Dobrowski
Description: Photo of waste sorting area and incinerator chute.

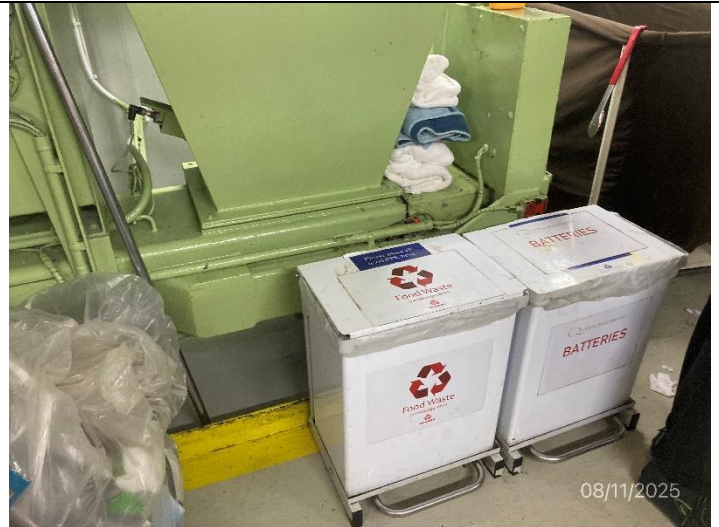
Photo # 10 Image: IMG_2962 Date: 8/11/2025
Taken by: Evan Dobrowski
Description: Photo of waste management area with food waste and battery storage bins.

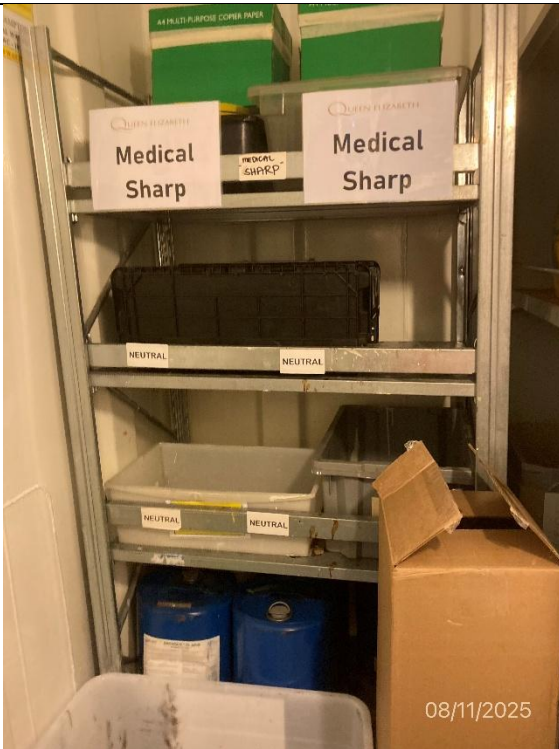
Hazardous waste is not offloaded in Seattle, only in Victoria on this route. Incinerators (2) are not used in port, only underway.

Photo # 11 Image: IMG_2965 Date: 8/11/2025
Taken by: Evan Dobrowski
Description: Photo of hazardous waste storage area.

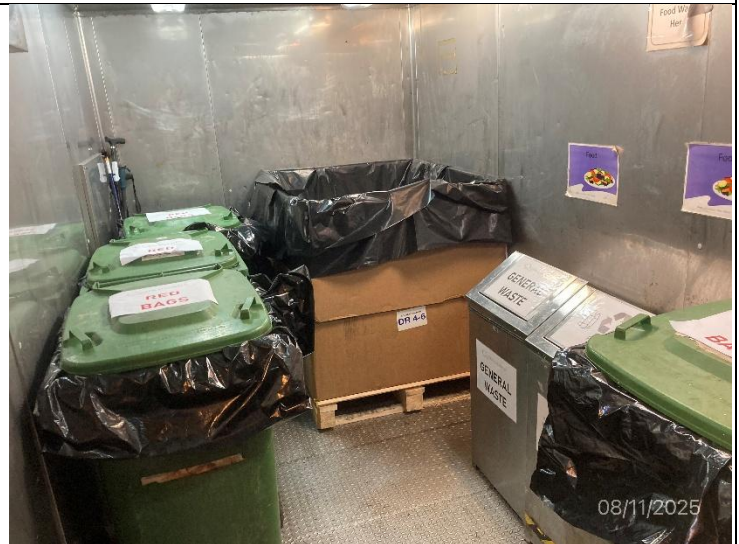
Photo # 12 Image: IMG_2967 Date: 8/11/2025
Taken by: Evan Dobrowski
Description: Photo of hazardous waste storage area.

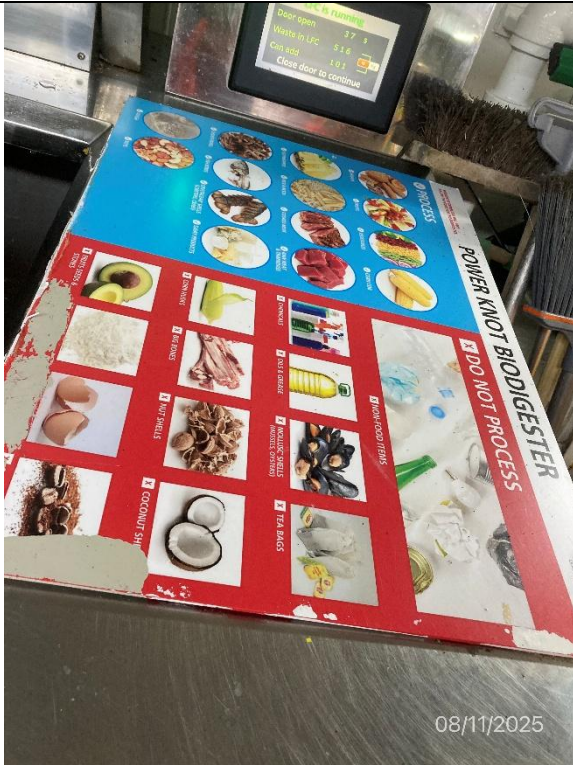
Food waste is sent from the galleys to biodigesters onboard. From there, liquid from the process goes to the graywater mixing tanks and the AWP while the dry solids go to the incinerator or discharged overboard when allowed. A grease separator collects grease from the galleys and is combined with used cooking oil for onshore recycling. Food waste discharges are logged into the NAPA system.

Photo # 17 Image: IMG_2969 Date: 8/11/2025
Taken by: Evan Dobrowski
Description: Photo showing food waste biodigester.

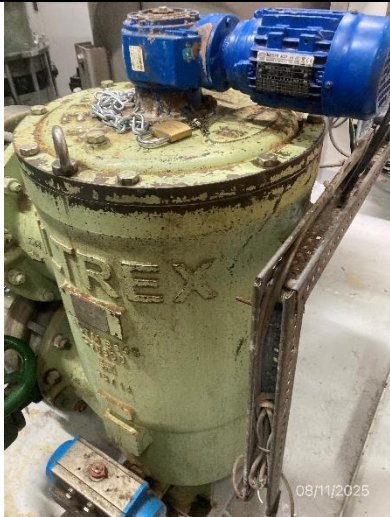
The vessel has four main engines and two emergency generators; five of these are running through the EGCS systems. ECA fuel-sulfur compliance is achieved either through the use of marine gas oil at about 0.01 % sulfur content (below the 0.1% sulfur content fuel ECA limit), or with higher sulfur heavy fuel oil (HFO) – typically 1.4-2.7% sulfur, treated by the EGCS to achieve equivalent emissions. The vessel was bunkering fuel during the inspection. Water is sprayed at the exhaust and is sent down the tower to the process tank. A de-aeration tank is used to settle the exhaust solids. Washwater is then treated by a centrifugal solids separator before discharging or being held onboard in tanks. A continuous monitoring system (CMS) is used to continuously monitor the discharge water, as well as influent for certain parameters. PAH, temperature, turbidity and pH are monitored at the effluent discharge.

Photo # 19 Image: IMG_2973 Date: 8/11/2025
Taken by: Evan Dobrowski
Description: Photo showing filtrex unit for EGCS.

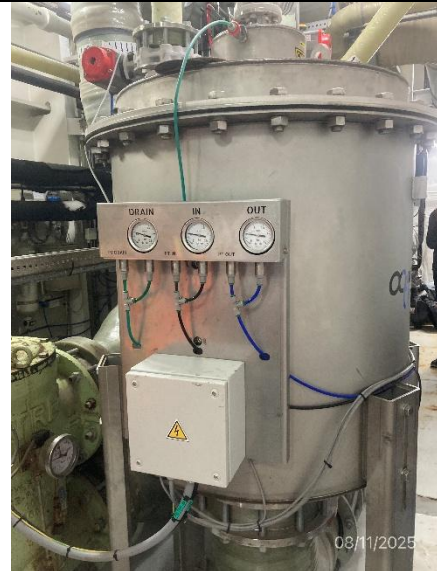
Photo # 20 Image: IMG_2974 Date: 8/11/2025
Taken by: Evan Dobrowski
Description: Photo showing filtration for EGCS.

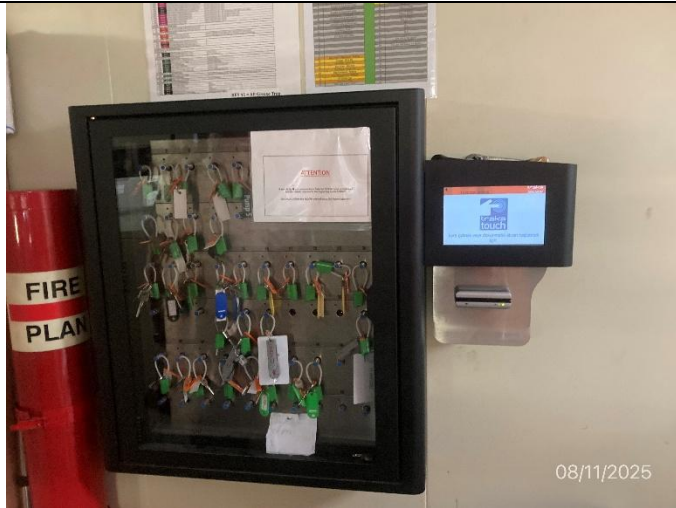
Photo # 21 Image: IMG_2975 Date: 8/11/2025
Taken by: Evan Dobrowski
Description: Photo showing locking key safe requiring badge to unlock.

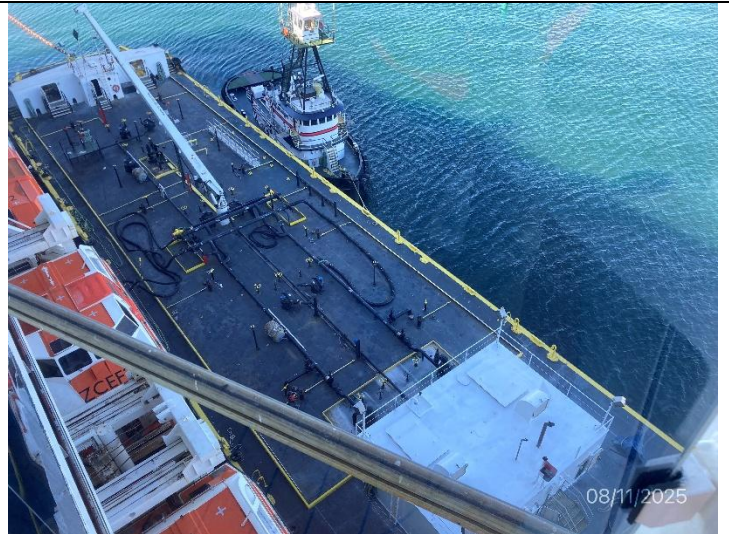
Photo # 22 Image: IMG_2935 Date: 8/11/2025
Taken by: Evan Dobrowski
Description: Photo showing bunkering tug and barge in containment boom.

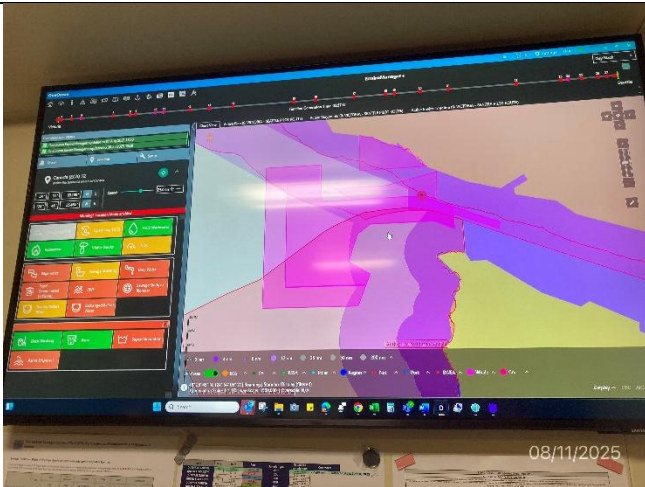
Photo # 23 Image: IMG_2937 Date: 8/11/2025
Taken by: Evan Dobrowski
Description: Photo showing ONEOCEAN environmental area near Olympic coast national marine sanctuary.
