**SHORELINE AREA:** Bone Creek from SR 9 to ball field access drive just east of trailer park area.

**REACH NUMBER: # 11**

# CITY OF SUMAS, WA

## Shoreline Jurisdiction

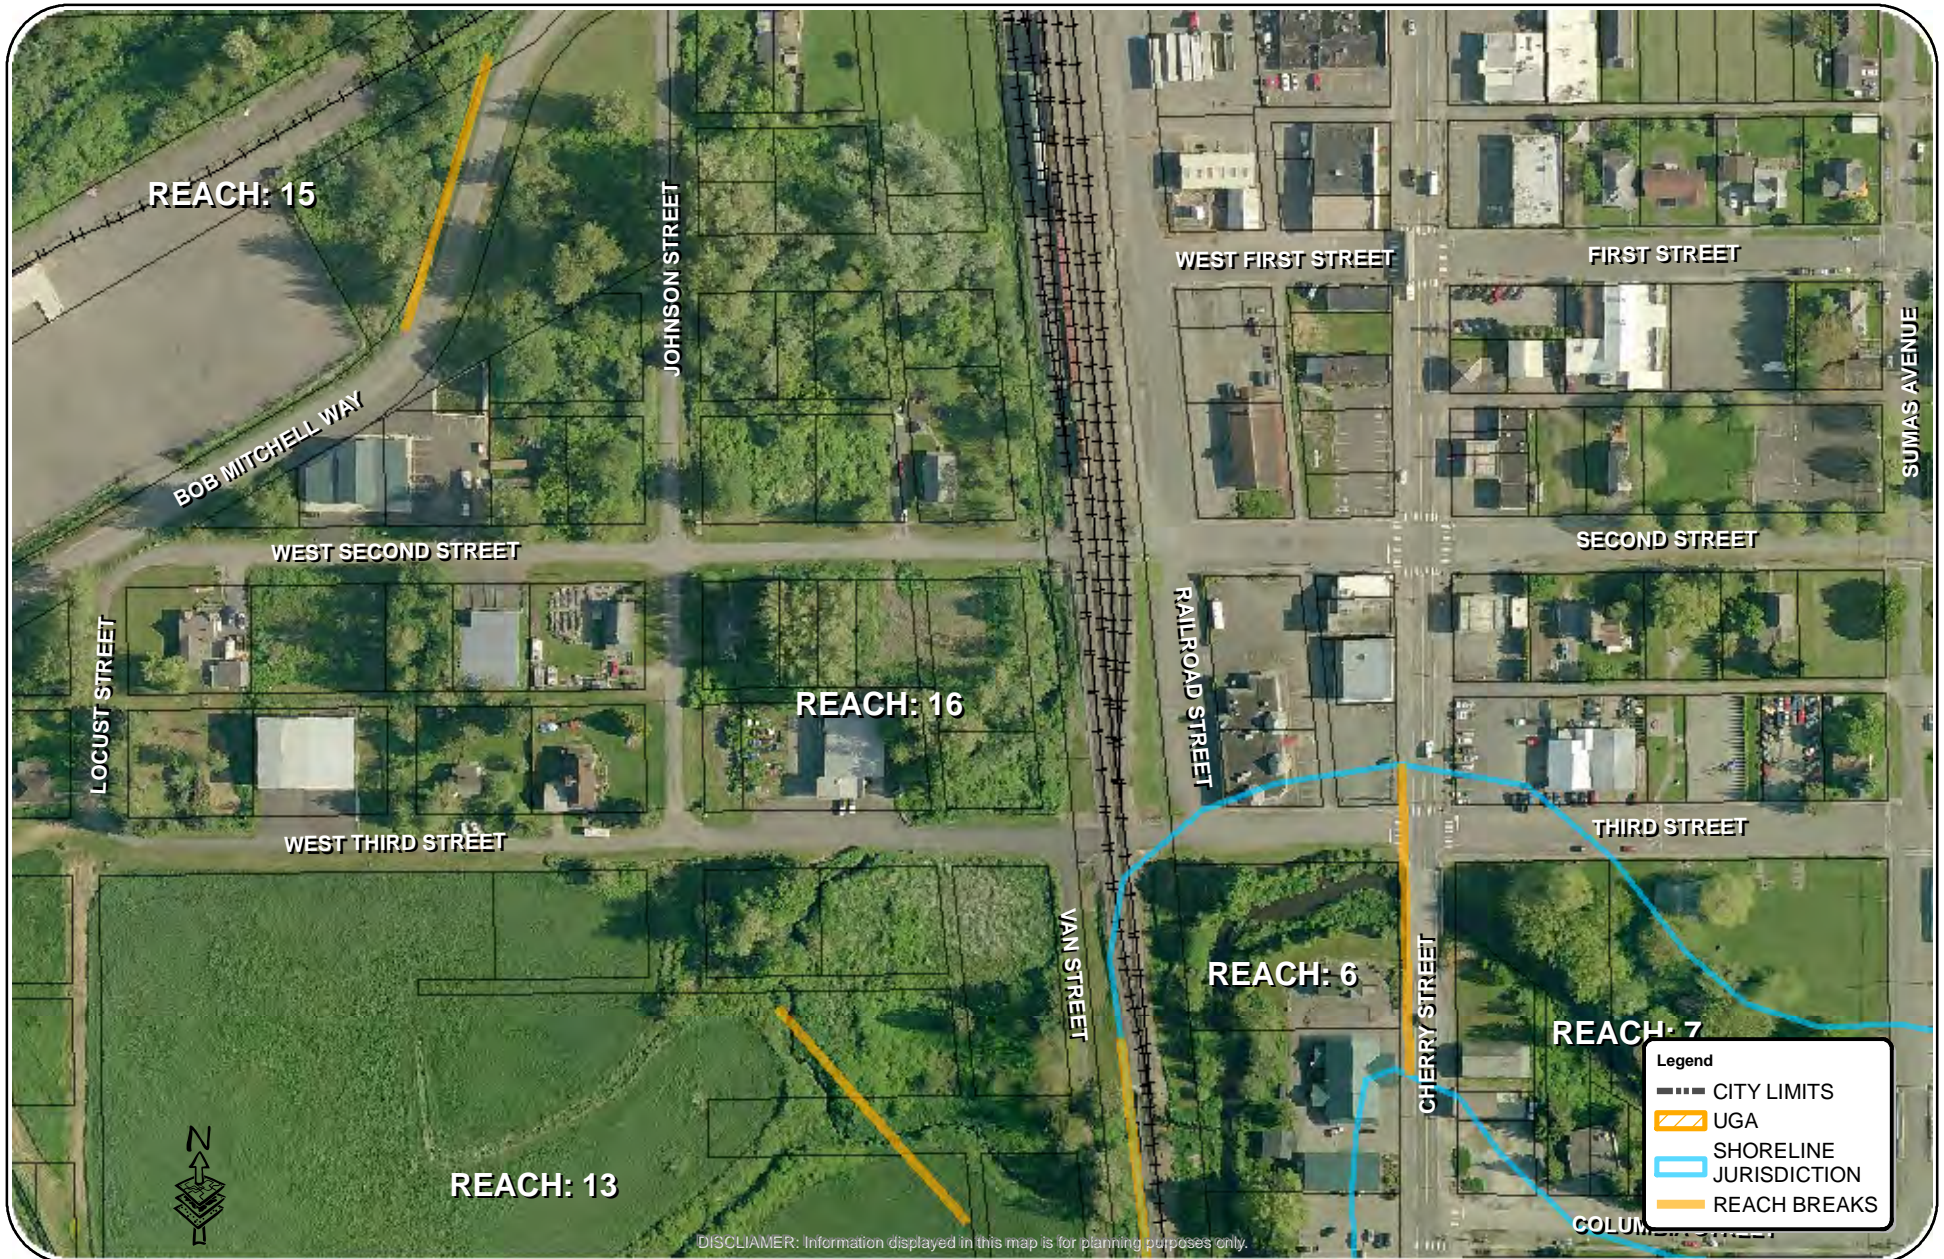
### Reach 16

Land Use	Current Shoreline Designation	N/A
	Current Land Use	Residential, undeveloped parcels, industrial, AG. (Ref # 3, 7)
	Zoning	Industrial, business general and public. (Ref # 2, 16) Portions of reach designated as natural system protection area in Comp Plan.
Potential Species Present	Wildlife species	None. (Ref # 12)
	Fish species	Coho, chum and cutthroat presence documented. (Ref # 13, 18)
	PHS species/habitat	Priority fish presence. (Ref # 12)
	TSE species	ESU for coho, fall/winter chum; RU for bull trout (Ref # 13)
	Invasive wildlife/fish species	No data.
Physical Environment	Acres of land in reach	
	Aquatic vegetation	No data
	Slope	No slope data listed by DOE (Ref # 6). Site class and moderate to high liquefaction hazard listed by Whatcom County (DNR 2004). (Ref # 17)
	Buildings	
	Culverts/stormwater utilities	No data. Culvert observed under West Third Street, West Second Street, Johnson Street, and Bob Mitchell Way (Ref # 3).

Geology	Glacial outwash. (Ref # 9)
	Tributary Creeks	None. (Ref # 1, 3, 13)
	Impervious surface	
	Roads/transportation	Three access arterials (Johnson, W. Second, W. Third Streets); Bob Mitchell Way at western terminus, railroad tracks at eastern terminus of reach. (Ref # 3, 7)
	Soils	Brisco silt loam; Puget silt loam (Ref # 4)
	Topography	35 to 40 feet elevation. (Ref # 6)
	FEMA	Entire reach is in the 100 year floodplain. (Ref # 2)
	Terrestrial Vegetation	The majority of the reach is characterized by native deciduous trees and shrubs. However, large patches of Himalayan blackberry and reed canarygrass are also present along the reach. Knotweed was also observed south of West Third Street (Ref # 3)
Riparian Function	Aquatic substrate type	No data.
	Channel confinement	Unknown, no data. (Ref # 13)
	Channel gradient	Low. (Ref # 3)
	Channel migration zone	Unknown.
	Creosote structures	No data/ none observed (Ref # 3, 7)

In-water structures	No data/ none observed (Ref # 3, 7)
	Fish passage blockages	Non-barrier at RR and none at additional road crossings. (Ref # 13)
	LWD presence	No data. Low recruitment potential, mostly shrubs and small trees. (Ref # 3, 9)
	Riffle/pool analysis	No data.
	DOE 303(d)	Category 4A for fecal and DO (TMDL approved by EPA). (Ref # 10)
	Toxic sites/land fills	None listed. (Ref # 8)
	Point source pollution	Scattered low intensity residential uses, railroad, light agriculture. (Ref # 3, 7)

<b>Limiting Factors</b>	<ul style="list-style-type: none"> <li>Zoning</li> <li>Water quality</li> <li>Property ownership</li> </ul>
	<b>Functions</b> <ul style="list-style-type: none"> <li>Sustainable</li> <li>Not Sustainable</li> </ul>	Sustainable at current levels: hydrologic, shoreline vegetation, and terrestrial & aquatic habitat. However, sustainability affected by private property ownership.
	<b>Priority Actions</b>	<ul style="list-style-type: none"> <li>Preservation of riparian corridor.</li> <li>Water quality improvement.</li> </ul>
	<b>Current Enhancement Projects</b>	None known. Portions of reach, northern and southern most designated as natural system protection area in Comp Plan.
	<b>Preservation/Enhancement Opportunities</b>	<ul style="list-style-type: none"> <li>Preservation of terrestrial vegetation, habitat and associated corridors. Particularly riparian corridors.</li> <li>Enhance riparian buffer: increase width of native shoreline vegetation in reed canarygrass areas.</li> <li>Remove invasive species.</li> </ul>
