## DAVY CROCKETT DATA and OPERATIONS (5/6/11)

# Davy Crockett Wreck Profile

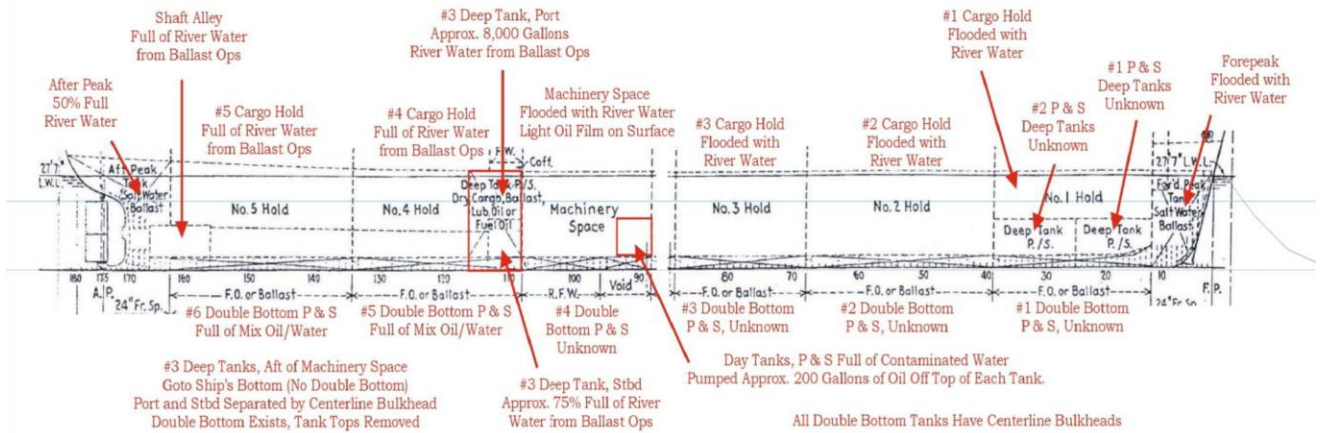
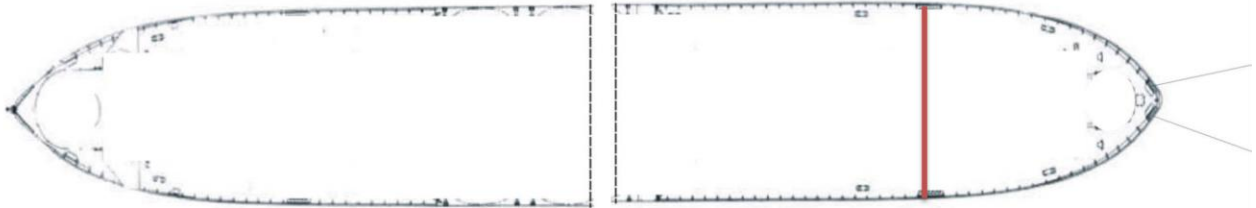
- April 2009: Letter of Concern drafted by Coast Guard urging owner to remove all free oil
- October 2010: Barge sold to current owner
- During the timeframe between December 2010 and January 2011 illegal scrapping operations caused the number 3 hold on the Davy Crockett to buckle resulting in a sheen

- Additional king tides further degraded the structural integrity of the barge and weakened the keel resulting in further oil discharges

Scale 1" = approximately 40'

April 22: The separation cut to separate the stern section of the vessel from the midsection completed.
