## **CHAPTER 5.**

# **MARINE SHORELINES - SOUTH PUGET SOUND**

## 5.1 Case Inlet, Pickering Passage and Peale Passage (including Harstene Island)

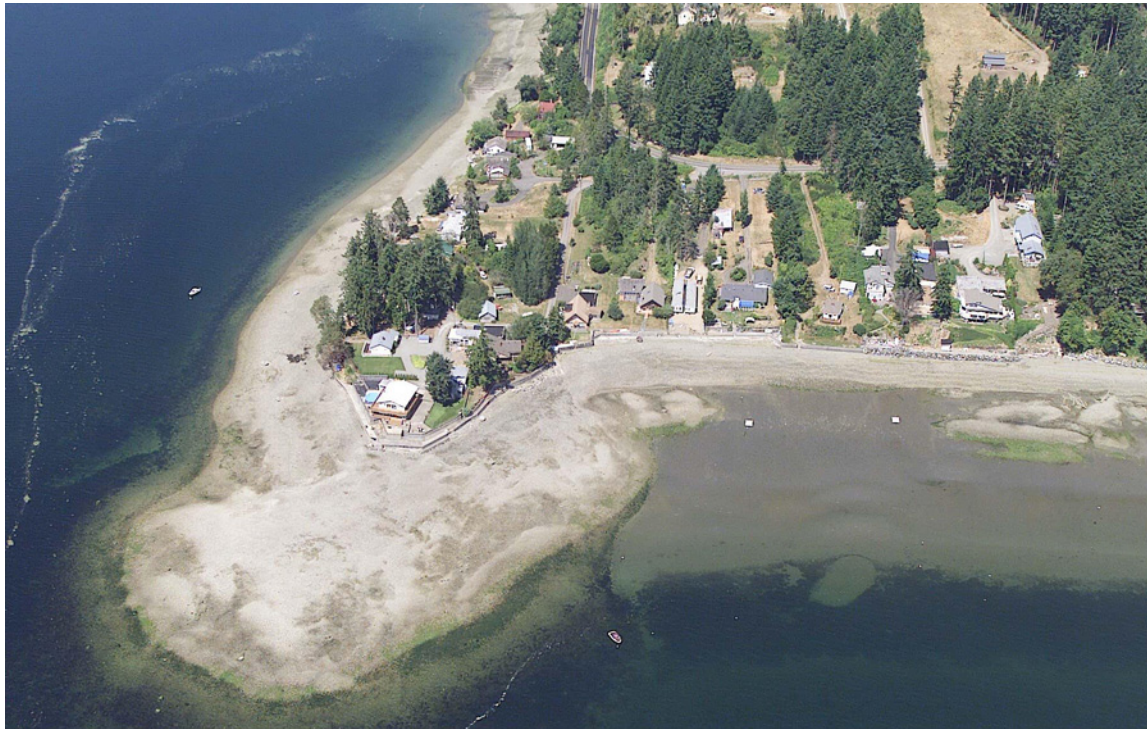
## CASE INLET - REACH 14

4.0 MI (ROCKY PT/ NORTH BAY)

SPU 3130, SPU 3131, SPU 3132

94.8 AC

Floodplain - 96% (91 acres) of the reach, excluding open water, is mapped as FEMA 1% annual chance floodplain

2% erosion, 21% landslide

Shoreform - 61% bluff backed beaches, 39% barrier beaches. Net shore drift -northward drift from Rocky Point to Point Victor.

Mostly moderately degraded with very small section of less degraded shoreline.

18% developed, 36% mud flat, 26% forest, 15% wetland, 5% floodplain/riparian (GAP, 2009);

29.1 acres of hardshell clam habitat. 2,011 lineal feet of patchy eelgrass.

Restore trees to riparian zone.  
Revegetate shoreline (Anchor, 2004).  
Remove bulkheads or replace with natural logs.  
Replace riprap protecting road with LWD.  
Realign road corridor.  
Remove remnant pilings.  
Remove potential filled areas/dike.

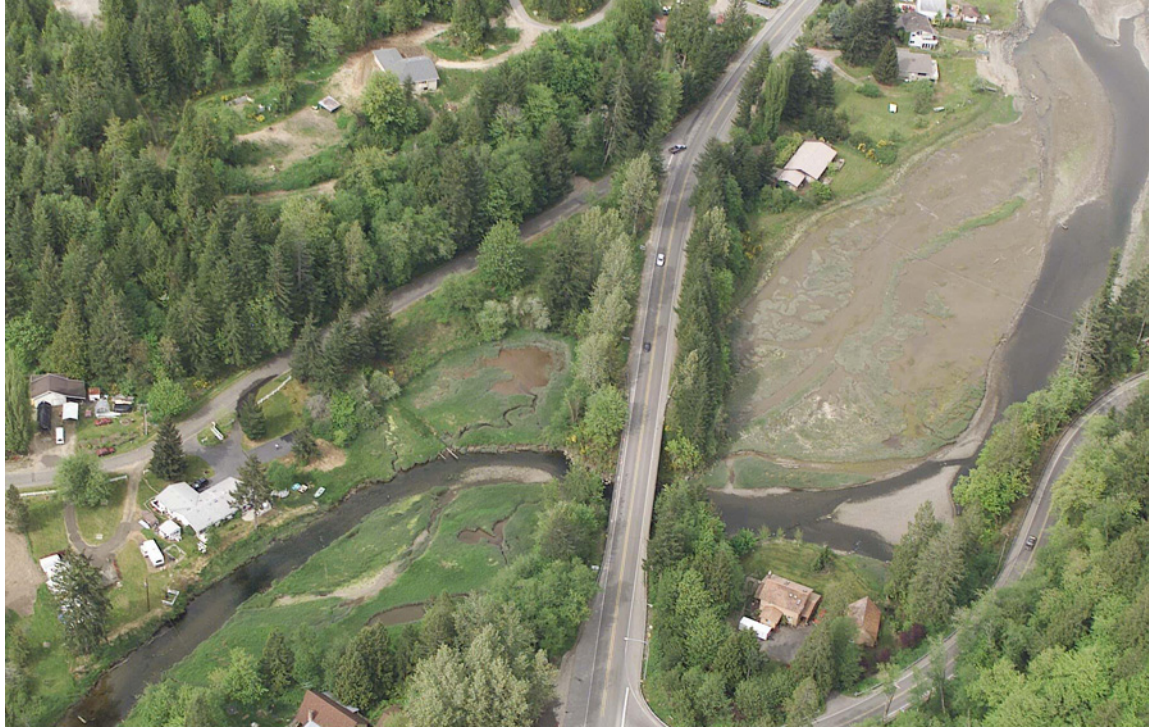
## CASE INLET - REACH 16

SHORELINE LENGTH	PSNERP PROCESS UNITS	REACH AREA
1.9 MI (ALLYN)	SPU 3130	48.1 AC

<b>HYDROLOGY (MAPS 4 AND 10)</b> Floodplain - 4% (2 acres) of the reach, excluding open water, is mapped as FEMA 1% annual chance floodplain	<b>HAZARD AREAS (MAP 12)</b> 11% erosion, 14% landslide
<b>SHOREFORM AND NET SHORE DRIFT (MAP 7)</b> Shoreform - 77% bluff backed beaches, 18% open coastal inlets, 5% barrier beaches. Net shore drift - predominantly northward drift.	<b>NEARSHORE PROCESS DEGRADATION (MAP 17)</b> Moderately degraded.
<b>LAND COVER (MAP 15)</b> 38% developed, 8% mud flat, 15% forest, 11% wetland, 28% floodplain/riparian (GAP, 2009); Riparian vegetation: 30% forest cover, 47% non-forest, 19% off-shore, 4% other natural vegetation, 0.5% water (PNPTC, 2011).	<b>HABITATS AND SPECIES (MAP 8)</b> 20.3 acres of hardshell clam beds. 697 linear feet of patchy eelgrass. Wetlands – 3.7 acres (7.7% of reach); wetland habitat types include estuarine intertidal aquatic bed and estuarine intertidal emergent.

Remove bulkheads or replace with natural logs

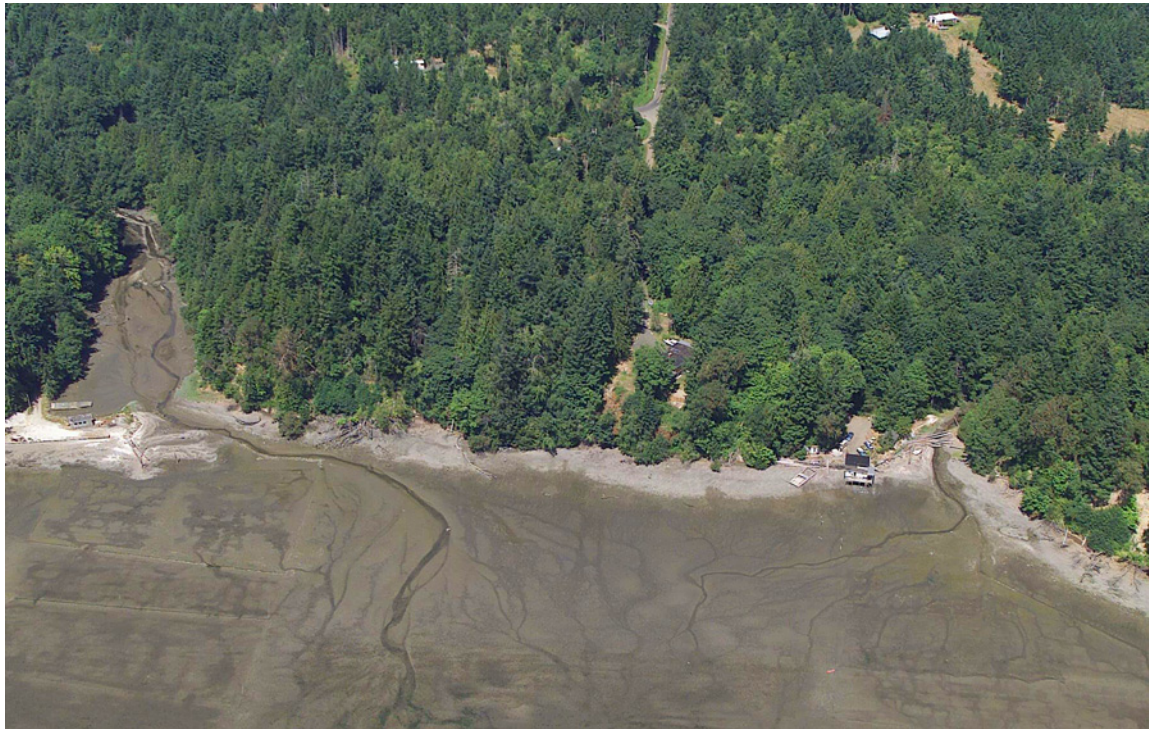
## TOTTEN INLET - REACH 38

SHORELINE LENGTH	PSNERP PROCESS UNITS	REACH AREA
3.7 MI	SPU 3077, SPU 3078	89.5 AC

Mostly less degraded, with some least degraded shoreline.

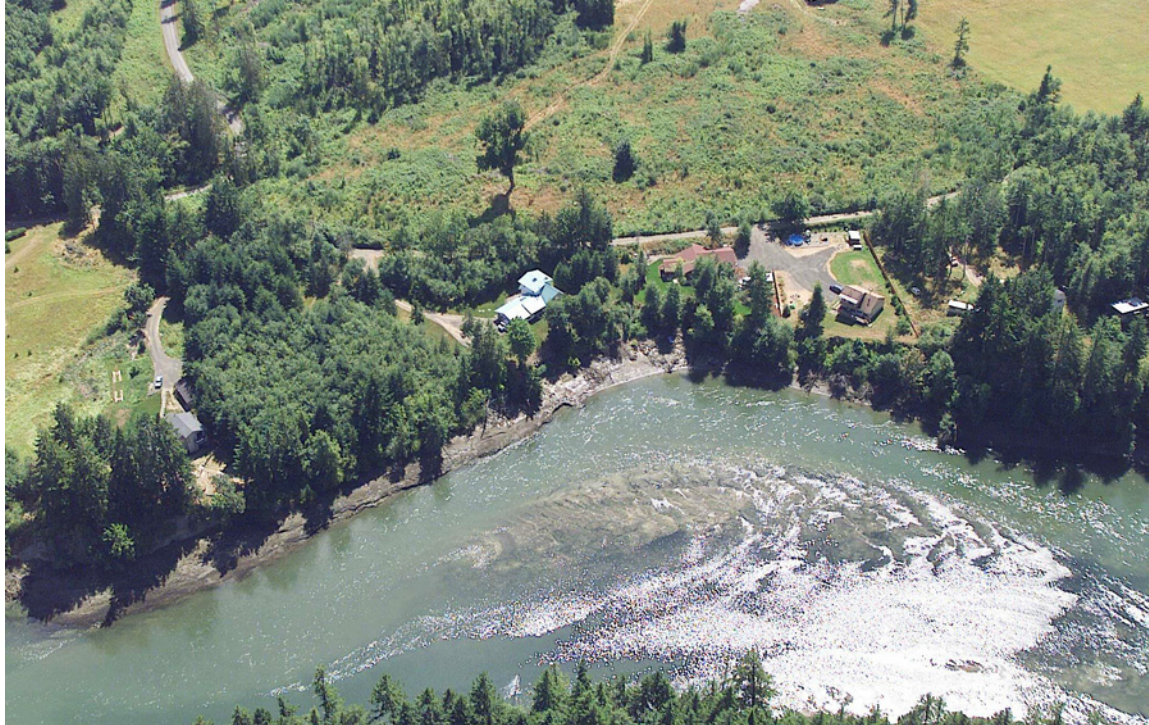
## LITTLE SKOOKUM INLET - REACH 36

SHORELINE LENGTH	PSNERP PROCESS UNITS	REACH AREA
12.4 MI	SPU 3082, SPU 3083, SPU 3084, SPU 3085, SPU 3086, SPU 3194, SPU 3195	294.2 AC

<b>HYDROLOGY (MAPS 4 AND 10)</b> Floodplain - 44% (130 acres) of the reach, excluding open water, is mapped as FEMA 1% annual chance floodplain	<b>HAZARD AREAS (MAP 12)</b> 3% erosion, 43% landslide
<b>SHOREFORM AND NET SHORE DRIFT (MAP 7)</b> Shoreform - 91% open coastal inlet, 7% bluff backed beach, 2% barrier beaches. Net shore drift - predominantly no appreciable drift, westward drift in a few cells at the mouth of the Little Skookum Inlet, eastward drift in a few cells on the north and south shores of the inlet.	<b>NEARSHORE PROCESS DEGRADATION (MAP 17)</b> Least degraded.
