State of Washington Department of Ecology
Cruise Ship Memorandum of Understanding, Cruise Operations in Washington State Inspection Report

Name and Location of Site Inspected: Volendam, Holland America Line Pier 66, Seattle, Washington	Additional Participants/Inspectors: Justine Asohmbom, Ecology
On-Site Representative(s): Name/Title/Phone/e-mail Keith David Bass, Environmental Officer onboard e: vodm-environmental_officer@hollandamerica.com Diana Mihalache, Manager, Environmental Permitting and Support e: DMihalache@HollandAmericaGroup.com p: 206-861-5827	
Responsible Official(s): Name/Title/Address/Phone/e-mail Patrick McGuire, Vice President, Environmental Operations and Policy 450 Third Avenue West, Seattle, WA 98119 e: PMcGuire@HollandAmericaGroup.com p: 206-225-6328	Other Facility Data: Notification made to Patrick McGuire on April 24, 2023 Flag: Netherlands

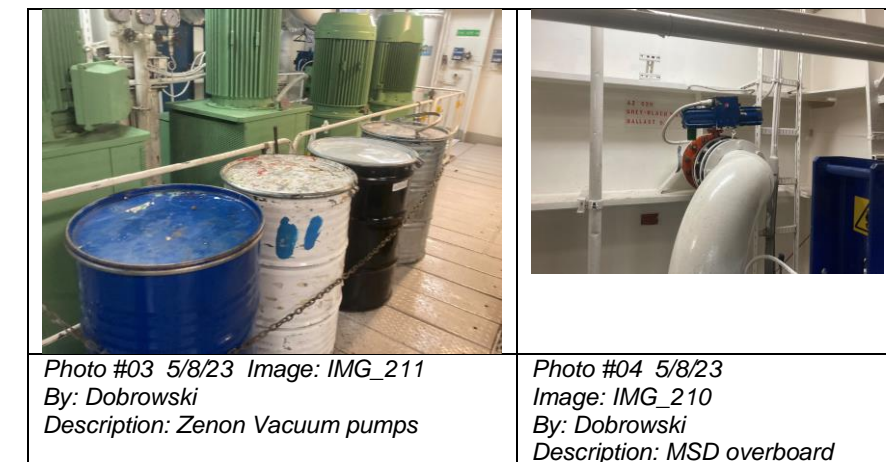
Blackwater includes toilet waste and medical drains and is sent by vacuum/jet to a Zenon bio membrane marine sanitation devices (photo #03). Description paraphrased from the schematic on the MSD system: Black water enters from the inlet into the aeration tank where the bacteria present in this section decomposes the blackwater in the presence of oxygen which is supplied by the aeration nozzles. A continuous supply of oxygen is necessary. The blackwater then enters into the settling section where settling takes place and flocs of activated sludge settles down along with other settleable matter. Sludge is returned back to the aeration section. The settled blackwater then enters into the disinfection section where chlorine is added. Flow then goes to dedicated holding tanks if not in an area of discharge (photo #04). Blackwater is not discharged in MOU related waters and all blackwater is treated. Settleable solids are monitored periodically and chlorine availability checked. Once per year, each MSD is taken off-line for a full maintenance cleaning. Solids are removed at this time, drummed and sent ashore.

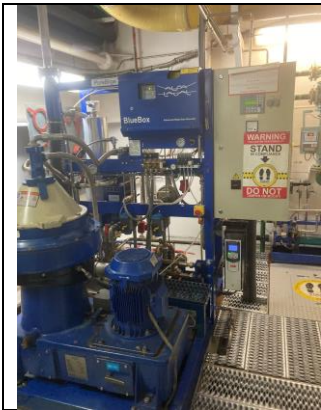
Dirty bilge water collected and is sent to one of two oily bilge tanks. Liquid moves to a centrifugal oily water separators (OWS). The system includes two stages of filtration and recirculates at >5 parts per million (ppm) oil content with the oily content meter (photo # 05). Oily sludge is collected from the system and sent ashore by truck. Maintenance on the OWS's includes regular cleaning of the filters and other regular checks and maintenance. Prior to discharge, the liquid is sent through a white box which only allows discharges <15 ppm. The discharge protocol for this route is outside the MOU related waters. The white

Photo #05 5/8/23 Image: IMG_204 By: Dobrowski Description: OWS oil content meter

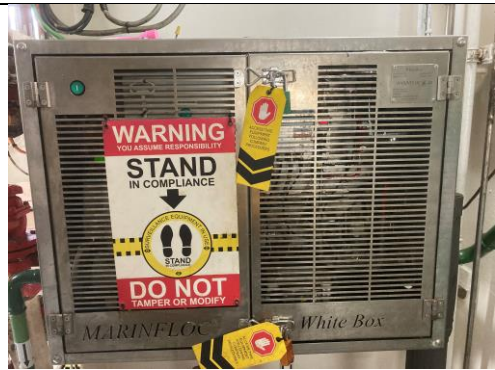
box (photo #06). The Chief Engineer and the EO have the two separate keys and both need to be present to open the white box. There is a record each time the white box door is opened and a video camera on OWS equipment. The chief Engineer and the EO have the ability to review camera recordings. All portable pumps are logged and only used for certain equipment. The EO confirmed that he is not aware of any rerouting of oily bilge. Holland America Line have been conducting trainings related to various wastestreams including oily bilge. The OWS was off and recirculating during the

Photo #06 5/8/23 Image: IMG_203 By: Dobrowski Description: OWS White Box

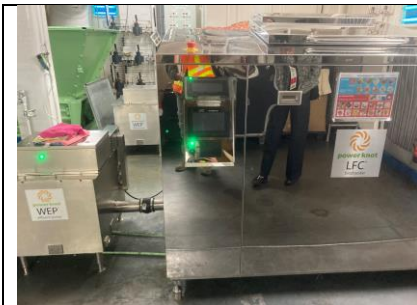
Food waste is segregated into soft and hard foods. Soft foods are fed into food waste biodigesters. The effluent from the food waste biodigesters is deposited into the grey water tanks and is discharged outside of MOU related waters. Hard foods are either incinerated or landed ashore as USDA

Photo #07 5/8/23 Image: IMG_184 By: Dobrowski Description: Food Processor

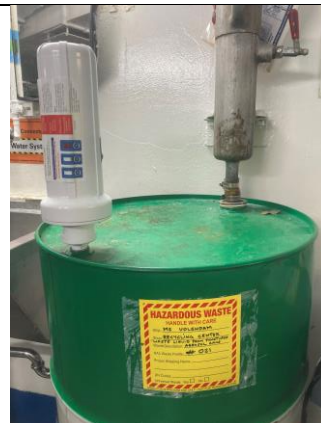
Photo #08 5/8/23 Image: IMG_183 By: Dobrowski Description: Aerosol Can Filtration

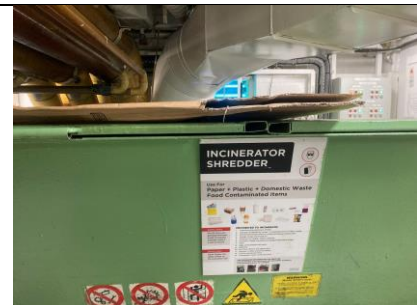
Photo #09 5/8/23 Image: IMG_185 By: Dobrowski Description: incinerator shredder

Garbage such as domestic and operational waste is offloaded in Seattle. Some USDA wastes, some food waste, biomedical bagged waste, some plastics, food contaminated cardboard, and some paper is incinerated with one incinerator. Ash is tested annually and offloaded as hazardous waste. The garbage record book was reviewed (photo # 10) and showed consistency with requirements.

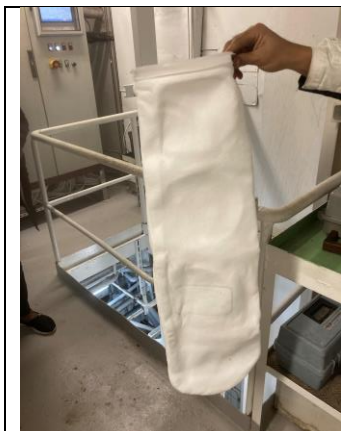
A wet scrubber for exhaust is installed on the VOLENDAM, there are total of 2 washwater discharges. In use on this trip are for engine 2 and 3 have filtration and were not being used at the time of inspection due to the vessel being in MOU waters and switching over to MGO fuel < 0.1% sulfur. The vessel is not equipped for shore power. The wet scrubbers 2 & 3 uses filters (photo #11,) and discharges are diluted and monitored before discharge.

Photo #11 5/8/23 Image: IMG_213
By: Dobrowski
Description: Wet Scrubber filter

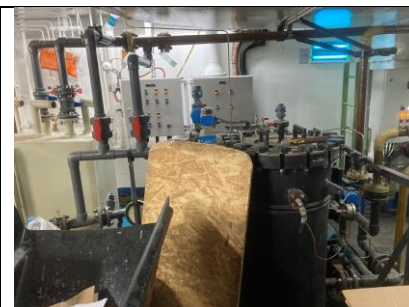
Photo #13 5/8/23
Image: IMG_190 By: Dobrowski
Description: Wet Scrubber Filters
