State of Washington Department of Ecology  
**Cruise Ship Memorandum of Understanding, Cruise Operations in Washington State Inspection Report**

<b>Name and Location of Site Inspected:</b> OCEANIA RIVIERA, Oceania Cruises Norwegian Cruise Lines Pier 66, Seattle, Washington	<b>Additional Participants/Inspectors:</b>
<b>On-Site Representative(s): Name/Title/Phone/e-mail</b> Fevola Vincenzo, Environmental Officer e: rva_envofficer@oceaniacruises.com	
<b>Responsible Official(s): Name/Title/Address/Phone/e-mail</b> Sarah Brown, Sr. Director, Environmental Operations Norwegian Cruise Lines  e: sbrown@nclcorp.com	<b>Other Facility Data:</b> Notification made to Sarah Brown and Robert Wilkinson on August 26, 2025.  Flag: Marshall Islands

**PHOTO ADDENDUM – OCEANIA RIVIERA  
OCEANIA CRUISES SEPTEMBER 9, 2025**

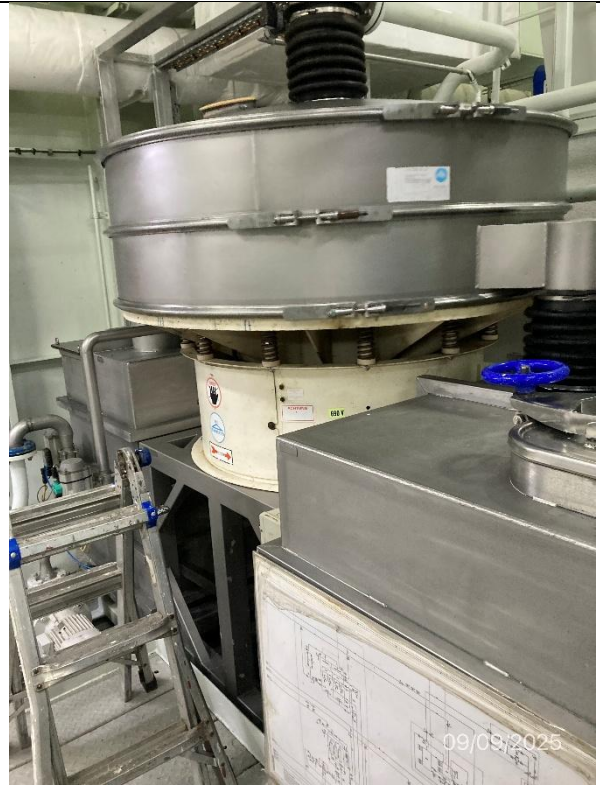
Photo # 2 Image: IMG\_3097 Date: 9/9/2025  
Taken by: Evan Dobrowski  
Description: Photo of MBR treatment system mixing tank

There are two MBR's on the vessel and the system is designed to treat both black and grey water; but can be used in several methods to segregate black and grey water. The first step is a prescreening press which filters out coarse solids

for both black and grey water. The second step is an aerated blackwater/greywater holding tank which feed to the MBR 1st stage of antifoam dosing and mixing. After this is the biological processing (permeate tank) followed by a two stage MBR fine filtration process.

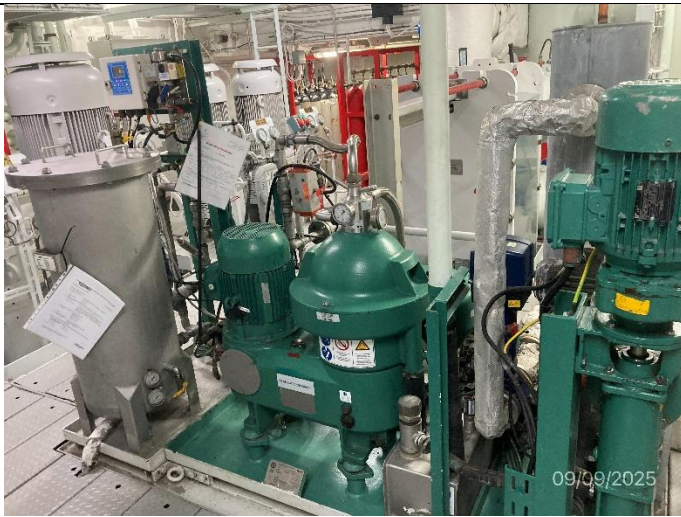
Photo # 3 Image: IMG\_3103 Date: 9/9/2025  
Taken by: Evan Dobrowski  
Description: Photo Centrifugal Oil Water Separator filter.

Dirty bilge water collected and is sent to one of two oily bilge tanks. Liquid moves to one centrifugal oily water separators (OWS).. The system includes two stages of filtration and recirculates at >5 parts per million (ppm) oil content with the oily content meter. Oily sludge is collected from the system and sent ashore by truck. Maintenance on the OWS's includes regular cleaning of the filters and other regular checks and maintenance. Prior to discharge, the liquid is sent through a white box which only allows discharges <15 ppm. The discharge protocol for this route is outside the MOU related waters. The Chief Engineer and the EO have the two separate keys and both need to be present to open the white box. There is a record each time the white box door is opened. The EO confirmed that he is not aware of any rerouting of oily bilge. The OWS was off and recirculating during the inspection and not discharging. If graywater tanks overflow or come in contact with oily bilge, the content is considered as oily bilge and treated through the OWS and the Captain and Chief Engineer are notified.

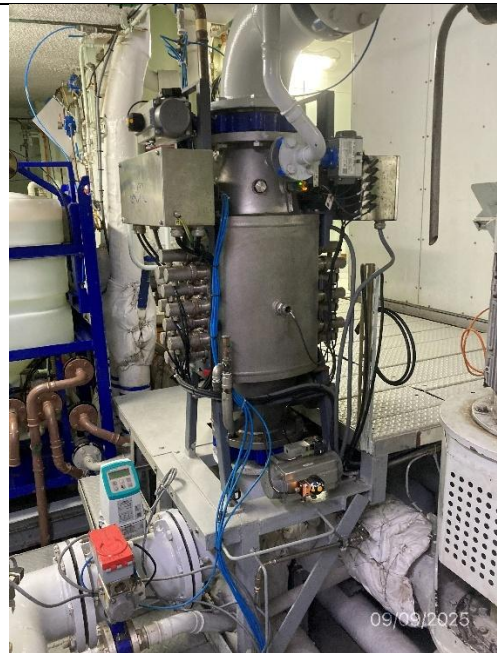
Photo # 4 Image: IMG\_3106 Date: 9/9/2025  
Taken by: Evan Dobrowski  
Description: Photo of UV filter component for the oily bilge filtration system.

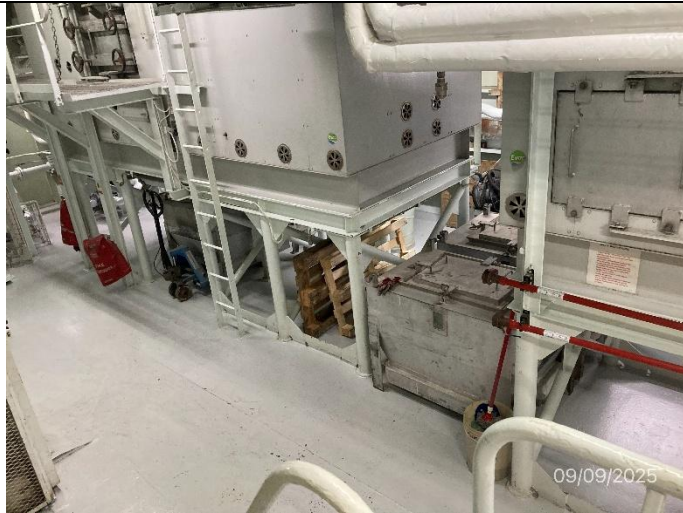
Photo # 5 Image: IMG\_3108 Date: 9/9/2025  
Taken by: Evan Dobrowski  
Description: Photo of incinerator room.

Garbage such as domestic and operational waste is offloaded. Some USDA wastes, some food waste, biomedical bagged waste, some plastics, cardboard, and paper is incinerated. Ash is tested annually and offloaded as hazardous waste. The garbage record book was reviewed and showed consistency with requirements.

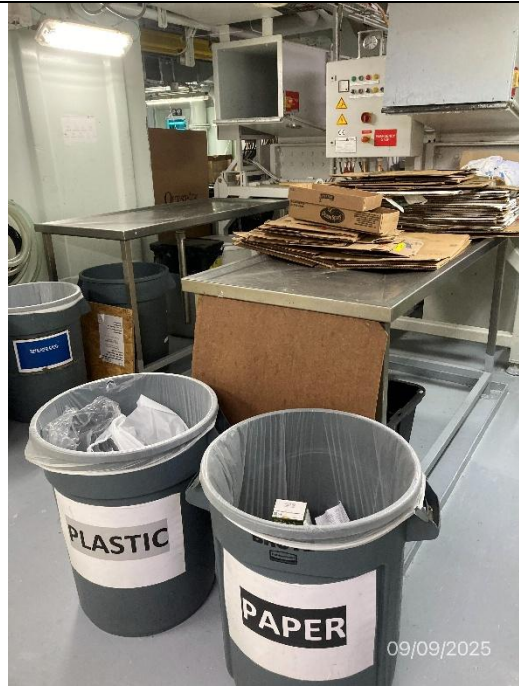
Photo # 6 Image: IMG\_2807 Date: 9/9/2025  
Taken by: Evan Dobrowski  
Description: Photo of sorting room and incinerator chute.

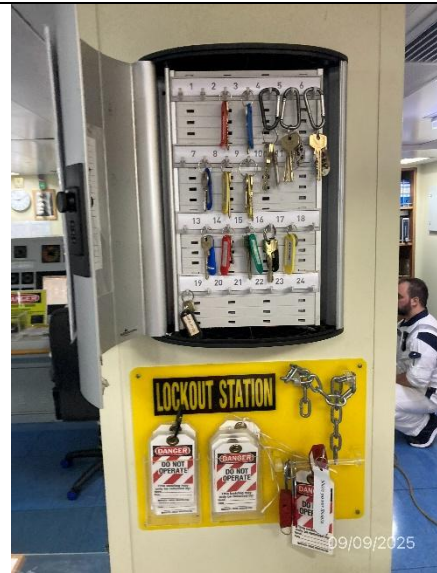
Photo # 8 Image: IMG\_3118 Date: 9/9/2025  
Taken by: Evan Dobrowski  
Description: Photo of key lock box

The protocol for discharges is a closed-loop process. There is communication between the ECR Officer on Watch and the Bridge staff for approval from the Bridge that the vessel is in an area authorized for discharge. The overboard valves have a lock which is electronically controlled. Some valves also had manual keyed locks, the keys for the locks are found in the engine control room. For the discharge valves only engineering and environmental officers have access to these keys. The discharge valves are then controlled electronically after the locks are removed and the discharges are logged into the system. Any change to the logs shows who made the change by staff passcode. Any changes are reviewed by the Bridge. The GPS system is connected to the log for accurate logging of the discharge location. The discharges all to occur outside of MOU related waters (Washington State waters, the Strait of Juan de Fuca up to the border with Canada and the OCNMS). For black water and gray water, the latitude and longitude coordinates are recorded in the system along with all other logs. The date, time and location of both the start and the stop of the discharges are recorded, along with port location, effluent type, speed, tank name and volume, valve name, and status of valve. The maker of the entry and reviewer/signer is also included, along with any notes. Navigation on the bridge shows clearly marked electronic maps indicating discharges to stop 13 miles outside the OCNMS (12 miles from shore and a one-mile buffer).

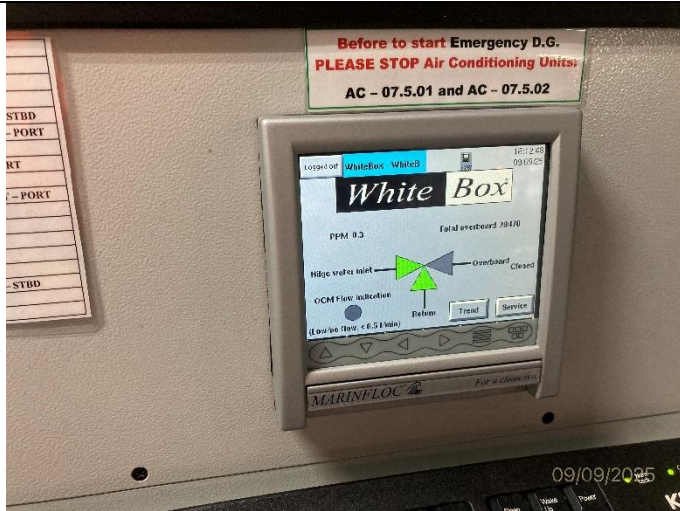
Photo # 9 Image: IMG\_3119 Date: 9/9/2025  
Taken by: Evan Dobrowski  
Description: Photo of Marinfloc White Box readings inside the ECR.

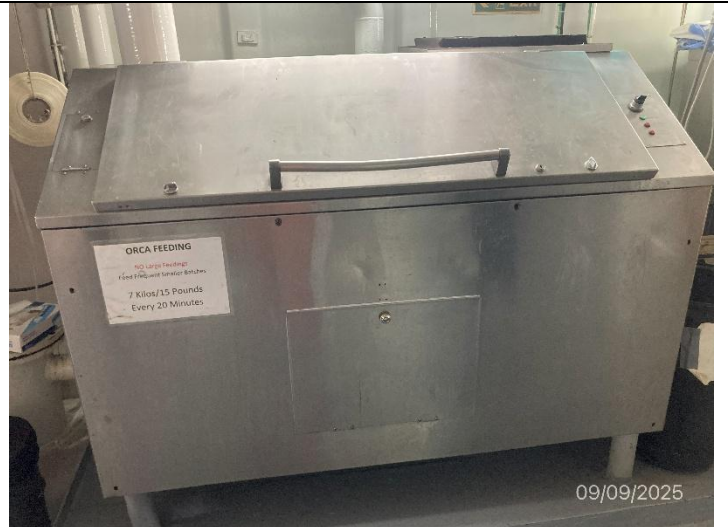
Photo # 10 Image: IMG\_3120 Date: 9/9/2025  
Taken by: Evan Dobrowski  
Description: Photo of food pulper/biodigester

Food waste is screened for materials that would damage the pulper systems/biodigester such as utensils or large materials. The screened material is removed from the system. The rest of the food waste is fed into pulpers/biodigesters. The pulpers/biodigesters grind the food waste into liquid waste which is either reused through the system or sent to the greywater tanks. The effluent from the food waste pulper is deposited into the grey water tanks and is discharged outside of MOU related waters. Hard foods are either incinerated or landed ashore as USDA waste. Used cooking oil is sent ashore for recycling.

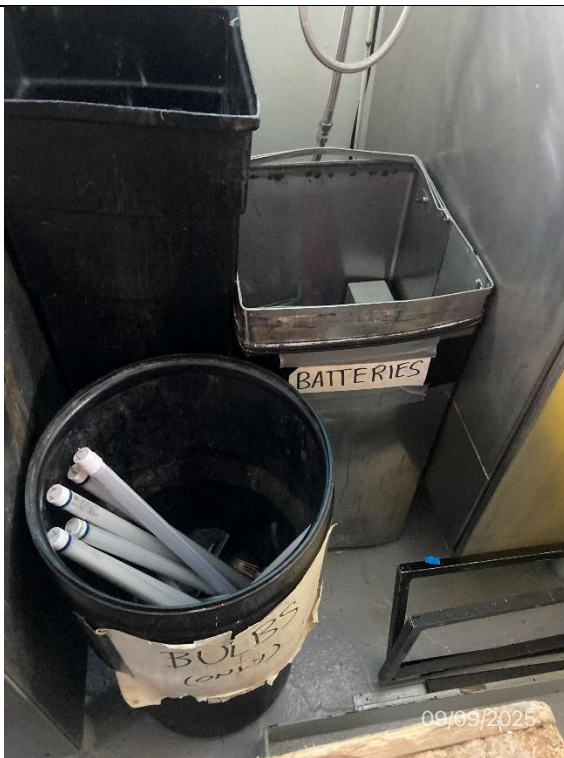
Photo # 11 Image: IMG\_3123 Date: 9/9/2025  
Taken by: Evan Dobrowski  
Description: Photo of battery and light bulbs collection buckets.

No photo waste is generated onboard this vessel. X-rays are done digitally without any waste. Fluorescent bulbs are held for offloading ashore as hazardous waste. Hazardous waste materials are stored separately in various dedicated locations throughout the vessel and include items such as paints, thinners, oily rags and debris, incinerator ash, chemicals, aerosols photo waste, and some batteries. Bio-medical waste is incinerated with sharps being offloaded as biomedical waste ashore. Hazardous waste is not being offloaded in Seattle. At the time of this inspection there was no hazardous waste storage onboard due to a recent offload in Victoria.

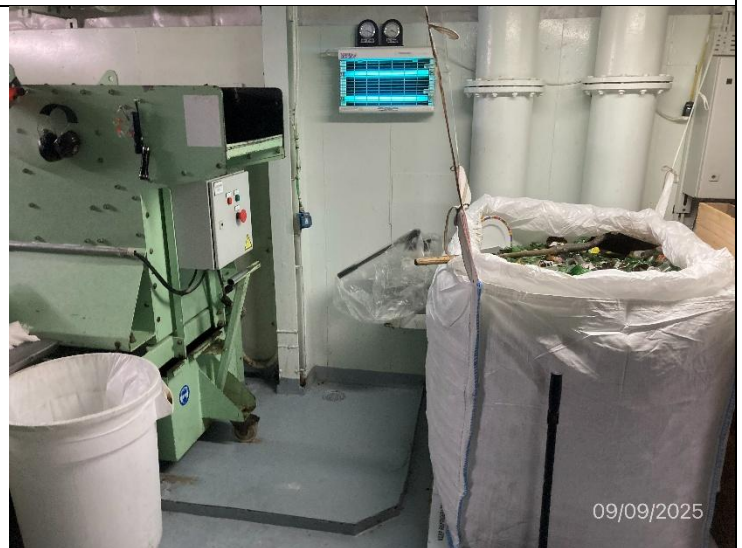
Photo # 12 Image: IMG\_3121 Date: 9/9/2025  
Taken by: Evan Dobrowski  
Description: Photo of glass crusher.

Glass, heavier plastics, aluminum, tin and steel cans, batteries, used cooking oil and other items are recycled.

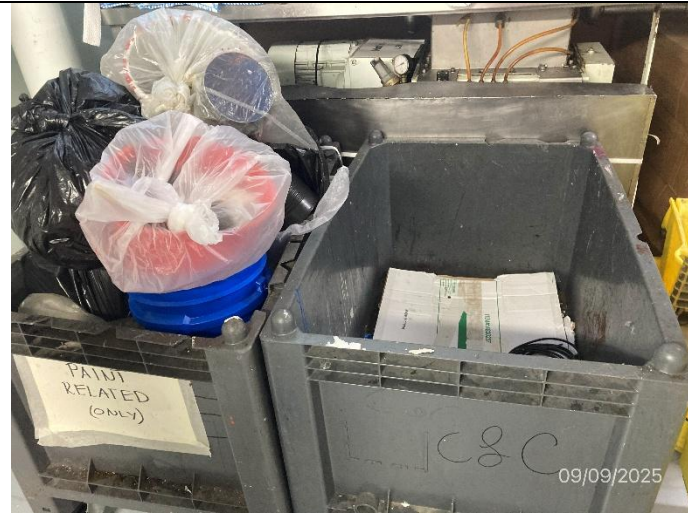
Photo # 13 Image: IMG\_3124 Date: 9/9/2025  
Taken by: Evan Dobrowski  
Description: Photo showing hazardous waste storage location.

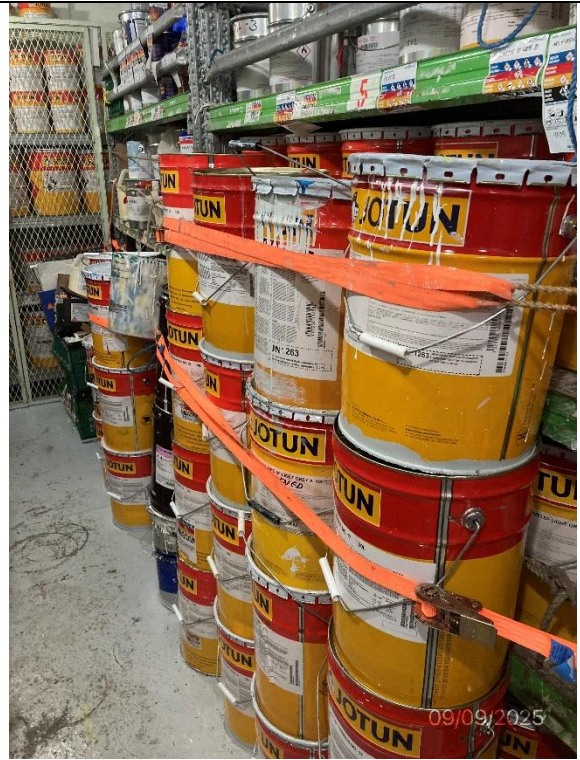
Photo # 14 Image: IMG\_3127 Date: 9/9/2025  
Taken by: Evan Dobrowski  
Description: Photo showing chemical storage room.

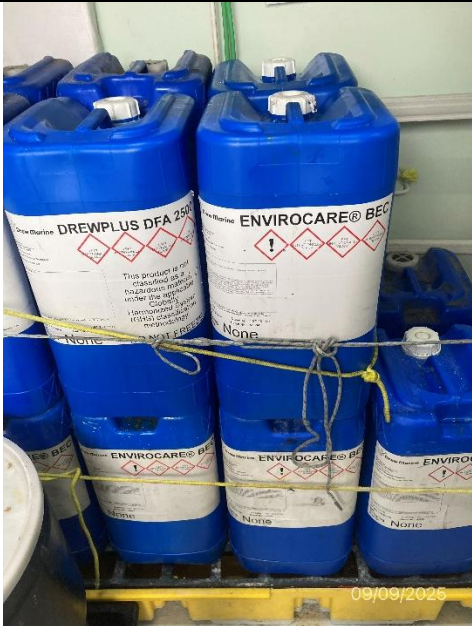
Photo # 15 Image: IMG\_3129 Date: 9/9/2025  
Taken by: Evan Dobrowski  
Description: Photo showing chemical storage area.

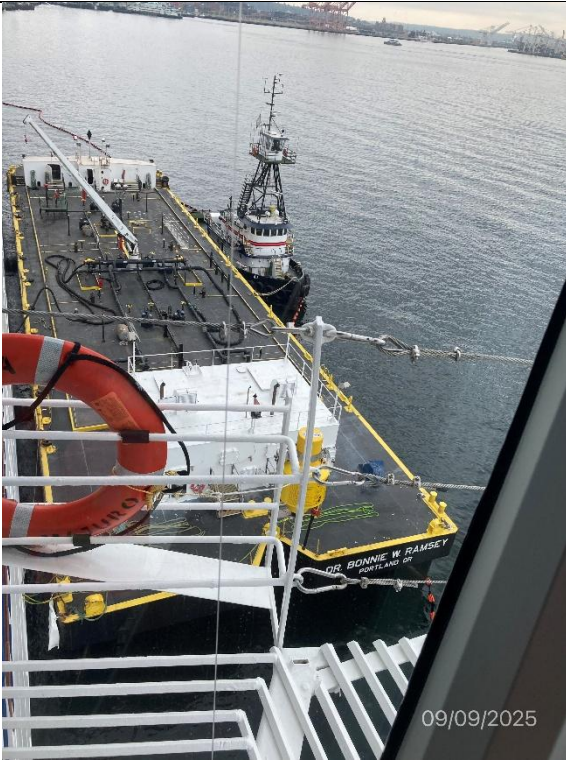
Photo # 17 Image: IMG\_3137 Date: 9/9/2025  
Taken by: Evan Dobrowski  
Description: Photo showing bunkering of fuel.

The OCEANIA RIVIERA is not equipped with an exhaust gas cleaning system (scrubber). While in MOU waters the vessel is switching over to MGO fuel < 0.1% sulfur.

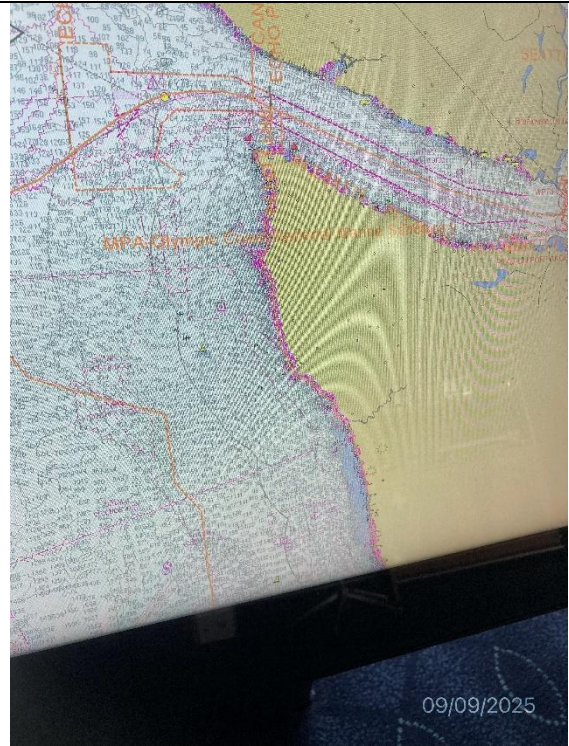
Photo # 18 Image: IMG\_3138 Date: 9/9/2025  
Taken by: Evan Dobrowski  
Description: Photo showing environmental control areas on navigational map.

The matrix also shows that Puget Sound is a designated No Discharge Zone for sewage. The matrix is overlaid onto the navigational screen to show the location where discharges stop just before the OCNMS and start upon entering Canadian waters when leaving Seattle.

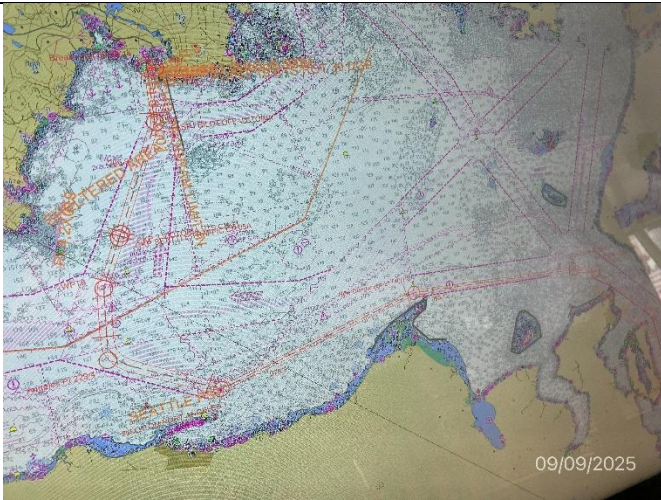
Photo # 19 Image: IMG\_3140 Date: 9/9/2025  
Taken by: Evan Dobrowski  
Description: Photo showing environmental control areas on navigational map.
