**CITY OF SUMAS
SHORELINE MASTER PROGRAM UPDATE
SHORELINE INVENTORY AND CHARACTERIZATION REPORT
TASK 2.3**

December 31, 2010 Draft

**CITY OF SUMAS
SHORELINE MASTER PROGRAM UPDATE**

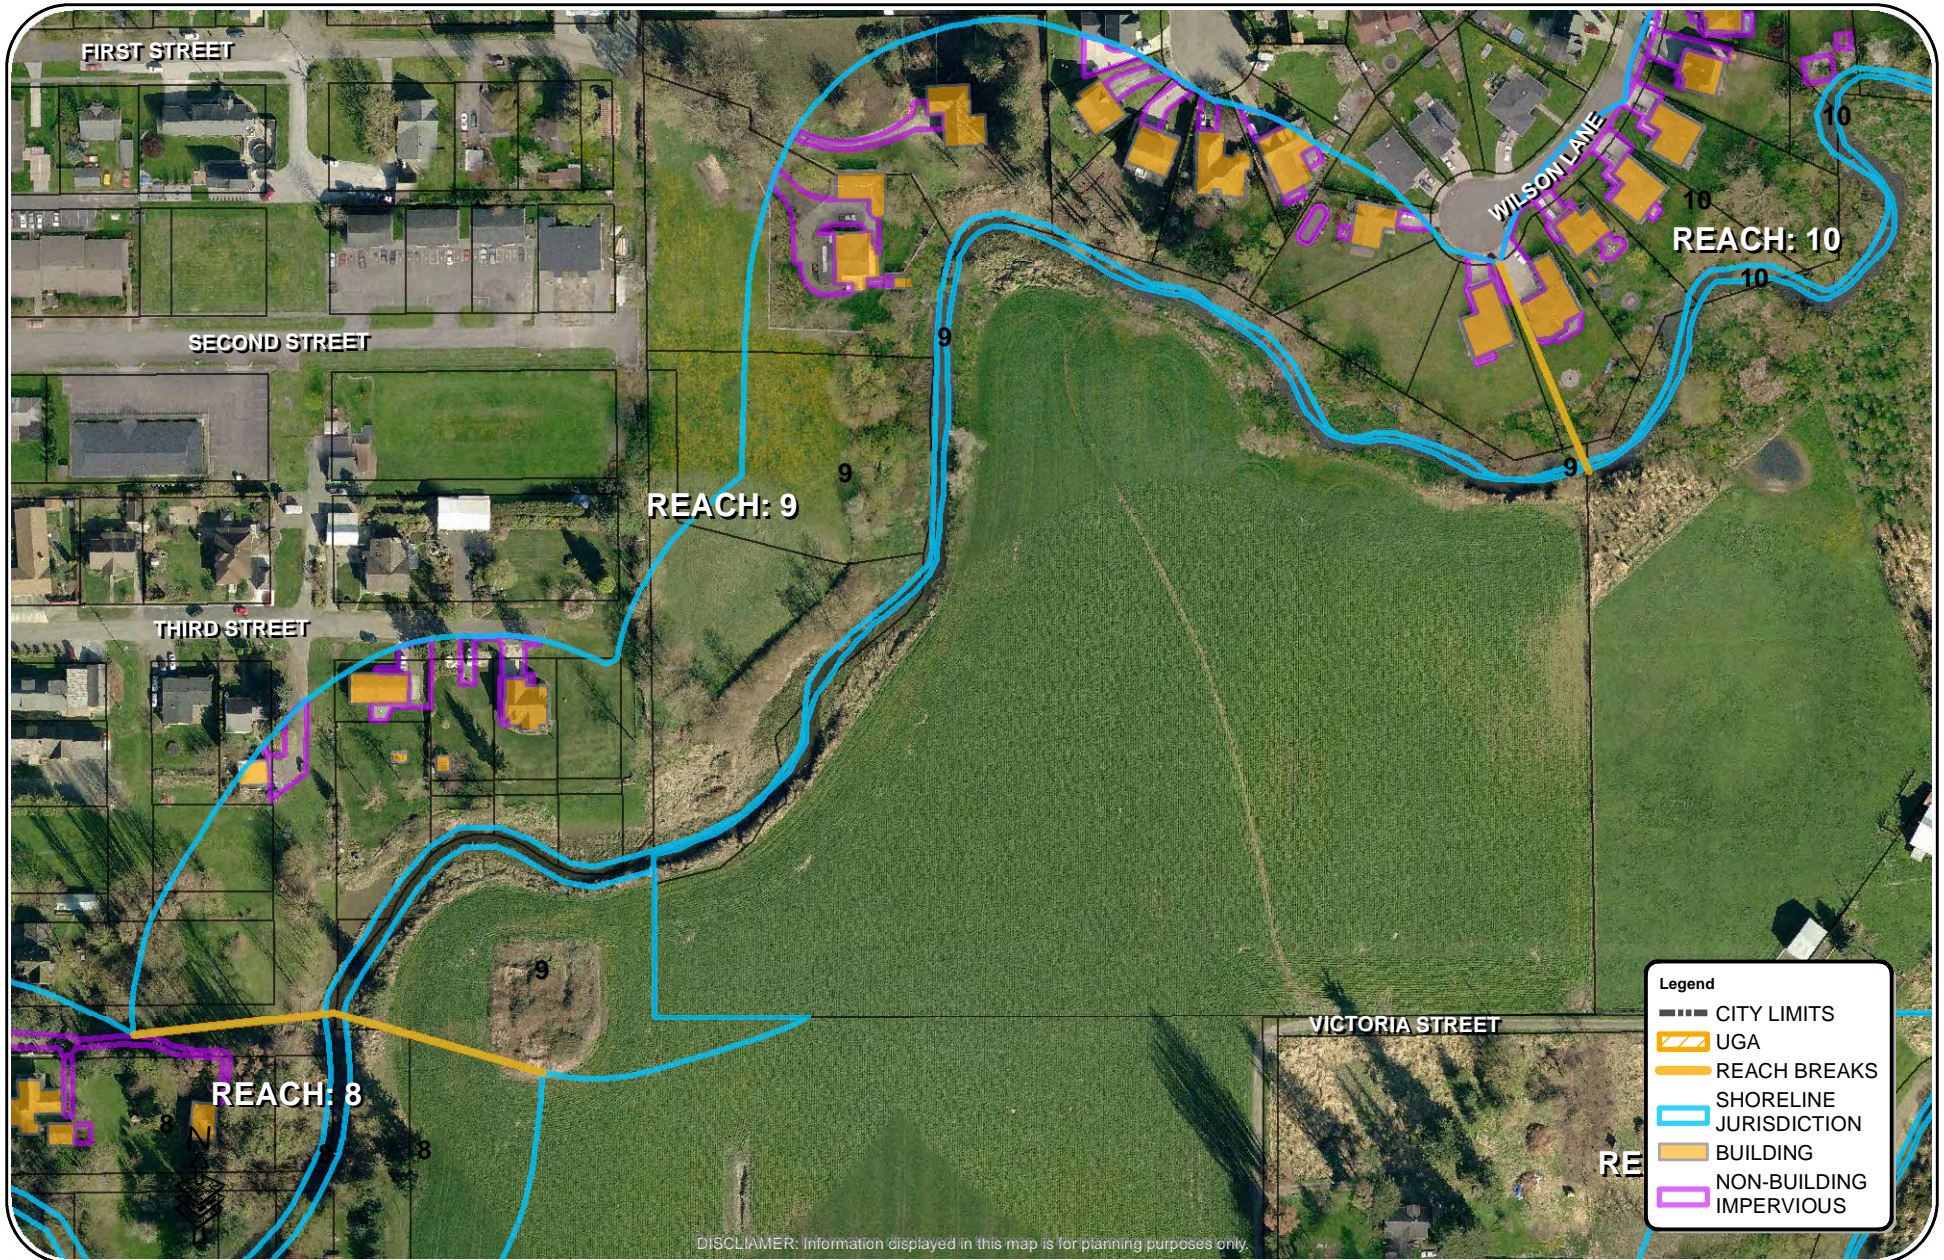
Shoreline Jurisdiction

Point source pollution	Groundwater wells show increased levels of ethylene dibromide in drainage; anthropogenic nitrate concentrations in surface water (Ref # 9). Scattered residential uses, crop agriculture. Higher intensity sources are located in the upper watershed where dairy and agriculture is more prevalent. (Ref # 16)
Historic & Cultural	Historic aerials	None available on-line. Presume geomorphology has been stable for several decades.
	Archeological sites	None indicated. (Ref # 5)
	Historic sites	None indicated. (Ref # 5)
	Parks & public access	None. (Ref # 1)
Function Analysis	Reach Function <ul style="list-style-type: none"> Hydrologic Shoreline Vegetation Habitat 	<p>Functioning with impairments. Rainfall dominated; flashy winter and early spring peaks, low summer, variable spring and fall flows. Impairment in basin due to loss of wetland area, draining, filling, ditching and removal of vegetation for agriculture in reach and upper watershed.</p> <p>Impaired. Majority of vegetation is non-native. Very little diversity of species or structure. Habitat value low; very little cover provided to creek.</p> <p>Terrestrial: Impaired, but could be improved.</p> <p>Aquatic: Functioning, with impairments.</p>

Limiting Factors	<ul style="list-style-type: none"> Existing land uses Water quality Zoning
	Functions <ul style="list-style-type: none"> Sustainable Not Sustainable 	Sustainable at current levels: hydrologic, shoreline vegetation, and terrestrial & aquatic habitat. However, sustainability affected by private property ownership.
	Priority Actions	<ul style="list-style-type: none"> Preservation of riparian corridor; enhance with trees and native vegetation for habitat and thermal cover. Water quality improvement.
	Current Enhancement Projects	None known.
	Preservation/Enhancement Opportunities	<ul style="list-style-type: none"> Enhance riparian buffer: increase width of native shoreline vegetation in pasture areas, added species diversity, added plants along the banks for shading. Removal of invasive species (Himalayan blackberry).

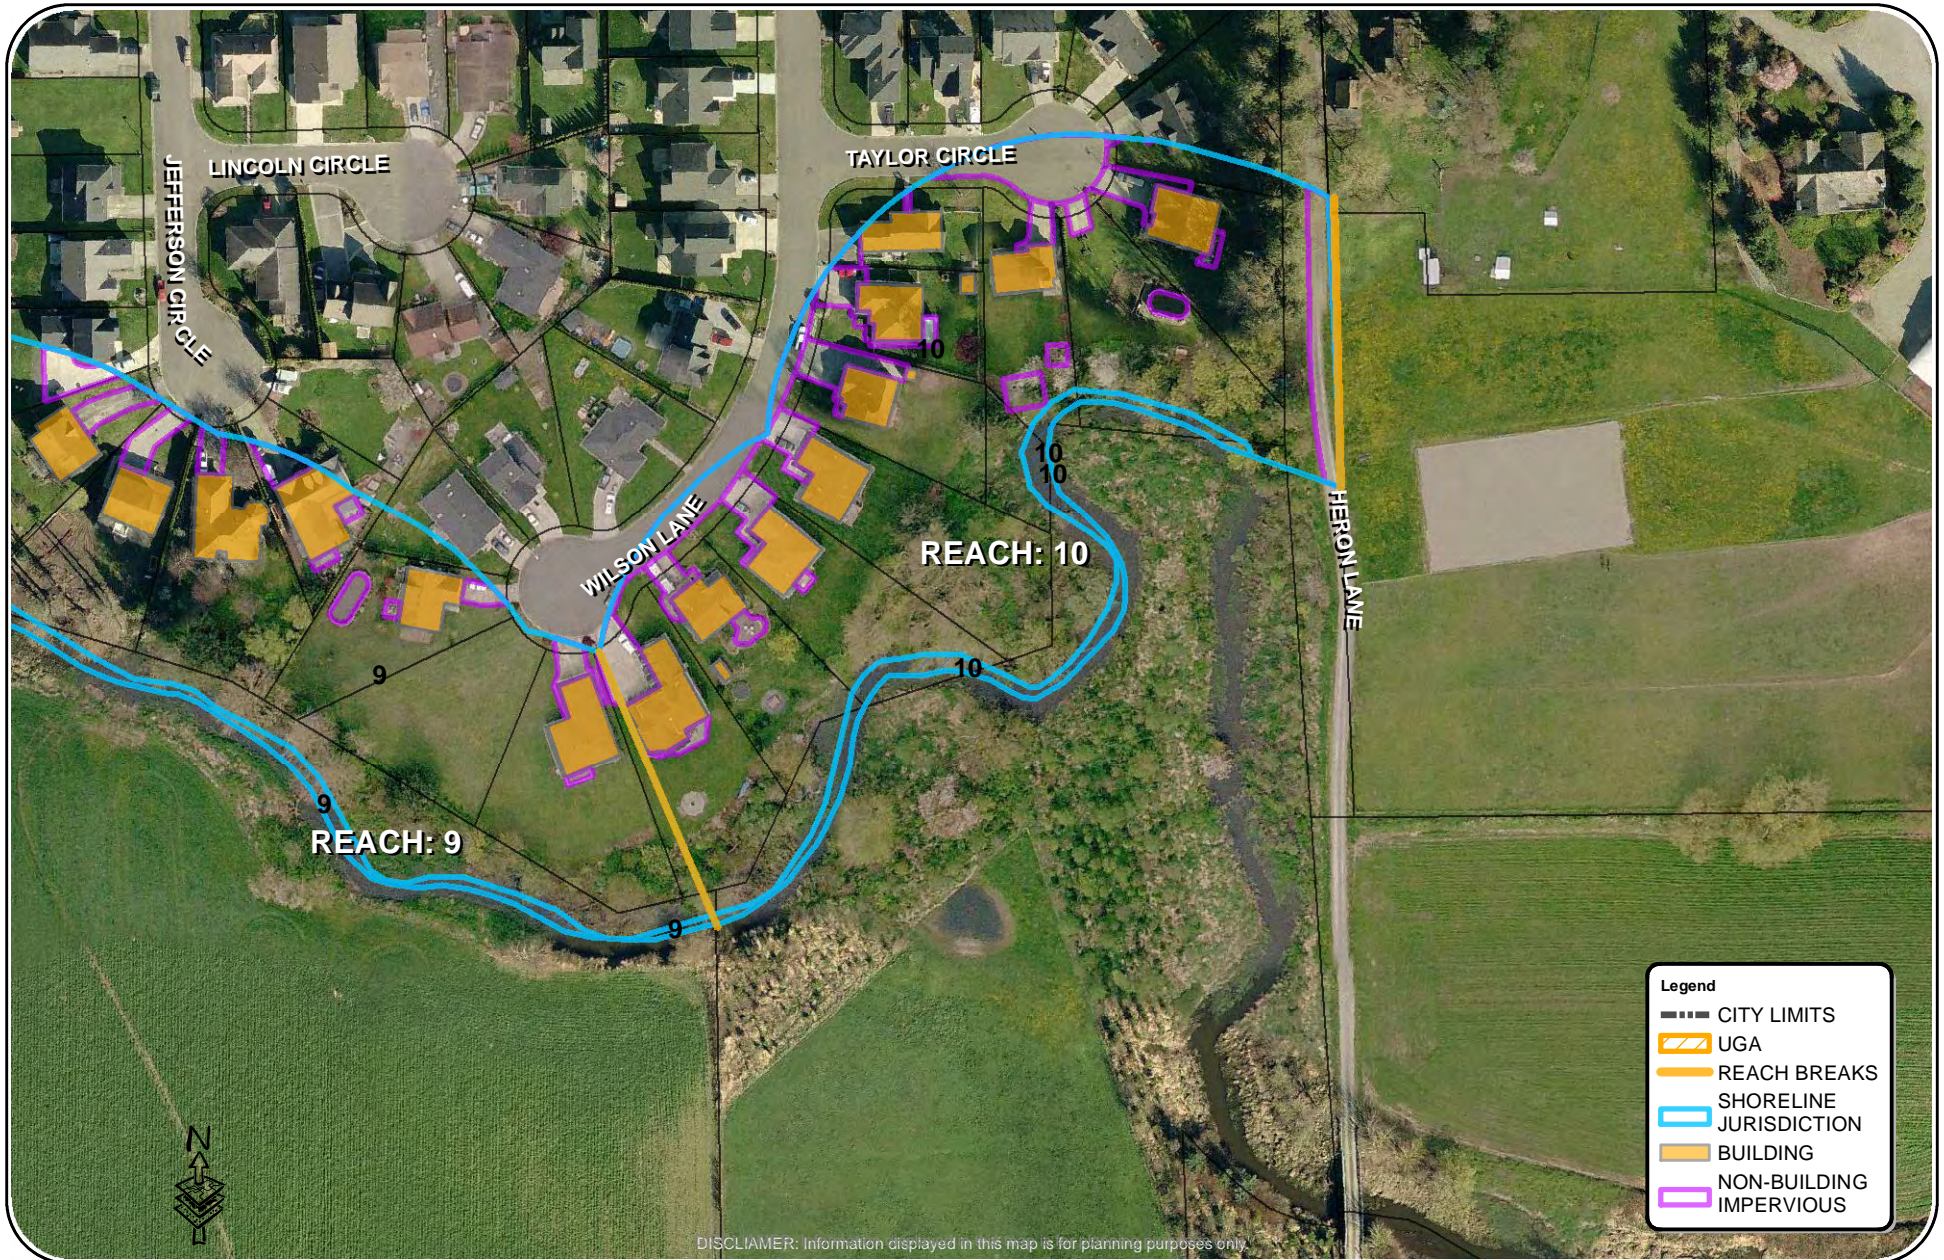
Shoreline Jurisdiction

Point source pollution	Groundwater wells show increased levels of ethylene dibromide in drainage; anthropogenic nitrate concentrations in surface water (Ref # 9). Residential uses. Higher intensity sources are located in the upper watershed where dairy and agriculture is more prevalent. (Ref # 16)
Historic & Cultural	Historic aerials	None available on-line. Presume geomorphology has been stable for several decades.
	Archeological sites	None indicated. (Ref # 5)
	Historic sites	None indicated. (Ref # 5)
	Parks & public access	None. (Ref # 1)
Function Analysis	Reach Function <ul style="list-style-type: none"> Hydrologic Shoreline Vegetation Habitat 	<p>Functioning with impairments. Rainfall dominated; flashy winter and early spring peaks, low summer, variable spring and fall flows. Impairment in basin due to loss of wetland area, draining, filling, ditching and removal of vegetation for agriculture in the upper watershed.</p> <p>Functioning in areas, impaired in other. Some native tree and shrub habitat along shoreline; open areas with blackberry and reed canarygrass. Residential lawn encroaches in areas. Fallow agricultural practice has allowed tree and shrubs to re-vegetate shoreline and buffer – although not all species are native. Potential for restoration.</p> <p>Terrestrial: Functioning, with impairments. Aquatic: Functioning with impairments.</p>

Limiting Factors	<ul style="list-style-type: none"> Existing land uses Water quality Zoning
	Functions <ul style="list-style-type: none"> Sustainable Not Sustainable 	Sustainable at current levels: hydrologic, shoreline vegetation, and terrestrial & aquatic habitat. However, sustainability affected by private property ownership.
	Priority Actions	<ul style="list-style-type: none"> Preservation of riparian corridor; buffer enhancement plantings to improve habitat and structure. Water quality improvement.
	Current Enhancement Projects	None known
	Preservation/Enhancement Opportunities	<ul style="list-style-type: none"> Preservation of terrestrial vegetation, habitat and associated corridors. Particularly riparian corridors. Enhance riparian buffer: increase width and species diversity of native shoreline vegetation, add plants along the banks to provide shading.

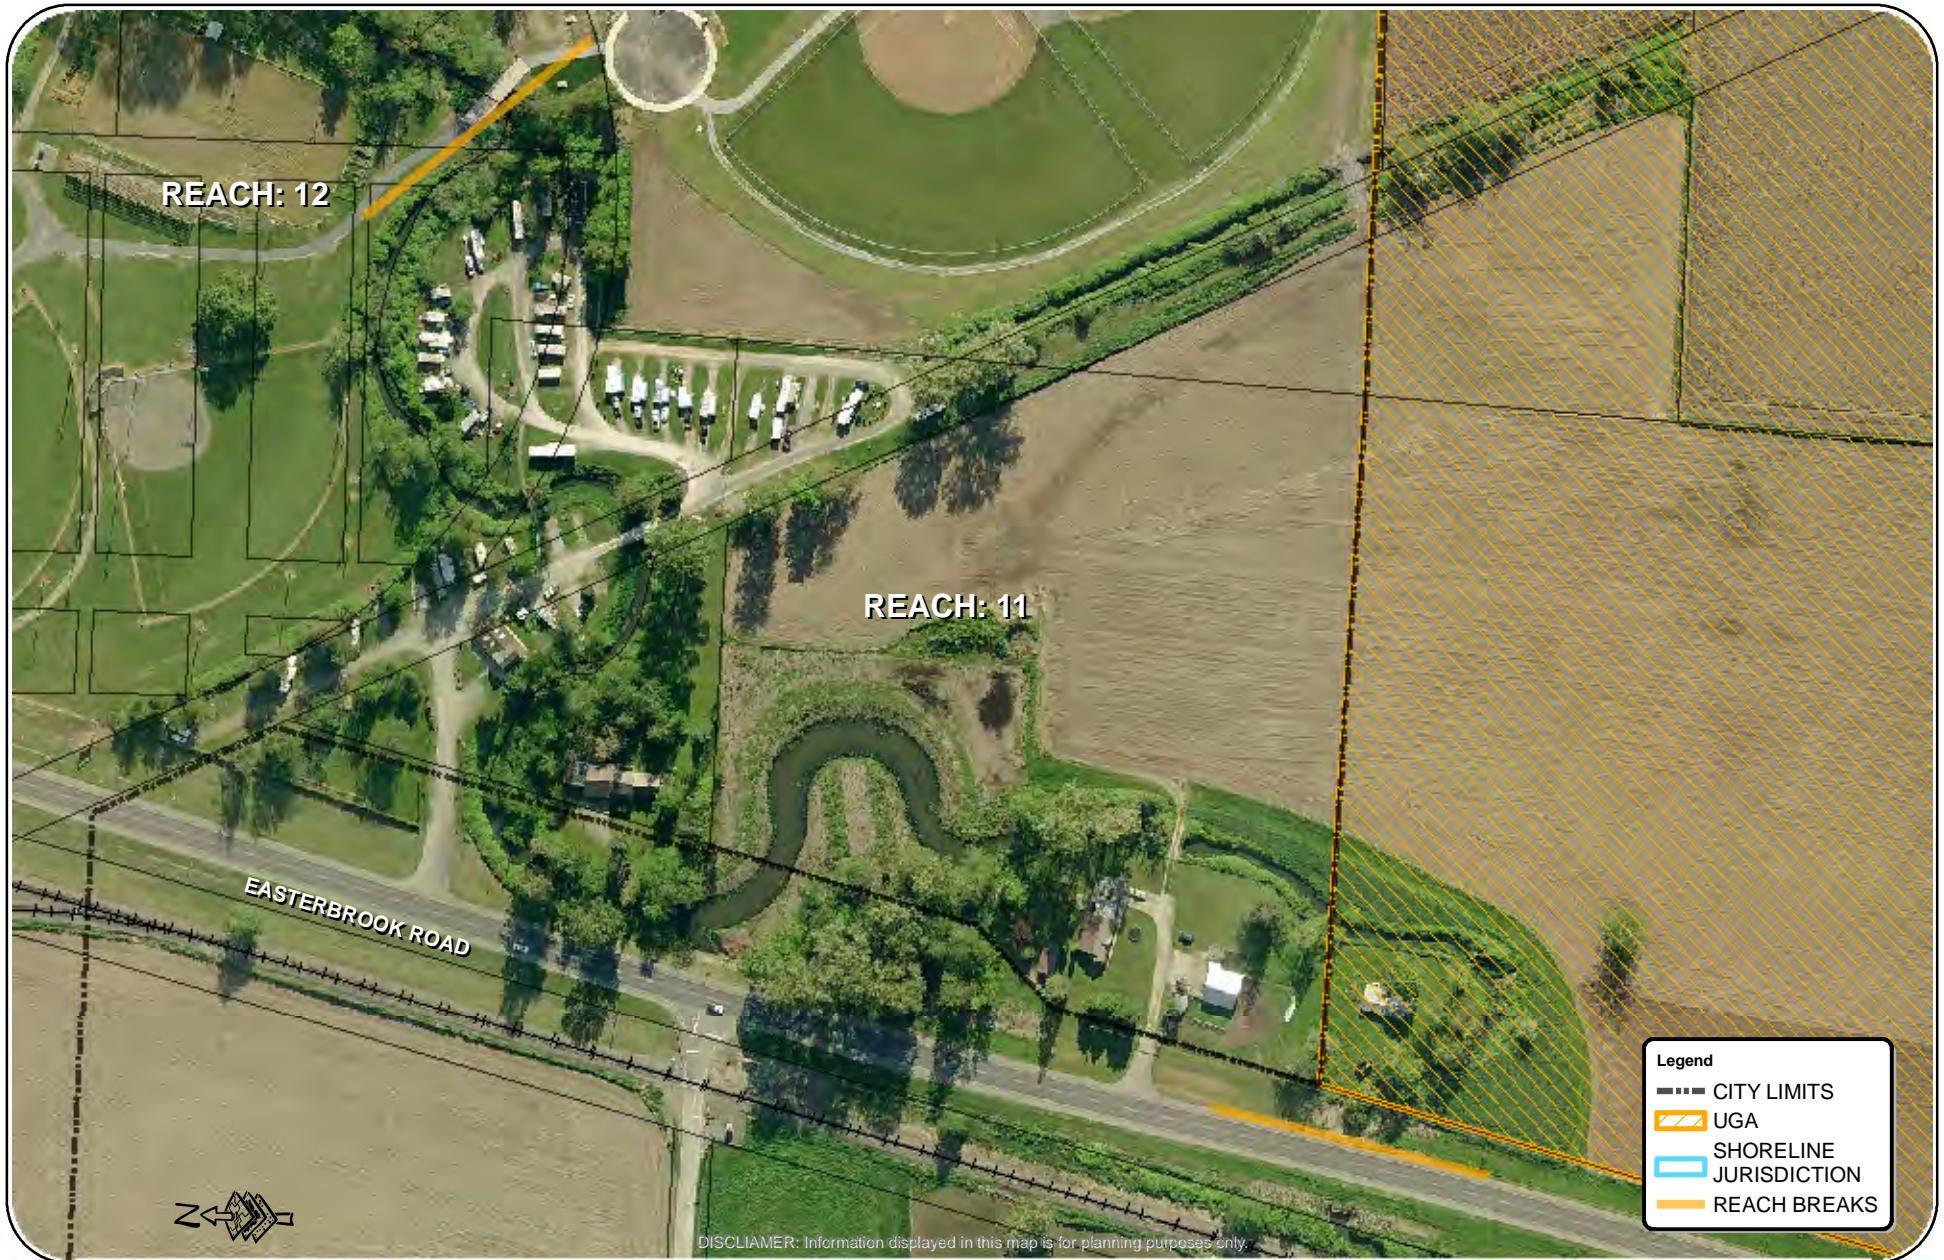
Shoreline Jurisdiction

Point source pollution	Agriculture, urban density trailer park. (Ref # 7)
Historic & Cultural	Historic aerials	None available on-line. Presume geomorphology has been stable for several decades.
	Archeological sites	None indicated. (Ref # 5)
	Historic sites	None indicated. (Ref # 5)
	Parks & public access	None. (Ref # 1)
Function Analysis	Reach Function <ul style="list-style-type: none"> Hydrologic Shoreline Vegetation Habitat 	<p>Functioning with impairments. Rainfall dominated; flashy winter and early spring peaks, low summer, variable spring and fall flows. Impairment in basin due to loss of wetland area, draining, filling, ditching and removal of vegetation for agriculture.</p> <p>Generally impaired; restoration along portion of reach, patches of native trees and shrubs are spotty. Agriculture and trailer park land uses have lead to degradation of vegetation.</p> <p>Terrestrial: Impaired; some restoration along creek will provide improved habitat in the future.</p> <p>Aquatic: Functioning, with impairments.</p>

Limiting Factors	<ul style="list-style-type: none"> Existing land uses Water quality Zoning
	Functions <ul style="list-style-type: none"> Sustainable Not Sustainable 	<p>Sustainable at current levels: hydrologic, shoreline vegetation, and terrestrial & aquatic habitat. However, sustainability affected by private property ownership.</p> <p>Terrestrial habitat likely not sustainable in majority of reach due to land uses.</p>
	Priority Actions	<ul style="list-style-type: none"> Water quality improvement.
	Current Enhancement Projects	Wetland/riparian enhancement project at southwestern end of reach.
	Preservation/Enhancement Opportunities	<ul style="list-style-type: none"> Preservation of terrestrial vegetation, habitat and associated corridors. Particularly riparian corridors. Enhance riparian buffer: increase width and species diversity of native shoreline vegetation. Remove invasive plant material (Himalayan blackberry, yellow flag iris). Fish usage is documented; habitat enhancement could be a opportunity target.

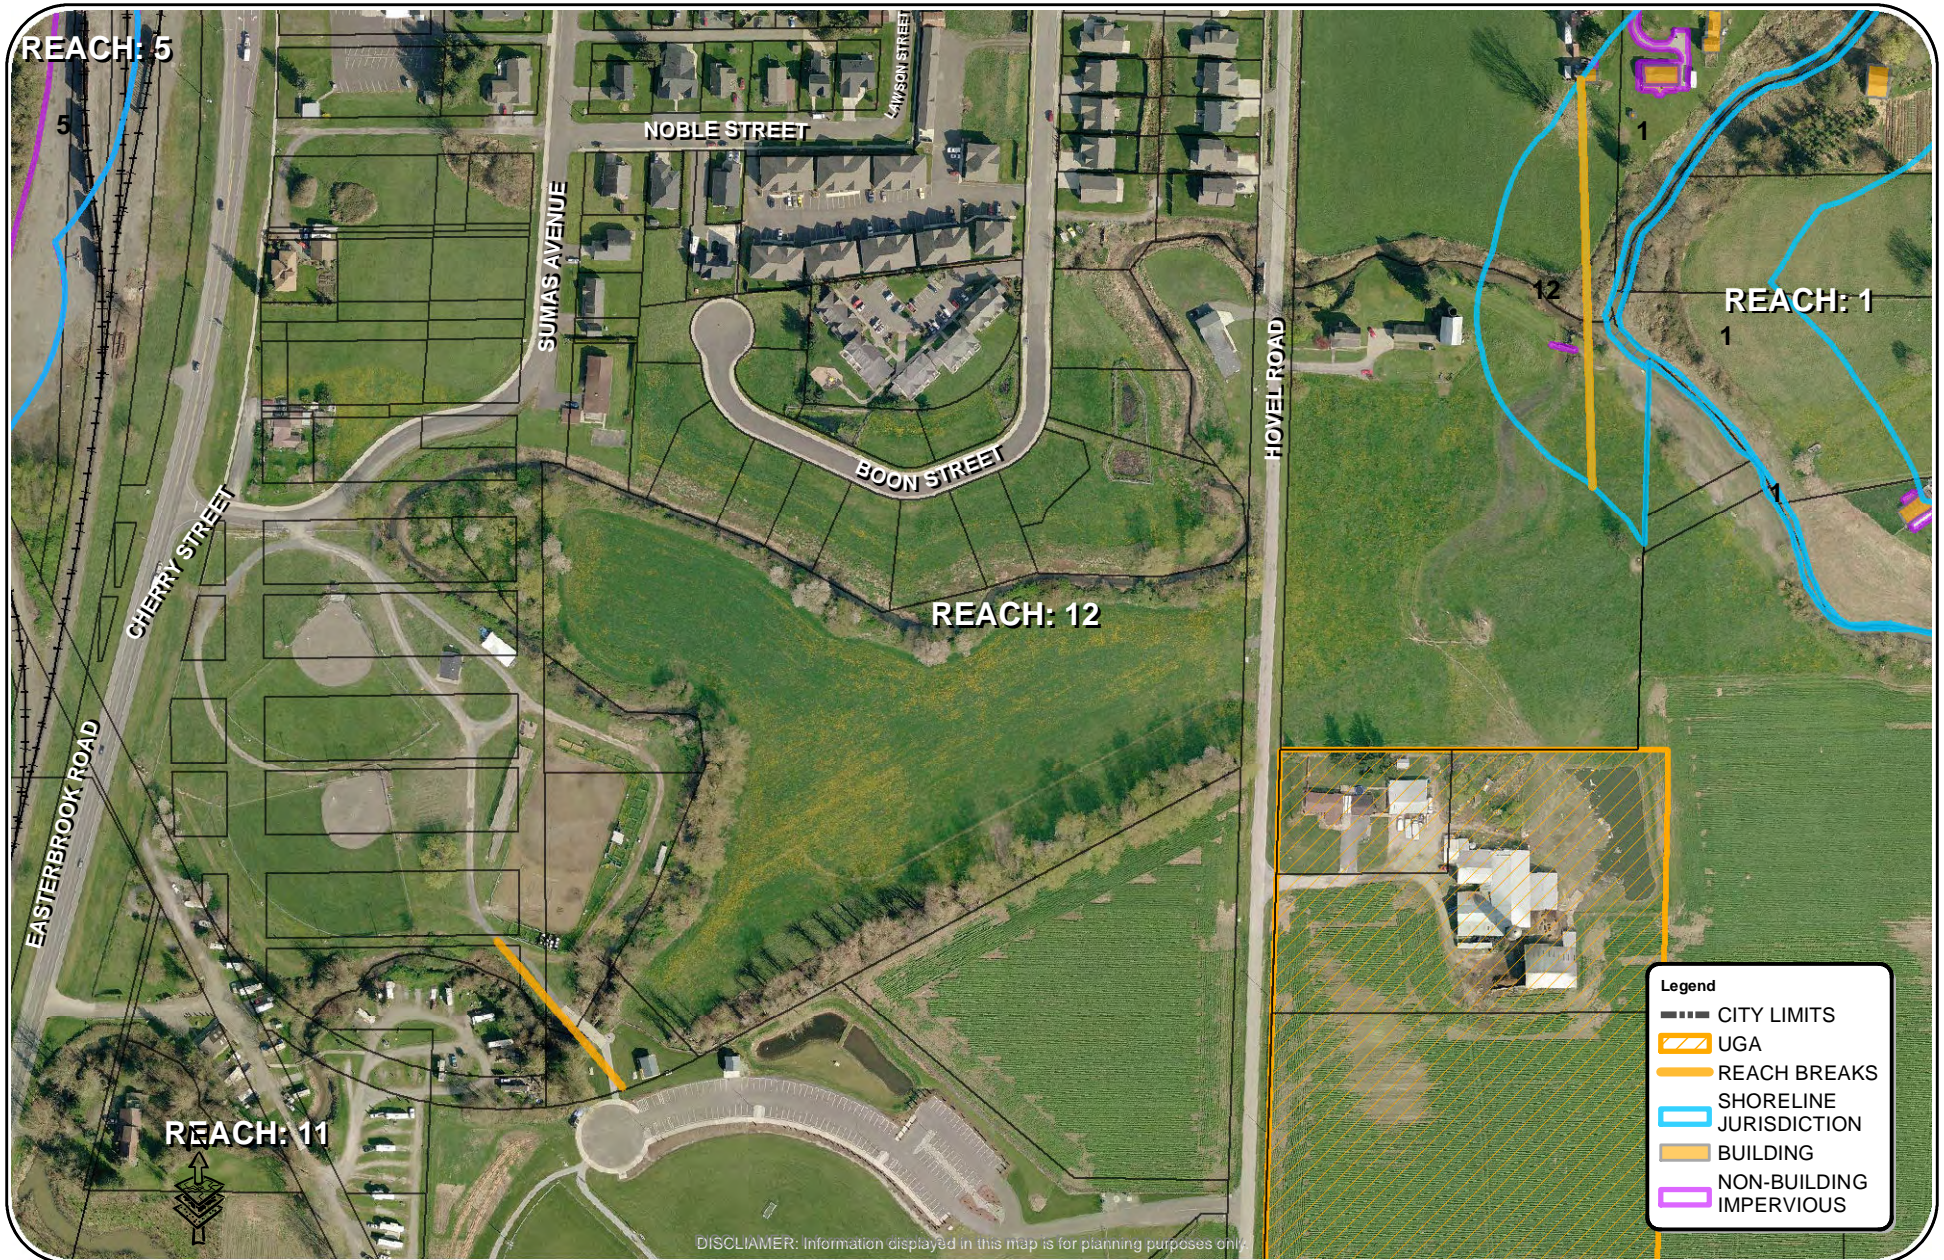
Shoreline Jurisdiction

Toxic sites/land fills	None listed. (Ref # 8)
	Point source pollution	Urban density residential uses, light agriculture, recreation. (Ref # 7)
Historic & Cultural	Historic aerials	None available on-line. Presume geomorphology has been stable for several decades.
	Archeological sites	None indicated. (Ref # 5)
	Historic sites	None indicated. (Ref # 5)
	Parks & public access	Southern portion of reach is public park, planned trail system. (Ref # 2)
Function Analysis	Reach Function <ul style="list-style-type: none"> Hydrologic Shoreline Vegetation Habitat 	<p>Functioning with impairments. Rainfall dominated; flashy winter and early spring peaks, low summer, variable spring and fall flows. Impairment in basin due to loss of wetland area, draining, filling, ditching and removal of vegetation for agriculture.</p> <p>Generally impaired; areas of native trees and shrubs in southwest portion of reach providing habitat and creek cover. Degraded in northeastern half of reach adjacent to agriculture and new residential development where there is no cover for creek.</p> <p>Terrestrial: Impaired; some opportunity for improvement (agriculture areas).</p> <p>Aquatic: Functioning, with impairments.</p>

Limiting Factors	<ul style="list-style-type: none"> Existing land uses Water quality Zoning
	Functions <ul style="list-style-type: none"> Sustainable Not Sustainable 	<p>Sustainable at current levels: hydrologic, shoreline vegetation, and terrestrial & aquatic habitat. However, sustainability affected by private property ownership.</p> <p>Terrestrial habitat likely not sustainable in portions of reach due to land uses (residential).</p>
	Priority Actions	<ul style="list-style-type: none"> Preservation of riparian corridor. Water quality improvement.
	Current Enhancement Projects	None known.
	Preservation/Enhancement Opportunities	<ul style="list-style-type: none"> Preservation of terrestrial vegetation, habitat and associated corridors. Particularly riparian corridors. Enhance riparian buffer: increase width of native shoreline vegetation in pasture areas, increase species diversity, plantings on banks to provide shading. Removal of invasive species (Himalayan blackberry). Fish usage is documented; habitat enhancement could be a opportunity target.

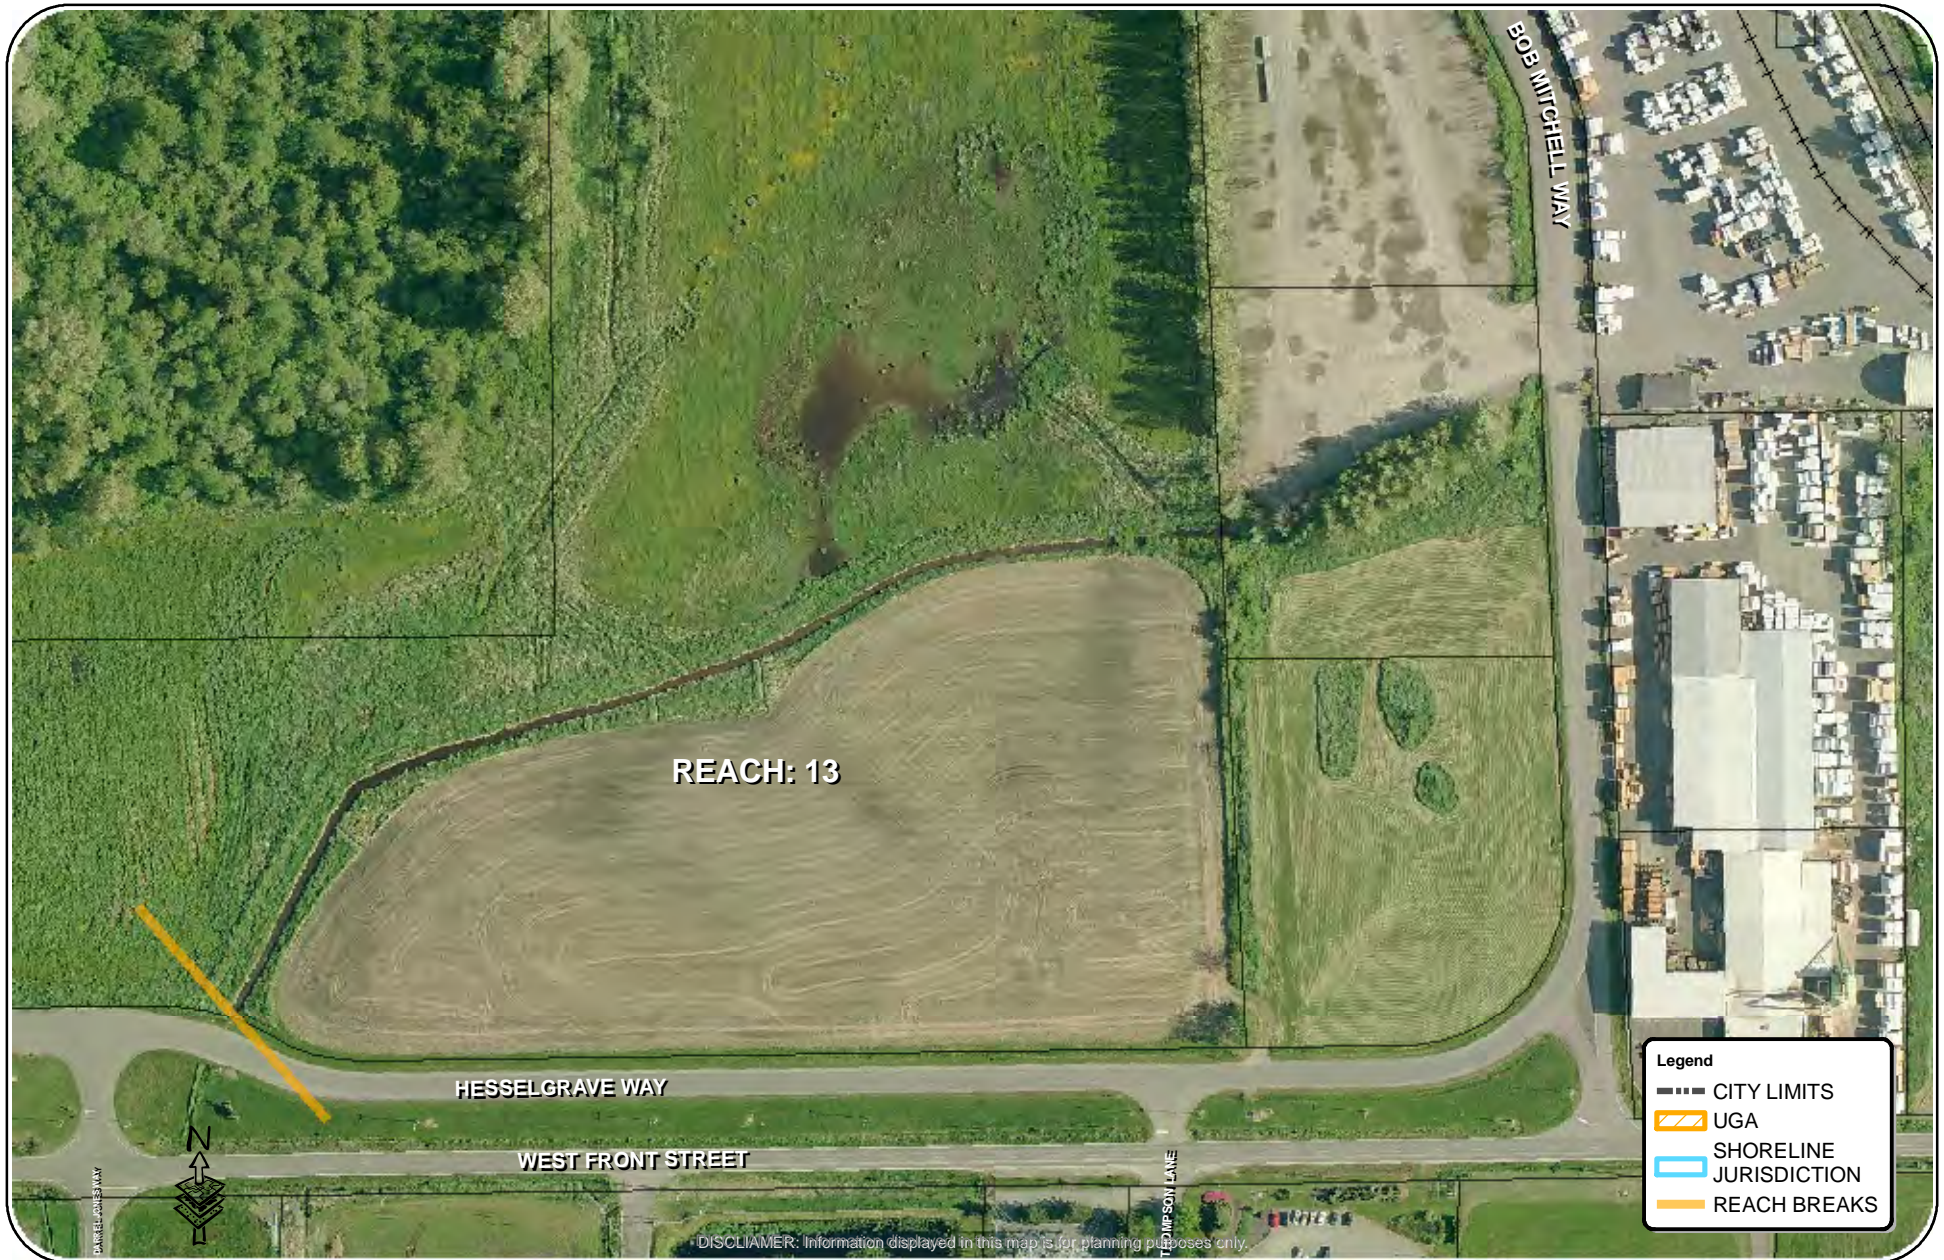
Shoreline Jurisdiction

Historic & Cultural	Historic aerials	None available on-line. Presume geomorphology has been stable for several decades.
	Archeological sites	None indicated. (Ref # 5)
	Historic sites	None indicated. (Ref # 5)
	Parks & public access	Trail planned along Halverstick Road. (Ref # 2)
Function Analysis	Reach Function <ul style="list-style-type: none"> • 	<p>A wetland system is located in this area of the city, which is zoned for, and is being used for, industrial purposes. The system is draining to the east, into Johnson Creek, via a man-made ditch. Much of the wetland system remains in tack but is degraded, as it has been converted to active, or currently fallow, pasture land. Forested wetland still remains in the western area of the reach. This system still provides good water quality functions and hydrologic functions (flood attenuation, water storage and base flow) to downstream areas, which include fish habitat. Habitat functions vary throughout the system, but is generally low in the reach as defined for this review.</p> <p>Functions in this system could be enhanced in areas that have not been developed. This system should be considered very important for its current functional level and for the potential this area holds, particularly with the loss of wetlands in the watershed.</p>

Limiting Factors	<ul style="list-style-type: none"> ▪ Zoning
	Functions <ul style="list-style-type: none"> • Sustainable • Not Sustainable 	
	Priority Actions	<ul style="list-style-type: none"> ▪ Wetland preservation
	Current Enhancement Projects	None known. Upper portion of reach designated as natural system protection area in Comp Plan.
	Preservation/Enhancement Opportunities	<ul style="list-style-type: none"> ▪ Wetland restoration/ enhancement opportunities.

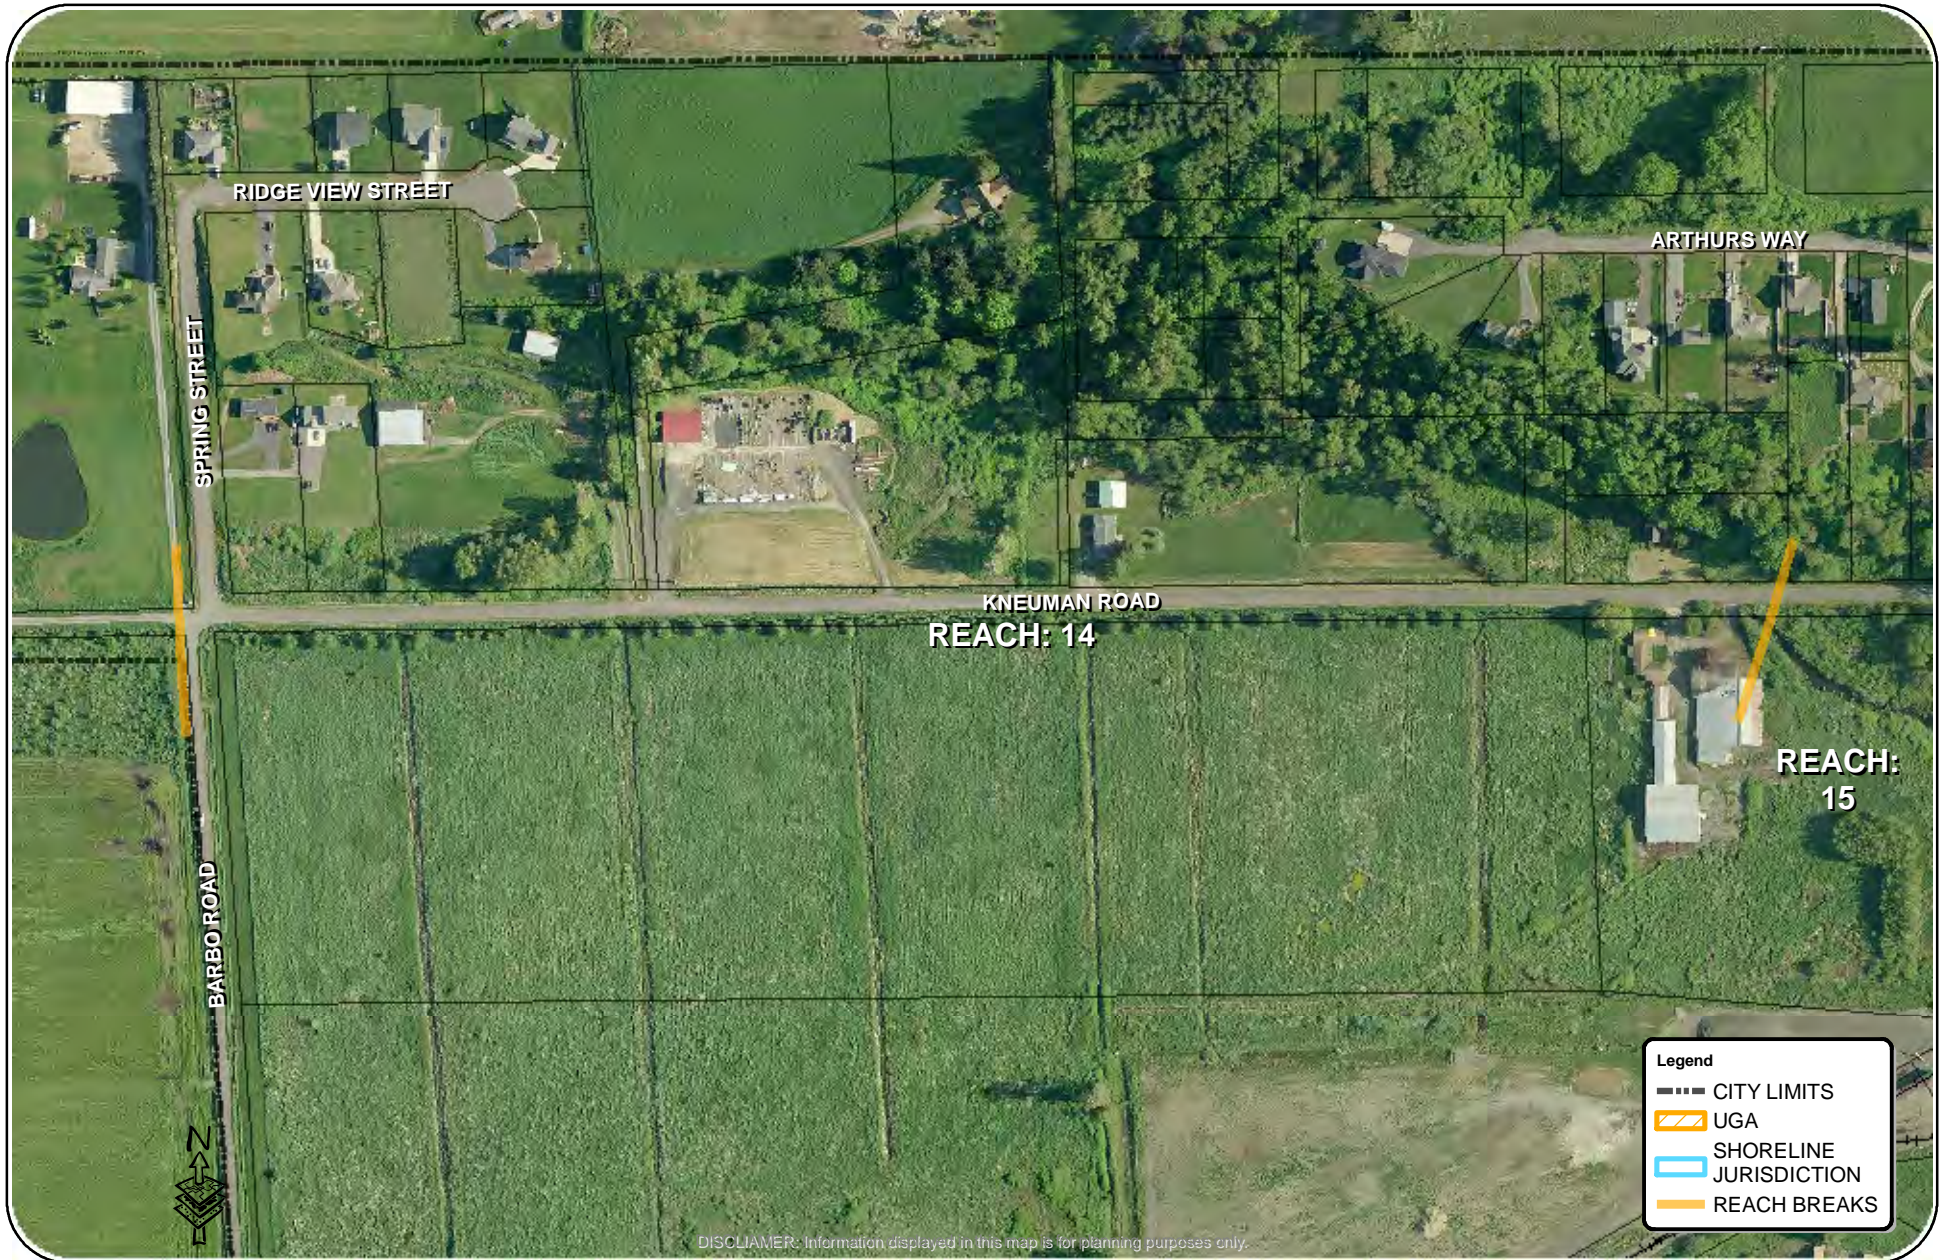
Shoreline Jurisdiction

Historic & Cultural	Historic aerials	None available on-line. Presume geomorphology has been stable for several decades.
	Archeological sites	None indicated. (Ref # 5)
	Historic sites	None indicated. (Ref # 5)
	Parks & public access	Sytsma wetland parcel and easement. (Ref # 1)
Function Analysis	Reach Function <ul style="list-style-type: none"> Hydrologic Shoreline Vegetation Habitat 	<p>Functioning with impairments. Groundwater dominated along with rainfall; flashy winter and early spring peaks, low summer, variable spring and fall flows. Impairment in basin due to loss of wetland area, draining, filling, ditching and removal of vegetation for agriculture. Wetland to the south has been trenched in several places, with water from the wetland draining directly into Sumas Creek.</p> <p>Impaired, however, trees have been planted directly adjacent to the south side of the ditch; Kneuman Road is on the north side. The remainder of the shoreline buffer is fallow agriculture.</p> <p>Terrestrial: Impaired; potential for enhancement.</p> <p>Aquatic: Impaired.</p> <p>As with Reach 13, the wetland systems associated with Sumas Creek are important for the functions they currently provided and for their rehabilitation potential; particularly in this reach as the wetland soils are organic in composition (see also discussion on Reach 13 data sheet).</p>

Limiting Factors	<ul style="list-style-type: none"> Zoning Water quality
	Functions <ul style="list-style-type: none"> Sustainable Not Sustainable 	Sustainable at current levels: hydrologic, shoreline vegetation, and terrestrial & aquatic habitat. However, sustainability affected by private property ownership.
	Priority Actions	<ul style="list-style-type: none"> Wetland preservation and rehabilitation.
	Current Enhancement Projects	Native plantings (trees and shrubs) along ditch. Designated as natural system protection area in Comp Plan.
	Preservation/Enhancement Opportunities	<ul style="list-style-type: none"> Enhance riparian buffer: increase width of native shoreline vegetation in pasture areas. Wetland restoration/ enhancement.

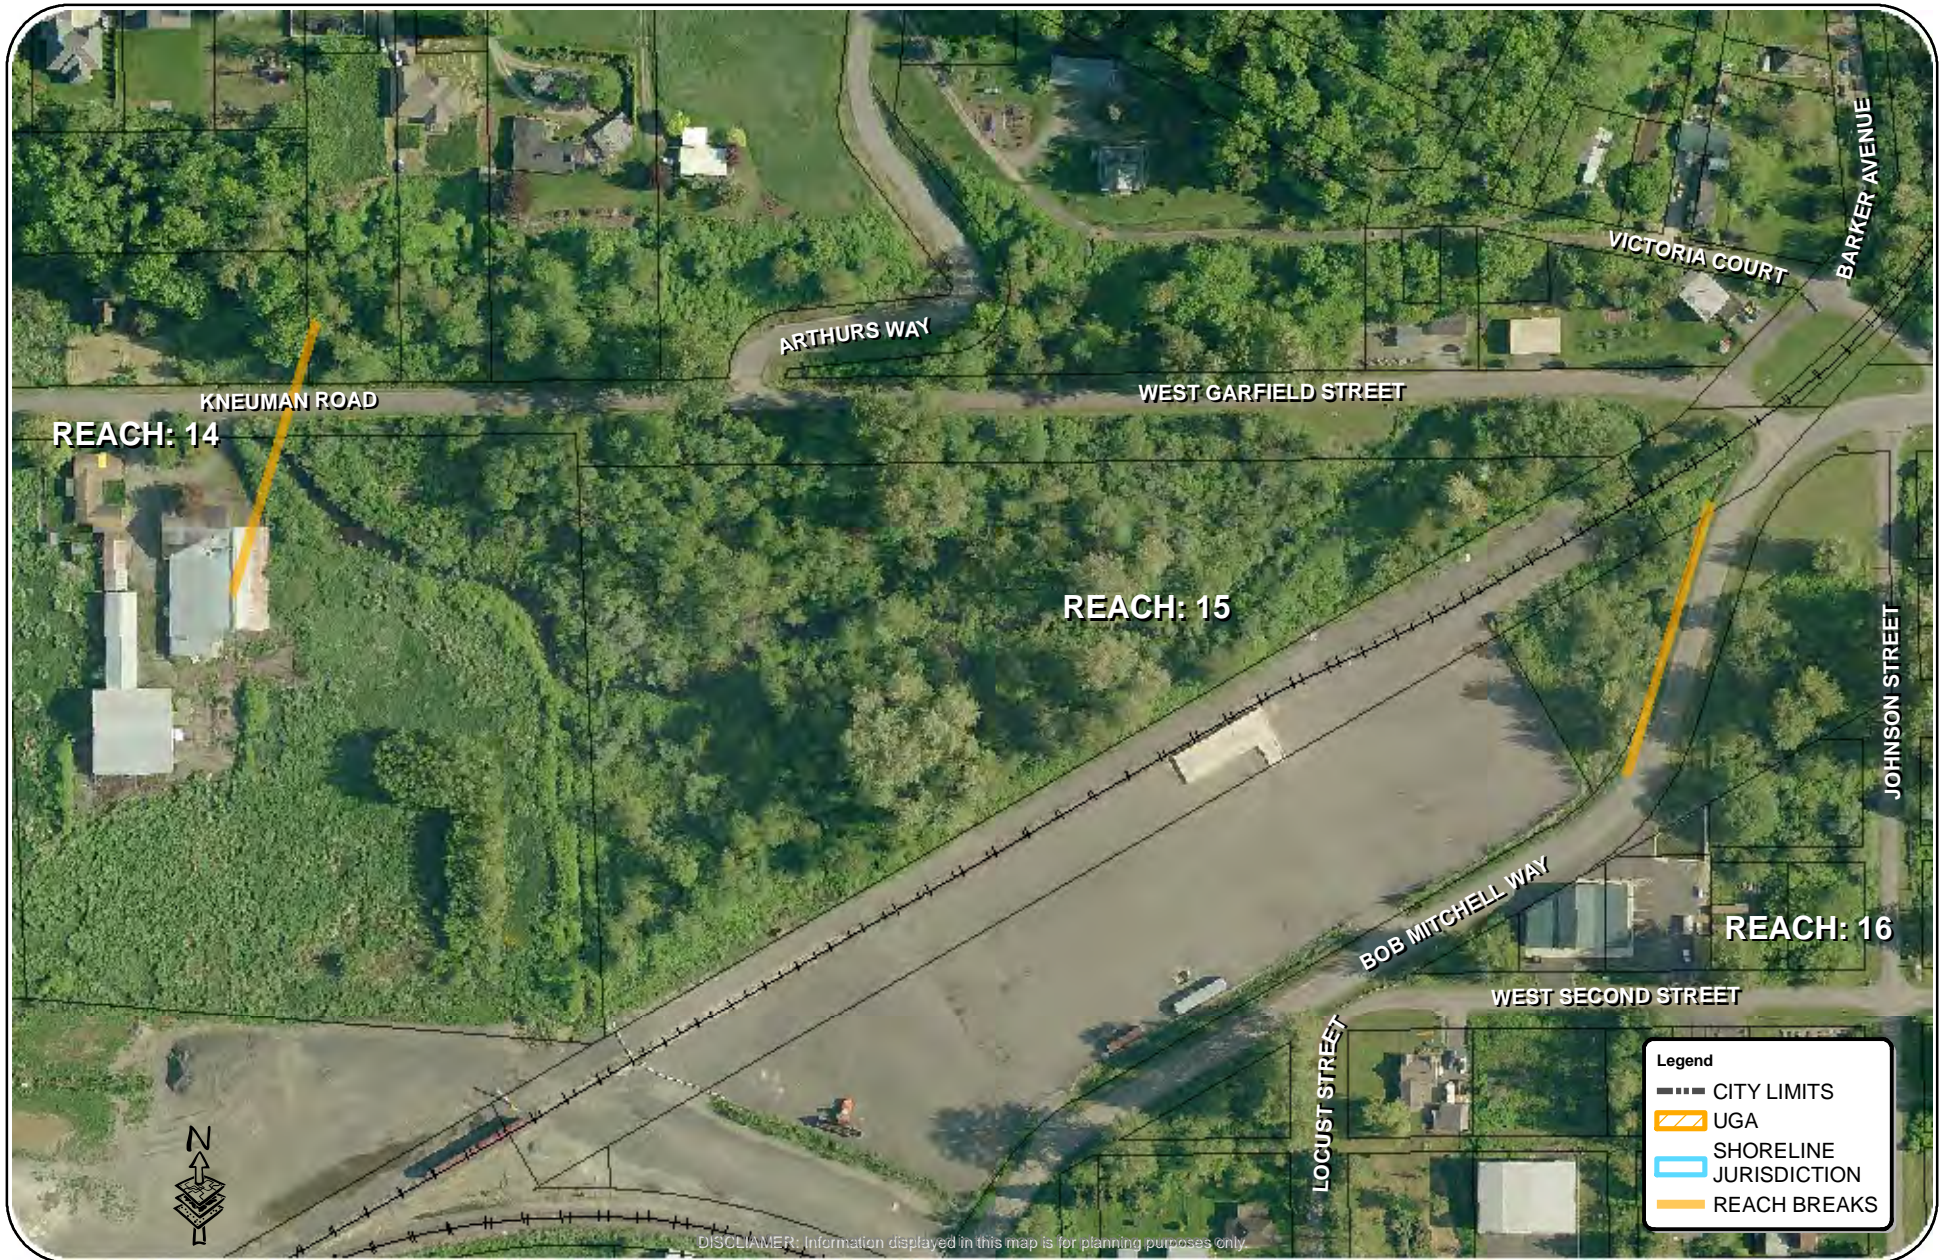
Shoreline Jurisdiction

Historic & Cultural	Historic aerials	None available on-line. Presume geomorphology has been stable for several decades.
	Archeological sites	None indicated. (Ref # 5)
	Historic sites	None indicated. (Ref # 5)
	Parks & public access	Public zoning eastern most portion of reach adjacent to Bob Mitchell Way. (Ref # 2)
Function Analysis	Reach Function <ul style="list-style-type: none"> Hydrologic Shoreline Vegetation Habitat 	<p>Functioning with impairments. Groundwater dominated along with rainfall; flashy winter and early spring peaks, low summer, variable spring and fall flows. Impairment in basin due to loss of wetland area, draining, filling, ditching and removal of vegetation for agriculture.</p> <p>Functioning, with some impairments. West portion of reach is degraded and dominated by non-native grasses and shrubs (agriculture use). Increasing amounts of trees and shrubs in the eastern portion provides more habitat and better cover for creek, although non-natives are likely present.</p> <p>Terrestrial: Functioning, with impairments. Some areas degraded; some native trees and shrub areas within reach. Function limited by industry to south and road to north.</p> <p>Aquatic: Functioning, with impairments.</p>

Limiting Factors	<ul style="list-style-type: none"> Zoning Water quality
	Functions <ul style="list-style-type: none"> Sustainable Not Sustainable 	Sustainable at current levels: hydrologic, shoreline vegetation, and terrestrial & aquatic habitat. However, sustainability affected by private property ownership.
	Priority Actions	<ul style="list-style-type: none"> Preservation of riparian corridor.
	Current Enhancement Projects	None known. Designated as natural system protection area in Comp Plan.
	Preservation/Enhancement Opportunities	<ul style="list-style-type: none"> Preservation of terrestrial vegetation, habitat and associated corridors. Particularly riparian corridors. Enhance riparian buffer: increase shading at western end by installing plants on the banks. Removal of invasive species (Himalayan blackberry).
