**CITY OF SUMAS
SHORELINE MASTER PROGRAM UPDATE
SHORELINE INVENTORY AND CHARACTERIZATION REPORT
TASK 2.3**

December 31, 2010 Draft

**CITY OF SUMAS
SHORELINE MASTER PROGRAM UPDATE**

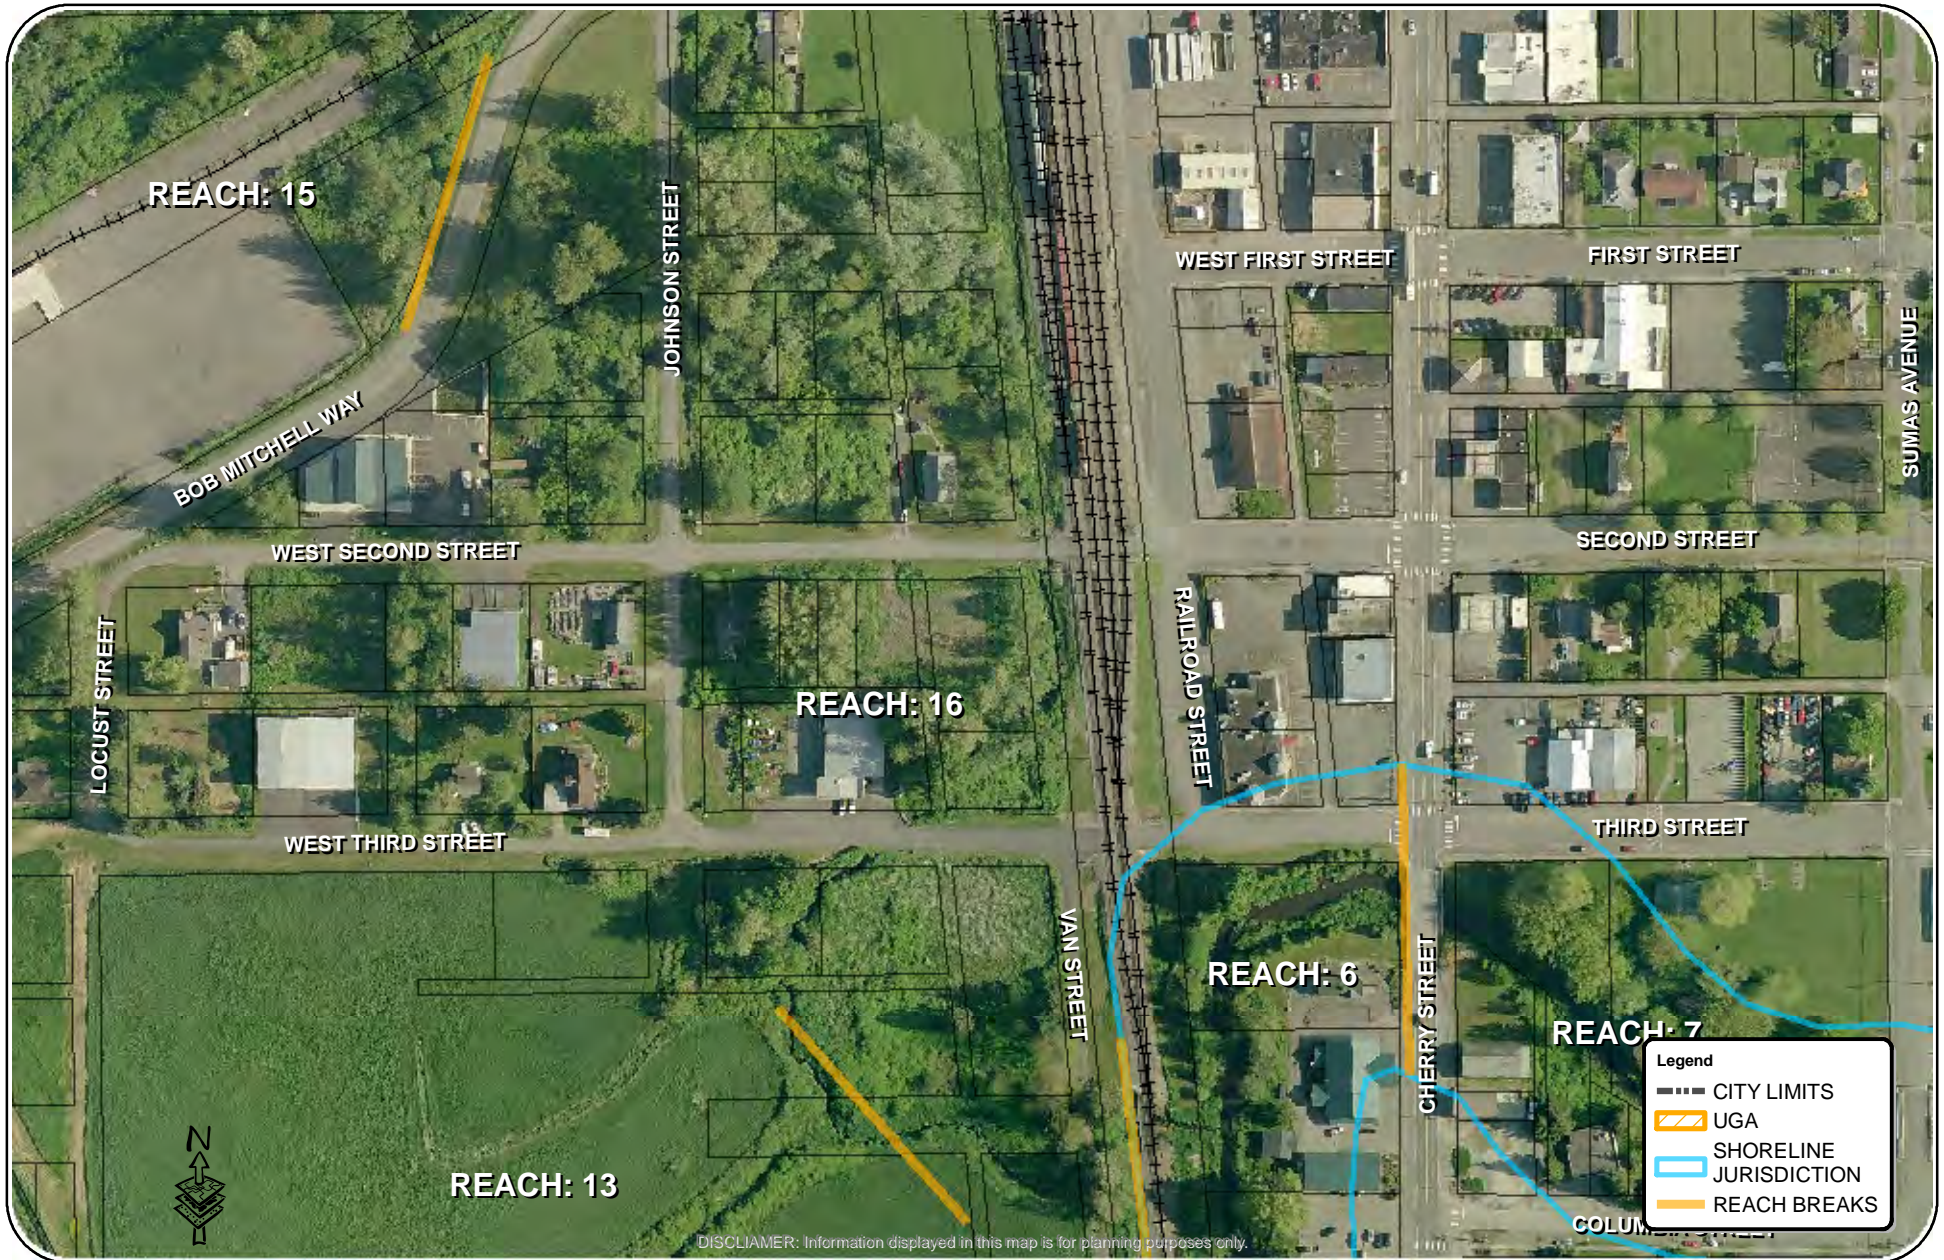
Shoreline Jurisdiction

Historic & Cultural	Historic aerials	None available on-line. Presume geomorphology has been stable for several decades.
	Archeological sites	None listed. (Ref # 5)
	Historic sites	Historic house (Parkinson House), Nooksack Bible Camp: both are in vicinity but probably not in shoreline jurisdiction. (Ref # 5)
	Parks & public access	Public zoning north western most portion of reach adjacent to Bob Mitchell Way. (Ref # 2)
Function Analysis	Reach Function <ul style="list-style-type: none"> Hydrologic Shoreline Vegetation Habitat 	<p>Functioning with impairments. Groundwater dominated along with rainfall; flashy winter and early spring peaks, low summer, variable spring and fall flows. Impairment in basin due to loss of wetland area, draining, filling, ditching and removal of vegetation for agriculture.</p> <p>Functioning, with some areas impaired. Approximately half of the reach is located in a residential area where trees and shrubs exist along the shoreline. The remainder of the reach (south end) is degraded and is dominated by non-native grasses and shrubs.</p> <p>Terrestrial: Impaired, particularly in the southern half of the reach.</p> <p>Aquatic: Functioning, with impairments.</p>

Limiting Factors	<ul style="list-style-type: none"> Zoning Water quality Property ownership
	Functions <ul style="list-style-type: none"> Sustainable Not Sustainable 	Sustainable at current levels: hydrologic, shoreline vegetation, and terrestrial & aquatic habitat. However, sustainability affected by private property ownership.
	Priority Actions	<ul style="list-style-type: none"> Preservation of riparian corridor. Water quality improvement.
	Current Enhancement Projects	None known. Portions of reach, northern and southern most designated as natural system protection area in Comp Plan.
	Preservation/Enhancement Opportunities	<ul style="list-style-type: none"> Preservation of terrestrial vegetation, habitat and associated corridors. Particularly riparian corridors. Enhance riparian buffer: increase width of native shoreline vegetation in reed canarygrass areas. Remove invasive species.
