State of Washington Department of Ecology
Cruise Ship Memorandum of Understanding, Cruise Operations in Washington State Inspection Report

Name and Location of Site Inspected: NORWEGIAN JEWEL, Norwegian Cruise Lines Pier 66, Seattle, Washington	Additional Participants/Inspectors:
On-Site Representative(s): Name/Title/Phone/e-mail Juan Garcia, Environmental Officer e: env21@NCL.com	
Responsible Official(s): Name/Title/Address/Phone/e-mail Sarah Brown, Sr. Director, Environmental Operations Norwegian Cruise Lines e: sbrown@nclcorp.com	Other Facility Data: Notification made to Sarah Brown and Robert Wilkinson on September 15, 2024 Flag: Bahamas

**PHOTO ADDENDUM – NORWEGIAN JEWEL
NORWEGIAN CRUISE LINES OCTOBER 1, 2024**

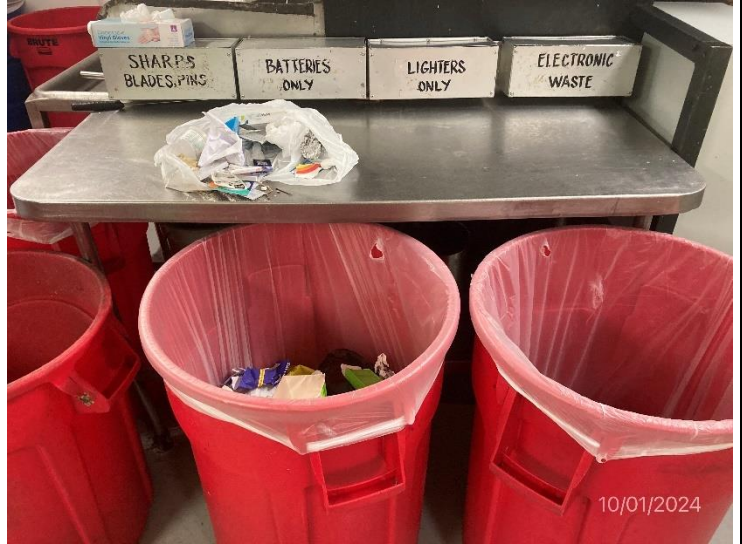
Photo # 2 Image: IMG_2064 Date: 10/1/2024
Taken by: Evan Dobrowski
Description: Photo of recycling sorting station.

Glass, heavier plastics, most cardboard, aluminum, tin and steel cans, batteries, used cooking oil and other items are recycled in Seattle.

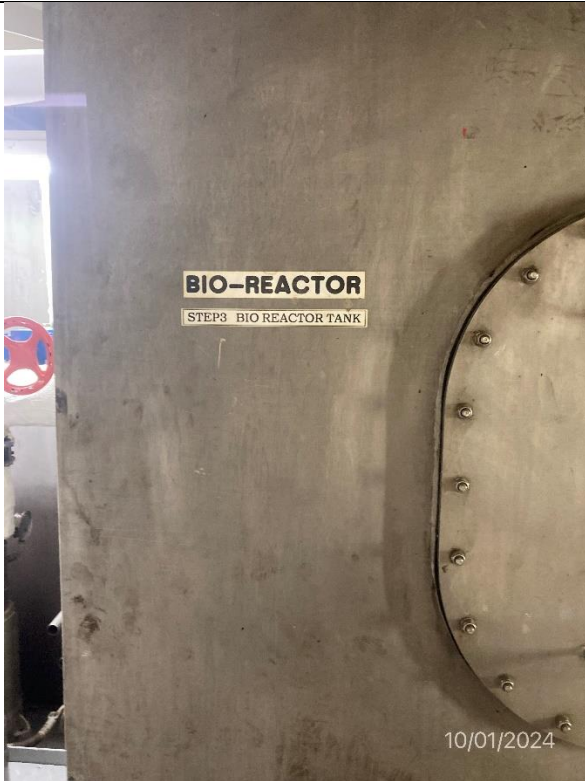
Photo # 9 Image: IMG_2081 Date: 10/1/2024
Taken by: Evan Dobrowski
Description: Photo of Bioreactor blackwater filtration system.

Blackwater includes toilet waste and medical drains and is sent by vacuum/jet to the Scanship marine sanitation devices. Description paraphrased from the schematic on the MSD system: Black water enters from the inlet into the aeration tank

where the bacteria present in this section decomposes the blackwater in the presence of oxygen which is supplied by the aeration nozzles. A continuous supply of oxygen is necessary. The blackwater then enters into the settling section where settling takes place and flocs of activated sludge settle down along with other settleable matter. Sludge is returned back to the aeration section. The settled blackwater then enters into the disinfection section where chlorine is added. Flow then goes to dedicated holding tanks if not in an area of discharge. Blackwater is not discharged in MOU related waters and all blackwater is treated. Settleable solids are monitored periodically and chlorine availability checked. Once per year, each MSD is taken off-line for a full maintenance cleaning. Solids are removed at this time, drummed and sent ashore.

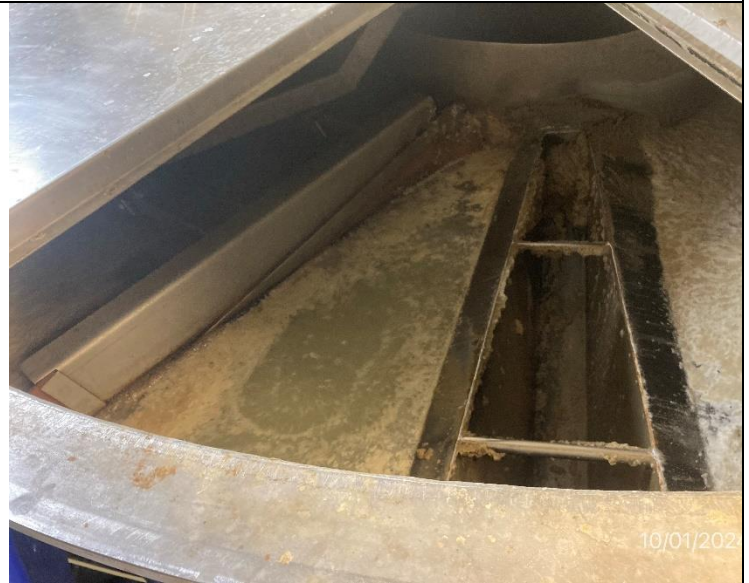
Photo # 10 Image: IMG_2084 Date: 10/1/2024
Taken by: Evan Dobrowski
Description: Photo of interior of flocculation tank B.

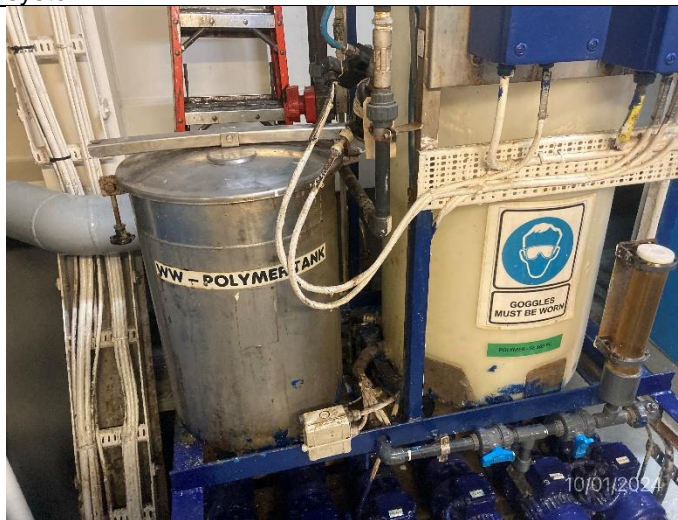
Photo # 11 Image: IMG_2088 Date: 10/1/2024
Taken by: Evan Dobrowski
Description: Photo of Polymer tank.

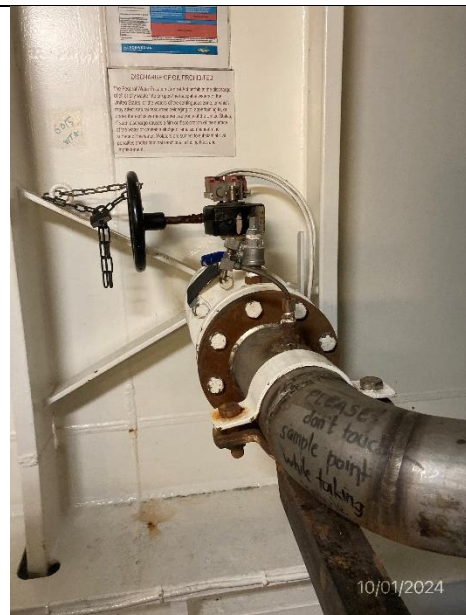
Photo # 12 Image: IMG_2089 Date: 10/1/2024
Taken by: Evan Dobrowski
Description: Photo of blackwater overboard discharge shut and locked manually.

The protocol for discharges is a closed-loop process. There is communication between the ECR Officer on Watch and the Bridge staff for approval from the Bridge that the vessel is in an area authorized for discharge. The overboard valves have a lock which has to be manually controlled. The keys for the locks are found in the engine control room and are controlled by a badge. The badge control will only allow that person to access certain keys allowed to them. For the discharge valves only engineering and environmental officers have access to these keys. The discharge valves are then controlled electronically after the locks are removed and the discharges are logged into the NAPA system. Any change to the logs shows who made the change by staff passcode. Any changes are reviewed by the Bridge. The GPS system is connected to the log for accurate logging of the discharge location. The discharges all to occur outside of MOU related waters (Washington State waters, the Strait of Juan de Fuca up to the border with Canada and the OCNMS). For black water and gray water, the latitude and longitude coordinates are recorded in the NAPA system along with all other logs. The date, time and location of both the start and the stop of the discharges are recorded, along with port location, effluent type, speed, tank name and volume, valve name, and status of valve. The maker of the entry and reviewer/signer is also included, along with any notes. Navigation on the bridge shows clearly marked electronic maps indicating discharges to stop 13 miles outside the OCNMS (12 miles from shore and a one mile buffer).

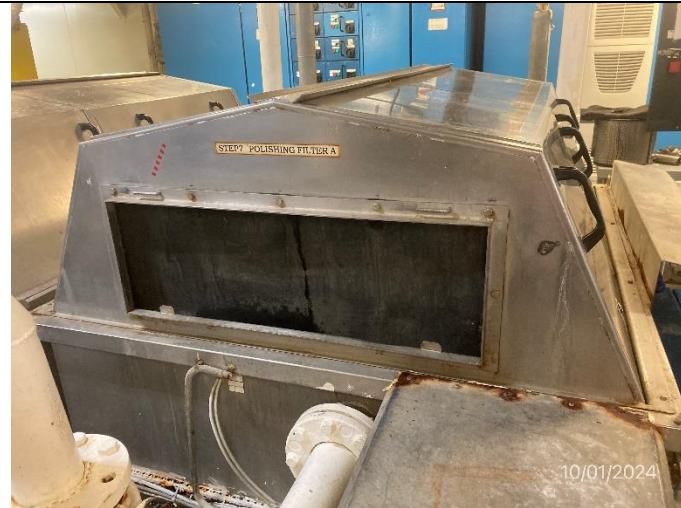
Photo # 13 Image: IMG_2090 Date: 10/1/2024
Taken by: Evan Dobrowski
Description: Photo of Polishing filter A

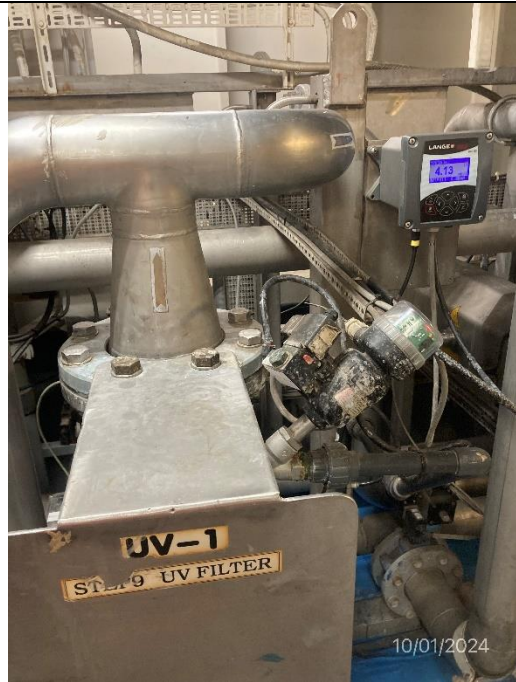
Photo # 14 Image: IMG_2091 Date: 10/1/2024
Taken by: Evan Dobrowski
Description: Photo of UV Filter

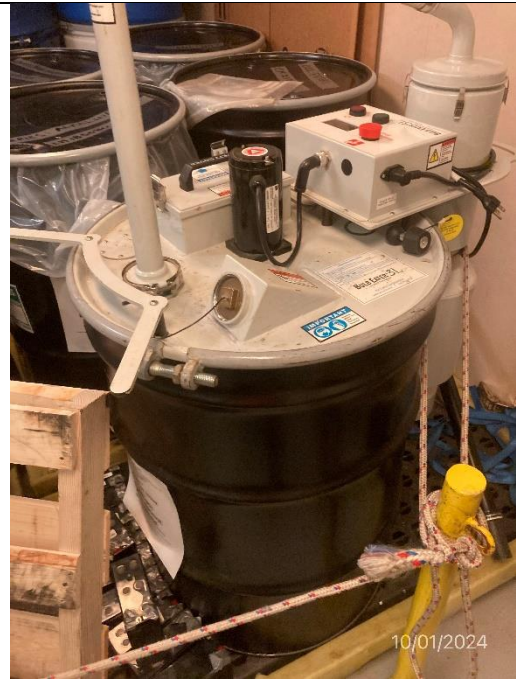
Photo # 16 Image: IMG_2108 Date: 10/1/2024
Taken by: Evan Dobrowski
Description: Photo of Bulb Crusher.

No photo waste is generated onboard this vessel. X-rays are done digitally without any waste. Fluorescent bulbs are crushed on board and held for offloading ashore as hazardous waste. Hazardous waste materials are stored separately in various dedicated locations throughout the vessel and include items such as paints, thinners, oily rags and debris, incinerator ash, chemicals, aerosols photo waste, and some batteries. Bio-medical waste is incinerated with sharps being offloaded as biomedical waste ashore. Hazardous waste is not being offloaded in Seattle. The Hazardous Waste Storage on this vessel did not have accurate logs regarding what was coming and going inside the hazardous waste storage locker. Hazardous waste tracking could be improved onboard.

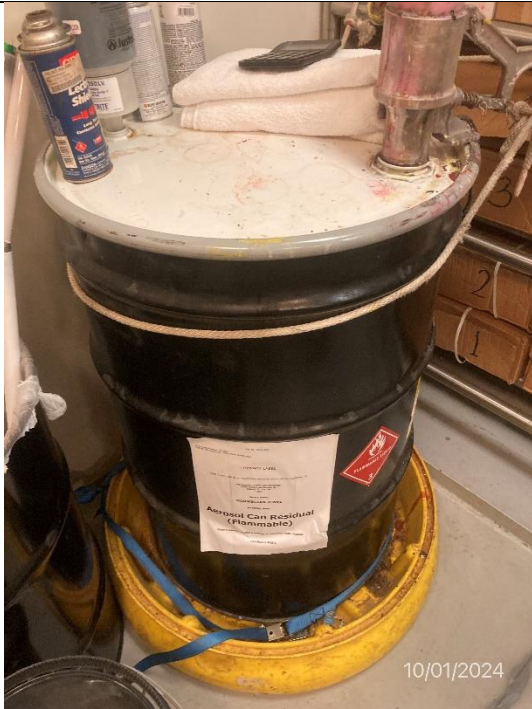
Photo # 17 Image: IMG_2109 Date: 10/1/2024
Taken by: Evan Dobrowski
Description: Photo showing Aerosol can crusher

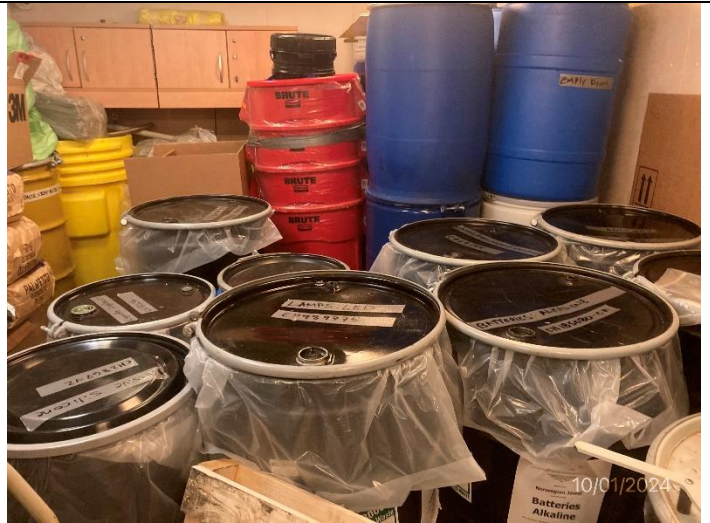
Photo # 18 Image: IMG_2112 Date: 10/1/2024
Taken by: Evan Dobrowski
Description: Photo showing hazardous waste storage locker.

The protocols for discharges are clear. Records were orderly and appeared consistent with the MOU. The Environmental Officer onboard this vessel when asked was unaware of the WA MOU and mentioned he had heard of it but had not read the materials. Some of the environmental officer's answers were inconsistent with WA MOU requirements; but engineering staff corrected during conversation. The Hazardous Waste tracking aboard the vessel could be improved as hazardous waste volumes were not clearly identified in the hazardous waste storage locker.

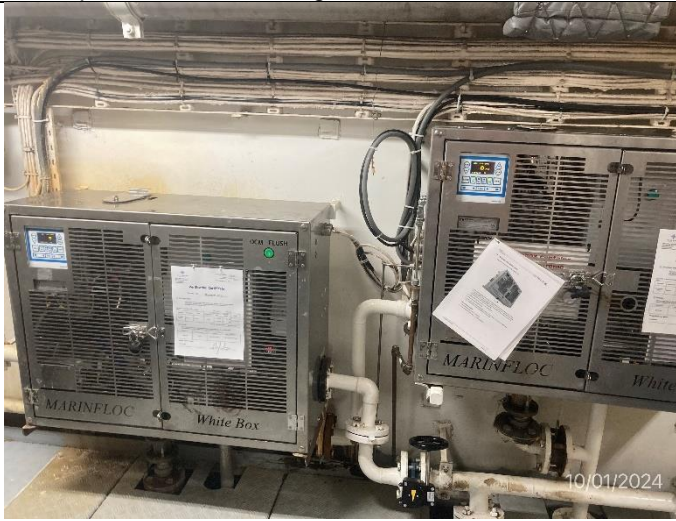
Photo # 19 Image: IMG_2105 Date: 10/1/2024
Taken by: Evan Dobrowski
Description: Photo showing double locked marinfloc white box system.

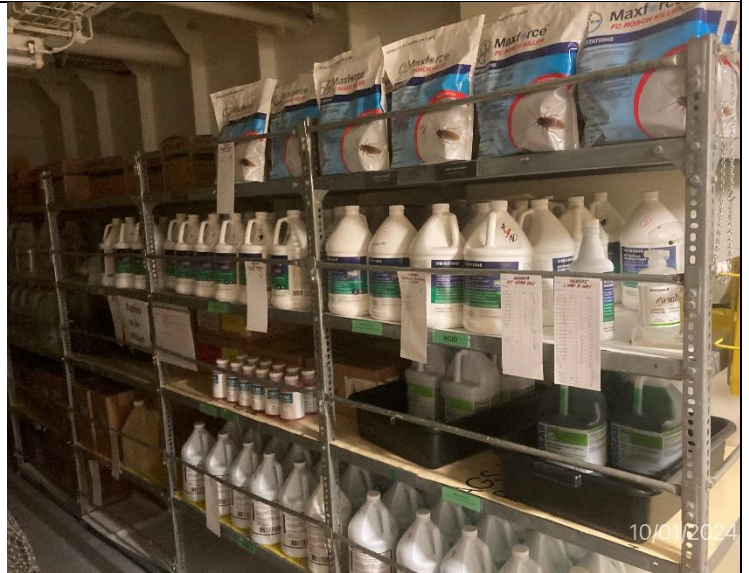
Photo # 20 Image: IMG_2115 Date: 10/1/2024
Taken by: Evan Dobrowski
Description: Photo showing housekeeping chemical storage area.

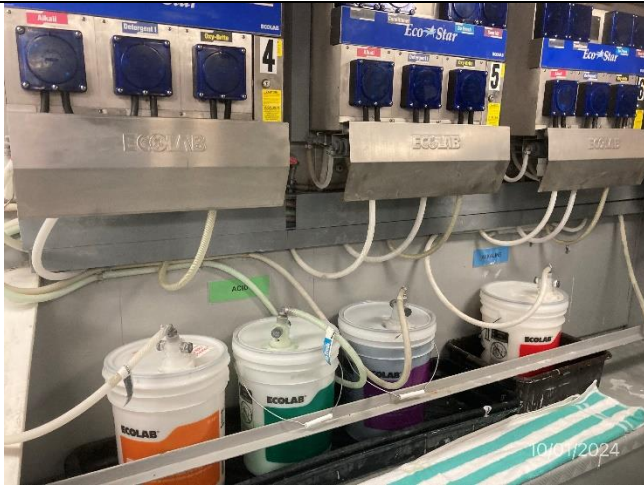
Photo # 21 Image: IMG_2119 Date: 10/1/2024
Taken by: Evan Dobrowski
Description: Photo showing laundry chemicals in use.
