State of Washington Department of Ecology  
**Cruise Ship Memorandum of Understanding, Cruise Operations in Washington State Inspection Report**

Northwest Regional Office  
 P.O. Box 330316  
 Shoreline, WA 98133  
 Phone: (425) 213-4230

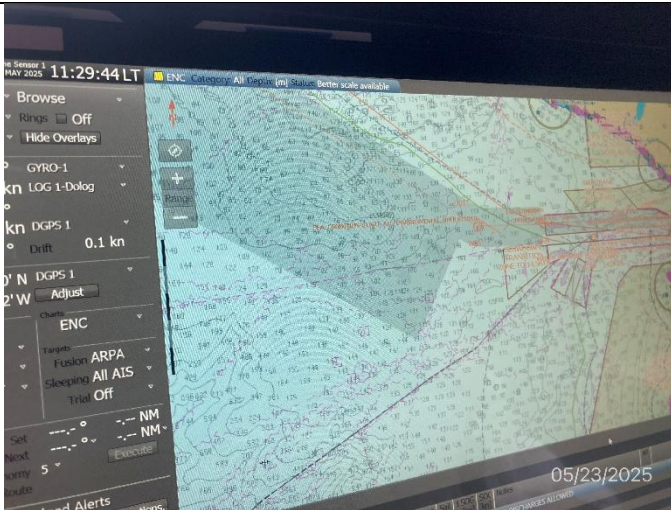
Photo # 3 Image: IMG\_2770 Date: 5/23/2025  
 Taken by: Evan Dobrowski  
 Description: Photo of map documenting environmental conditions/discharge locations.

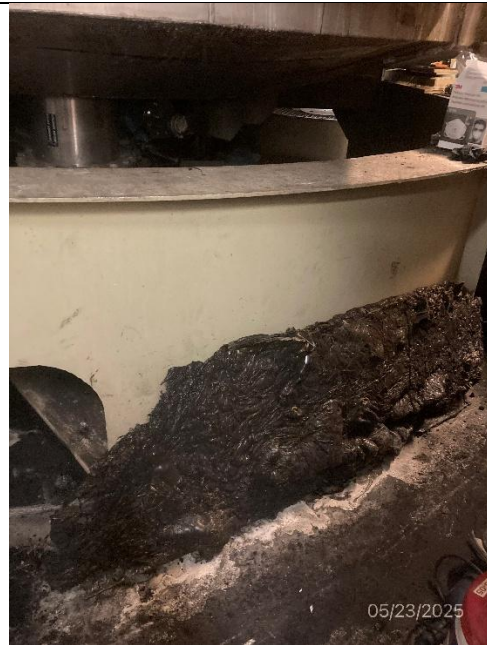
Photo # 4 Image: IMG\_2763 Date: 5/23/2025  
 Taken by: Evan Dobrowski  
 Description: Photo of EGCS tower being repaired due to overheating. The black section is the plastic interior EGCS material that is being replaced.

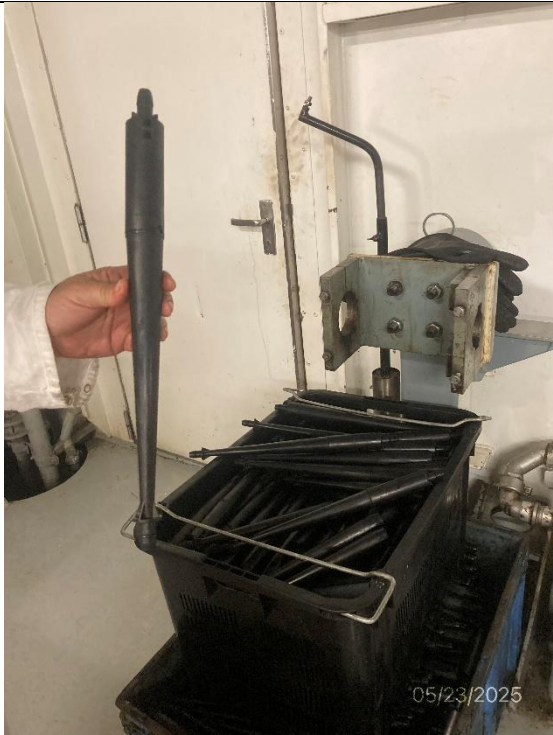
Photo # 5 Image: IMG\_2762 Date: 5/23/2025  
 Taken by: Evan Dobrowski  
 Description: Photo replacement misters for damaged EGCS tower.
