HYDROLOGY ANALYSIS  
**Sprague Lake**  
CITY OF SPRAGUE, WASHINGTON

Subject: HYDROLOGY ANALYSIS, SPRAGUE LAKE, CITY OF SPRAGUE,  
WASHINGTON

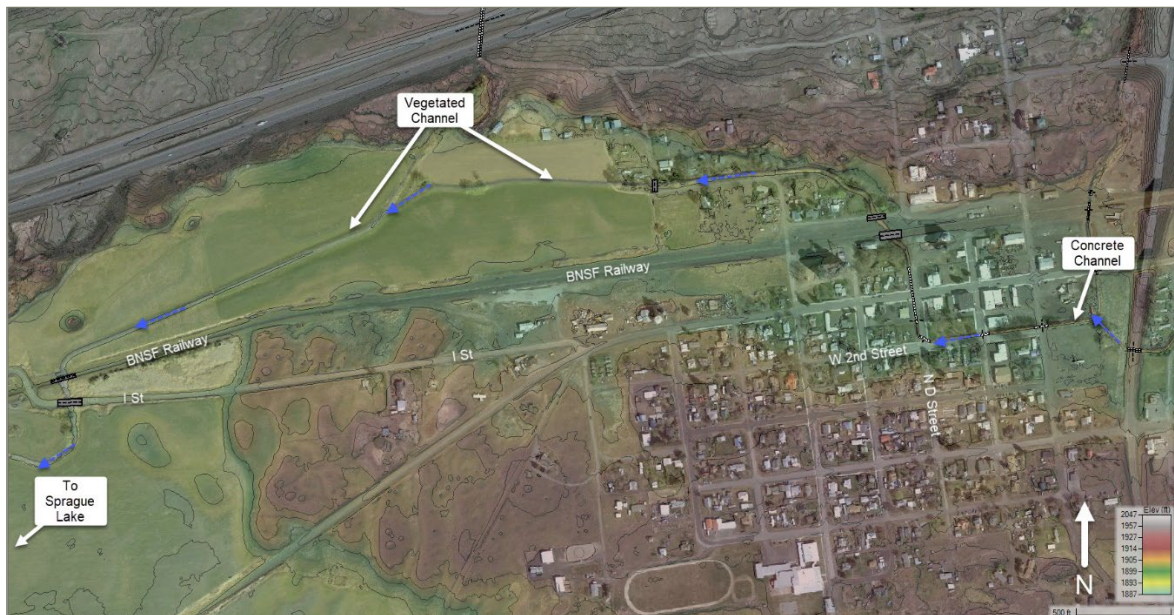
**Exhibit 2-1: City of Sprague Drainage Network**

The City surface water is drained by a series of concrete open channels and box culverts, which roughly follow West 2nd Street and North D Street. These channels collect stormwater throughout the City and discharge it under the BNSF railway to the north into a man-made vegetated channel. This vegetated channel meanders west and crosses the BNSF railway a second time, as well as I Street to the south. The vegetated channel then transitions into a natural streambed over the remaining 2 river miles as it winds through pastureland and eventually meets the shoreline of Sprague Lake (Exhibit 2-1).

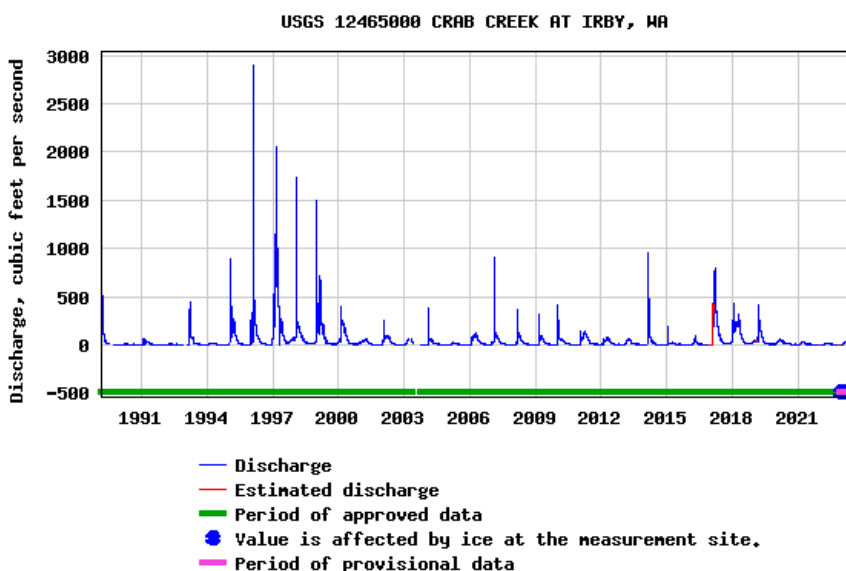
**Exhibit 3-9: Crab Creek Flow Hydrograph (1990 to 2023)**

Upon review of the runoff data pertaining to Crab Creek, it is evident that the peak flow observed during the 2017 flood event at the Crab Creek Irby location approximately corresponds to a flood magnitude of a two-year return period, approximately 793 cubic feet per second (cfs), as recorded by the gauge. To provide visual context for this event, a graphical representation depicting the relative magnitude of this 2017 event (red line), in relation to more significant Crab Creek flood events during the 1990s, is presented below in Exhibit 3-9.

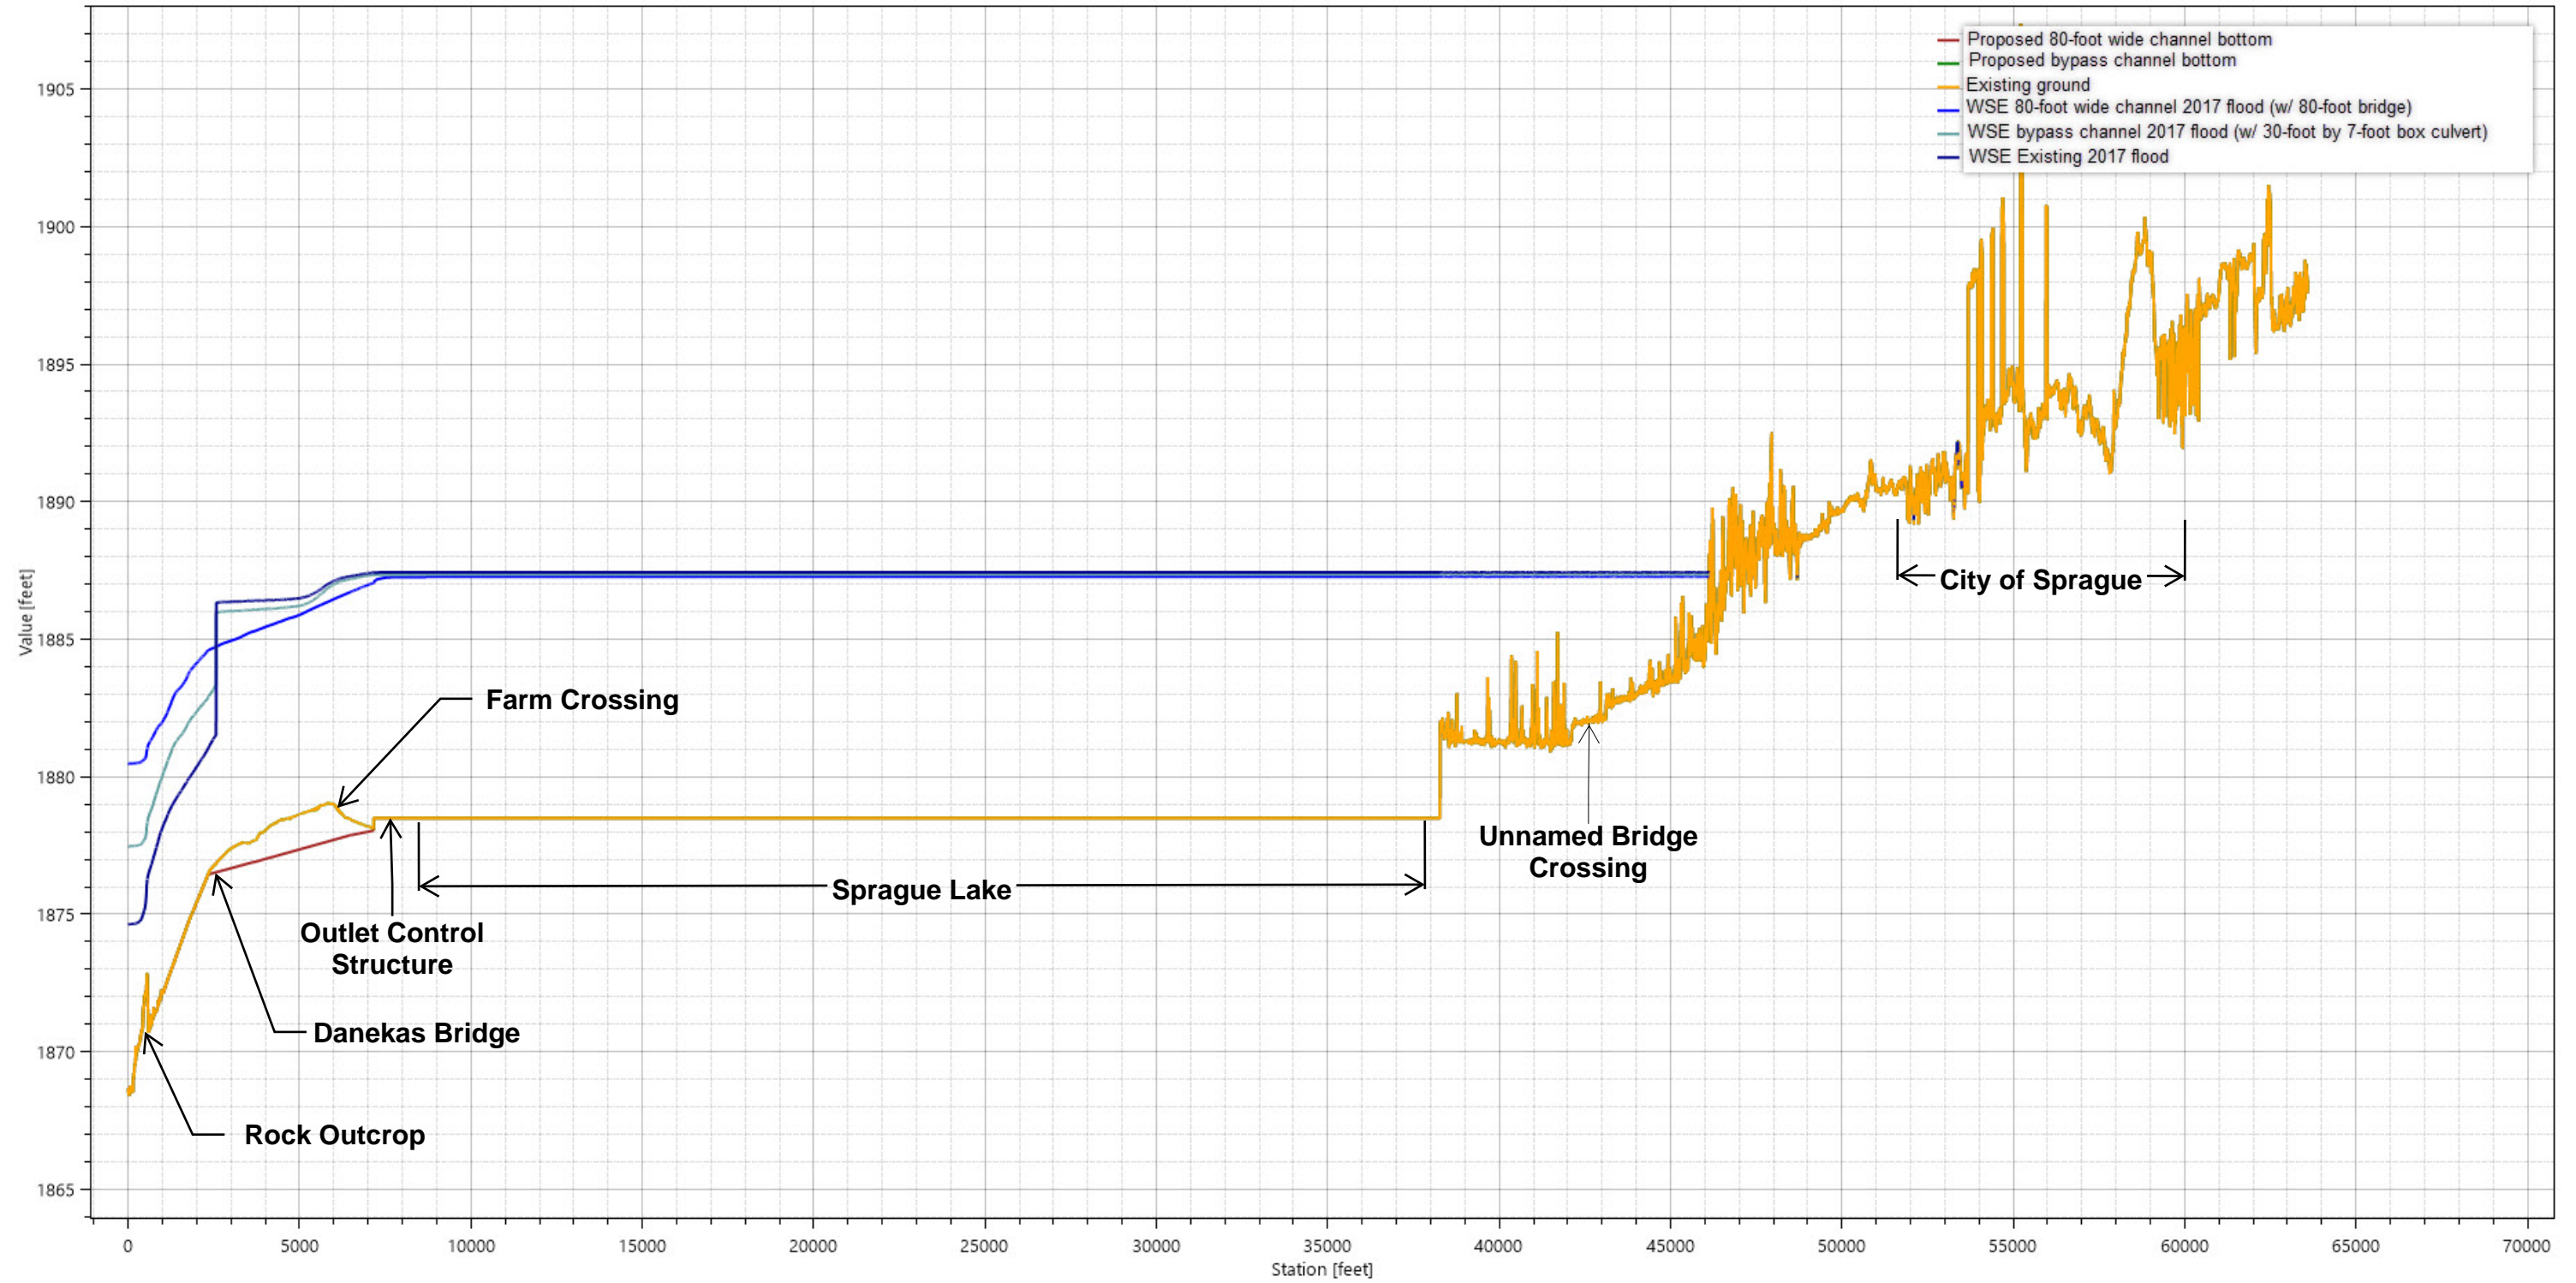
Figure 6

October 2023  
2017 Flood Profile - Peak Water Surface Elevations Large Scale Alternatives
