SHORELINE RESTORATION PLAN

SAN JUAN COUNTY

Prepared by
Herrera Environmental Consultants, Inc.

Approved by San Juan County Council
April 5, 2016

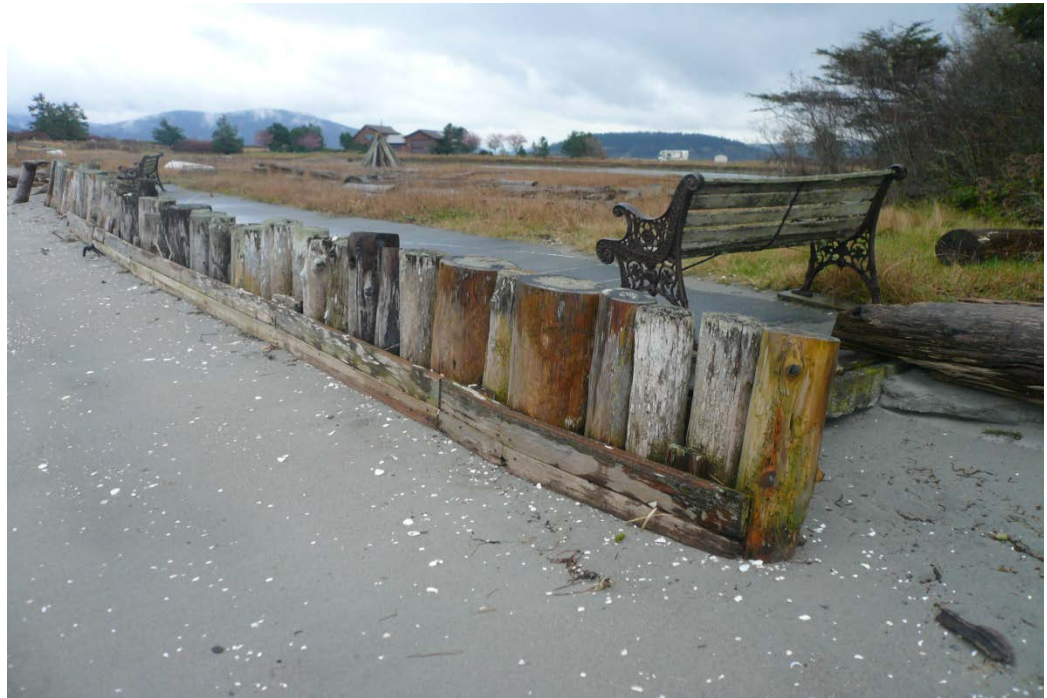
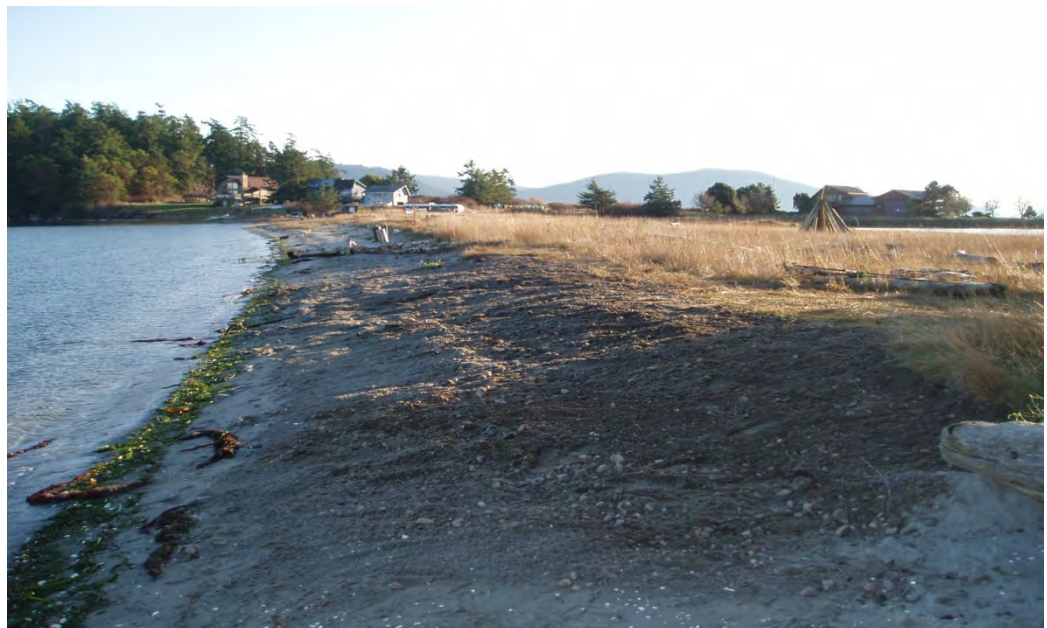
Figure 3. Shoal Bay Forage Fish Restoration Project, Before and After Restoration, Lopez Island, Washington.

Before:

After:

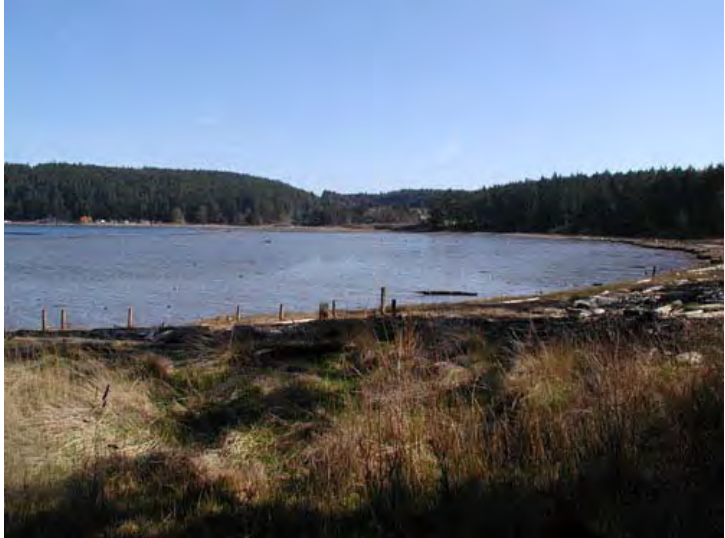
Project name	Table A1. Mud Bay Bulkhead Removal		
Location	Lopez Island

Project sponsor		
	Project status	Study Complete: Dormant	
	Target habitat	Forage fish spawning, juvenile salmon migration	
	Current ownership	Private, SJC County	
	Zoning	Rural Farm Forest	
	Hydrogeomorphic classification	Nearshore	
	Project size	NA	
	Strategy	Restoration	
Existing conditions	Shoreline armoring, including riprap armoring along a county road and wood bulkheads on private properties have changed the natural beach processes of Mud Bay. Friends of the San Juans also completed a shoreline feasibility analysis to design and restore natural beach processes in 2007.		
Project description	The riprap along the county road and the wood bulkheads on private property would be removed. The removal of these features would restore natural beach processes of Mud Bay.		
Future threats	Increased development along Mud Bay, augmentation of the riprap along the county road.

Project rationale	A reduction of suitable spawning habitat in documented surf smelt and Pacific herring spawning locations has also occurred. Year-round surf smelt spawning has also been documented in Mud Bay. Mud Bay's extensive shallow water ecosystem provides important feeding and rearing habitat for juvenile salmon as well as for salmonid prey species. Due to these factors, Mud Bay was ranked by Friends of the San Juans as one of the highest priority sites for restoration.		
Functions restored	Forage fish spawning habitat, juvenile salmon rearing habitat, salmonid prey species habitat.

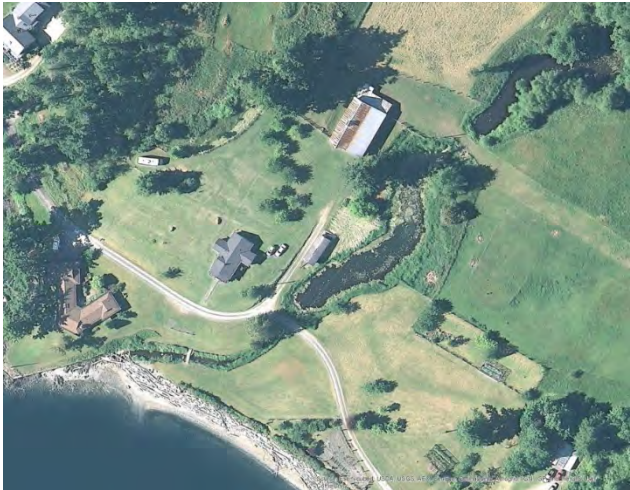
Project name		Table A3. Pickett Springs Salt Marsh Restoration		
Location		Orcas Island

Project sponsor		
		Project status		Studies complete: Dormant
		Target habitat		Nearshore salt marsh
		Current ownership		Private
		Zoning		Residential
		Hydrogeomorphic classification		Nearshore, estuarine
		Project size		1-acre
		Strategy		Restoration
Existing conditions		Two fresh water ponds have formed above a series of perched culverts, which impede tidal exchange in the creek above. The culverts also impede fish passage into the creek.		
Project description		A salt marsh will be restored by removing culverts that impede tidal exchange. In addition, the ponds and associated ditches will be dug out, allowing the tidal prism to reach upstream. The project will improve fish passage and access to prey resources, providing rearing habitat in approximately 500 feet of stream.		
Future threats		Development of the watershed and surrounding farm land, failing septic systems in the surrounding watershed.

Project rationale		Salt marshes are highly productive nearshore environments, and provide important rearing habitat for juvenile Chinook salmon and other juvenile salmonids.		
Functions restored		Tidal exchange into a former lagoon/salt marsh, improved fish passage, juvenile salmon habitat.

Pickett Springs salt marsh is located on Pickett Springs Creek, a Type 3 stream that is culverted in two places near its confluence with Eastsound (Wild Fish Conservancy 2012b) (see Table A3 in Appendix A). One of the culverts is located under EJ Young Road. Both culverts restrict creek flow, resulting in two freshwater ponds. Replacement of the culverts with bridges or appropriately-sized box culverts would substantially improve habitat conditions at the mouth of the creek, including re-creation of a salt marsh. In addition, the existing ponds would be regraded to allow the tidal prism to extend further upstream, increasing the area of salt marsh habitat created. This project is currently considered dormant.

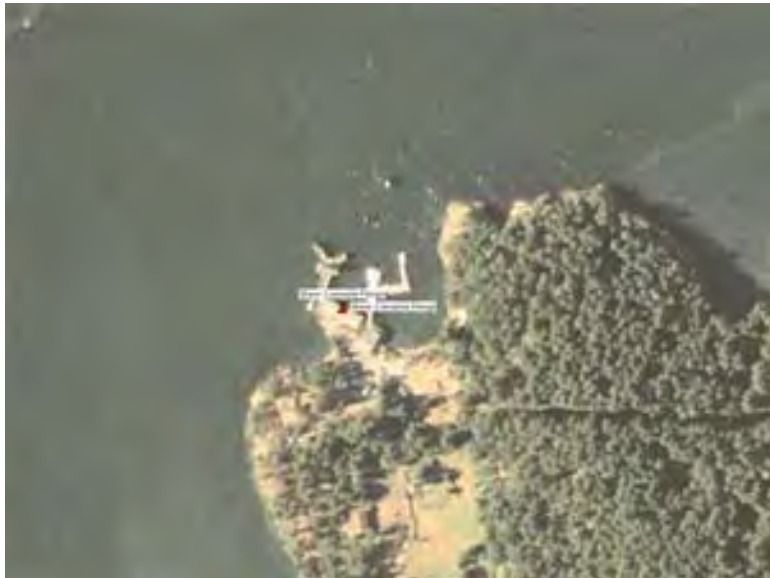
Project name	Table A4. Shaw Landing Creosote Bulkhead Removal		
Location	Shaw Island

Project sponsor		
	Project status	Studies complete: Dormant	
	Target habitat	Nearshore Embayment	
	Current ownership	Private	
	Zoning	Rural Farm Forest	
	Hydrogeomorphic classification	Nearshore	
	Project size	NA	
	Strategy	Restoration	
Existing conditions	Approximately 67 creosote-treated logs were used to mitigate erosion associated with ferry wake and storm waves along a private/community dock adjacent to the Shaw Island Ferry Ramp. The creosote-treated logs were used to bulkhead the backshore to prevent additional shoreline erosion.		
Project description	The creosote-treated logs would be replaced with inert materials.		
Future threats	Continued release of creosote into the surrounding environment.		
Project rationale	Creosote is a carcinogenic compound; placement of creosote-treated wood along the shoreline creates a chronic source of contamination to the surrounding nearshore environment.

Functions restored	Improved sediment and water quality conditions near the creosote-treated bulkhead, including eelgrass beds.

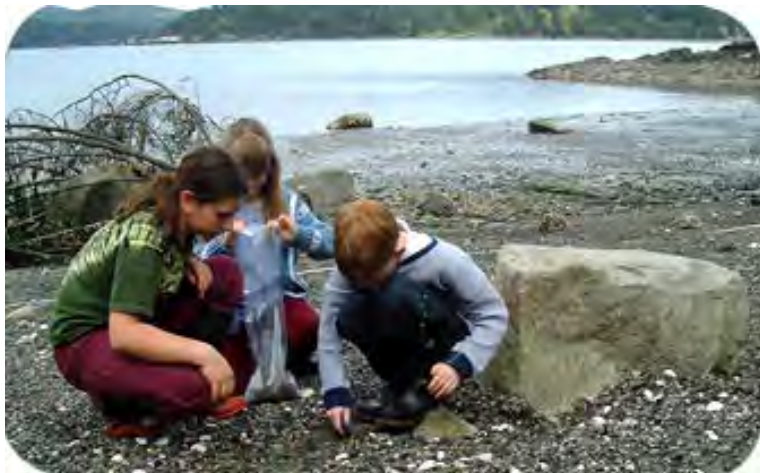
Project name	Table A5. Blind Bay Forage Fish Habitat Restoration		
Location	Blind Bay, Shaw Island

Project sponsor	Friends of the San Juans	
	Project status	Design Complete: Ongoing	
	Target habitat	Forage fish spawning	
	Current ownership	San Juan County	
	Zoning	Rural Residential / Farm Forest	
	Hydrogeomorphic classification	Nearshore	
	Project size	493 feet of shoreline, 5,919 ft ²	
	Strategy	Restoration	
Existing conditions	Riprap and a number of groins were constructed along Blind Bay Road, which was constructed adjacent to the shoreline. This area of Blind Bay is considered protected with a maximum fetch measuring less than 2 miles. In addition, two drift cells converge at the center of the southern beach.		
Project description	Beach nourishment will be used in Blind Bay to improve spawning habitat substrate at a documented surf smelt spawning beach. Feasibility and initial design work has been completed.

Future threats	Increased development in Blind Bay, augmentation of rip rap and groins along Blind Bay.		
Project rationale	The beaches of Blind Bay are considered valuable forage fish spawning habitat, with documented surf smelt spawning in the Bay. Beach modifications related to the construction of Blind Bay Road have degraded long stretches of shoreline.		
Functions restored	Beach nourishment will improve and expand spawning habitat for forage fish.

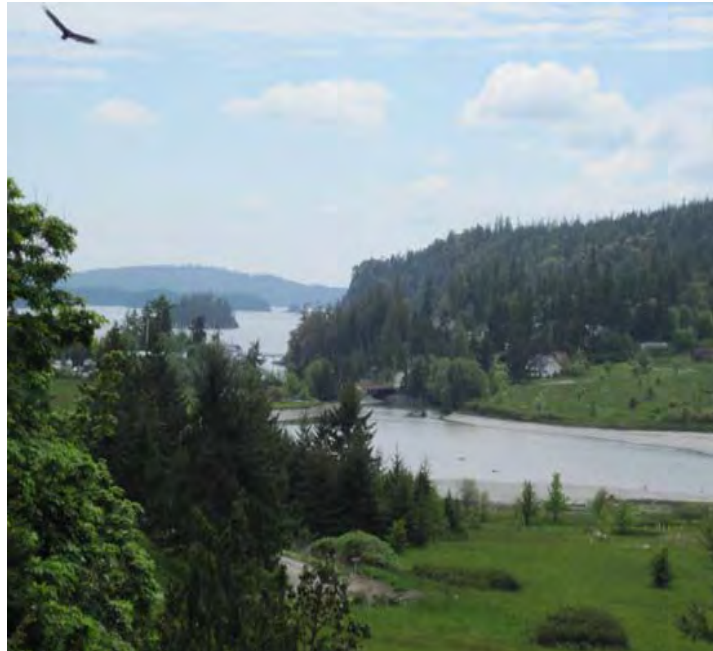
Project name	Table A7. Deer Harbor Bridge Replacement and Estuary Restoration		
Location	Channel Road between Deer Harbor and Cayou Lagoon, Orcas Island

Project sponsor	San Juan County Public Works	
	Project status	Pre-restoration studies and design completed. Final bridge design and construction ongoing.	
	Target habitat	Estuary restoration, juvenile salmon and forage fish habitat, revegetation, and fish barrier removal.	
	Current ownership	San Juan County Public Works	
	Zoning	Residential	
	Hydrogeomorphic classification	Estuarine	
	Project size	3.4 acres	
	Strategy	Restoration	
Existing conditions	In 1970, the Deer Harbor Bridge on Channel Road was replaced with a new bridge, which was constructed with abutments that reduce the channel width by 50 percent. The bridge abutments constrict flow in and out of the estuary. An artificial rock sill was also constructed under the bridge to protect the bridge pilings from scour. The sill now acts like a dam, further restricting sediment movement and tidal flow patterns. Deer Harbor is the largest estuary on Orcas Island and provides valuable habitat for juvenile salmon and forage fish.

Project description	The Deer Harbor Bridge is nearing the end of its useful life and needs to be replaced. San Juan County Public Works has acquired grant funding to pay for the “improved bridge”, which includes increasing the spanned channel width and removing the rock sill below the bridge. These improvements will restore natural tidal flow patterns in Cayou Lagoon and reduce the on-going accumulation of fine sediment in the lagoon. The bridge replacement will entail construction of a stair-step weir to address a fish passage barrier (headcut) on Fish Trap Creek, which discharges to the Deer Harbor Estuary.		
Future threats	Additional development in the Fish Trap Creek watershed, increased water diversion from Fish Trap Creek, increased development around Cayou Lagoon.

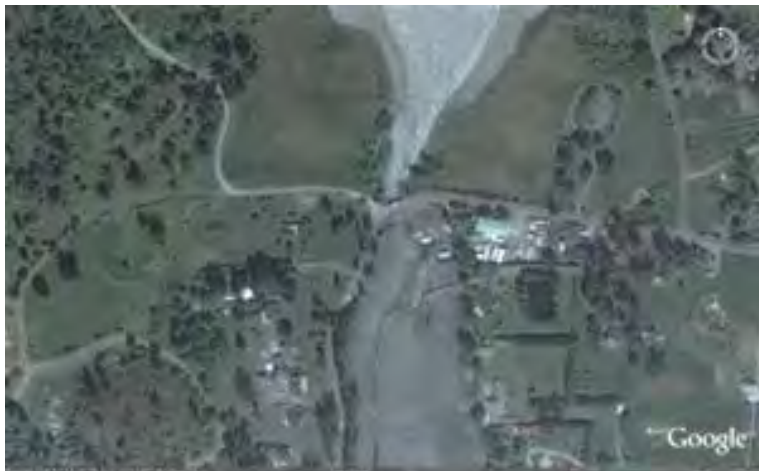
Project name		Table A8. Deer Harbor Wood Waste Removal	
Location		Orcas Island

<p>Michael Durland: Deer Harbor Wood Waste Removal (R09-1530) Attachment #3, Deer Harbor Boatworks property</p>		Project sponsor	
		Project status	Dormant
		Target habitat	Estuary
		Current ownership	Michael Durland
		Zoning	Residential
		Hydrogeomorphic classification	Nearshore
		Project size	NA
		Strategy	Restoration
Existing conditions	Until the 1960s and 1970s, a sawmill operated on Deer Harbor. A bulldozer was used to in the estuary to clear an area used for maneuvering logs. A sawdust burner was located on the beach on the south end of the property. Deer Harbor Boatworks now occupies the site.		
Project description	Removing the wood waste produced from the historic saw mill, which is approximately 12 to 18 deep. It is anticipated that 2,000 cubic yards of material may need to be removed.		
Future threats	Increased development surrounding Deer Harbor, maintaining existing Deer Harbor bridge, potential contaminant (dioxin) release from the wood waste.

Project rationale	Large quantities of fine-grained wood waste left over from the historic sawmill limits natural ecosystem functioning in the affected areas and should be removed.		
Functions restored	Restoration of native clam and oyster beds, improved habitat for juvenile salmon and forage fish.

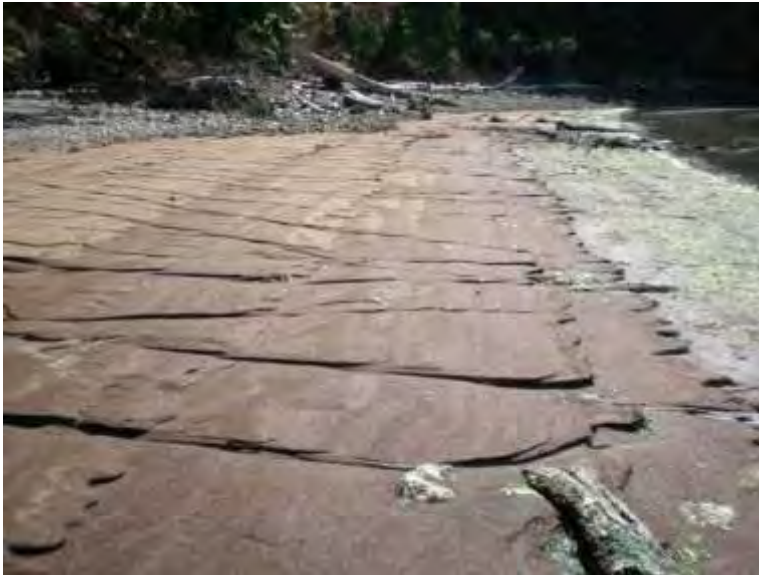
Project name	Table B1. Thatcher Bay Nearshore Restoration		
Location	Thatcher Bay, Blakely Island

Project sponsor	Skagit Fisheries Enhancement Group	
	Project status	Completed Dec. 2015	
	Target habitat	Nearshore Embayment	
	Current ownership	Blakely Island Trust	
	Zoning	Rural Farm Forest	
	Hydrogeomorphic classification	Nearshore, estuarine	
	Project size	1.8 acres	
	Strategy	Restoration	
Existing conditions	An historic sawmill operated in Thatcher Bay from 1879 to 1942; sawmill activities resulted in the accumulation of large quantities of wood waste in the intertidal and subtidal areas of the bay.		
Project description	Approximately 12,900 cubic yards of wood waste-contaminated material was removed from the beach at an elevation of approximately 8 feet MLLW to -8 feet MLLW. The project site was backfilled with clean sediment suitable for forage fish spawning after the wood waste is removed.

Future threats	Development of the surrounding shoreline, timber harvest in the Spencer Lake/Creek watershed.		
Project rationale	The large accumulation of fine wood waste in Thatcher Bay alters the substrate and causes anaerobic decomposition of the organic material, resulting in elevated levels of sulfide (a toxic byproduct) in the intertidal sediments. Removal of the wood waste will improve habitat for forage fish, juvenile salmon, and benthic biota.		
Functions restored	Forage fish spawning habitat, improved habitat for benthic biota, and the establishment of intertidal flora and fauna such as eelgrass.

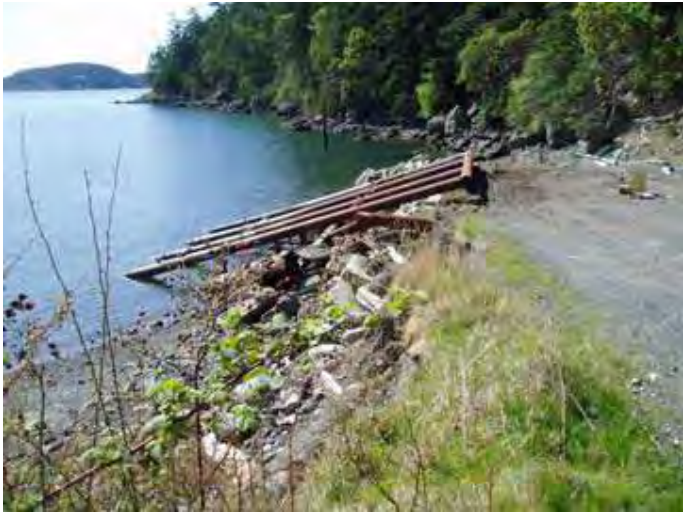
Project name		Table B2. North Thatcher Bay Forage Fish Restoration Project	
Location		North Thatcher Bay, Blakely Island

Project sponsor		Friends of the San Juans
	Project status		Completed in November, 2013.
	Target habitat		Forage fish and juvenile salmon habitat
	Current ownership		Private
	Zoning		Rural Farm Forest
	Hydrogeomorphic classification		Nearshore, pocket beach
	Project size		1 acre
	Strategy		Restoration
Existing conditions		A large, degraded log handling and beach access facility sat directly on a documented surf smelt spawning beach in Thatcher Bay. The structure negatively impacted backshore, beach, and intertidal habitats and coastal processes important to a variety of fish species. Also, there were over 20 creosote piles and dolphins in the Bay.	
Project description		This project rehabilitated a known surf smelt spawning beach and restored overhanging marine riparian vegetation, creating a future large woody debris source. Existing fill material was removed, including concrete debris, steel cables, and boulders on the beach adjacent to the ramp. Future activities include restoration implementation, and education/outreach and dissemination.

Future threats		Development of the Thatcher Bay area, increased logging and road construction in the surrounding watershed.	
Project rationale		There is a high probability of use by juvenile salmon, surf smelt, and sand lance in Thatcher Bay. This project restored forage fish spawning habitat and improve nearshore marine habitat for juvenile salmon and salmon prey by removing historic logging armoring, fill and beach debris from intertidal habitat. This project will also restore natural beach conditions through the use of beach nourishment and shoreline regrading.	
Functions restored		Enhancement of forage fish spawning habitat through removal of intertidal beach debris, improved intertidal habitat conditions for juvenile salmon, forage fish, and other fish species.

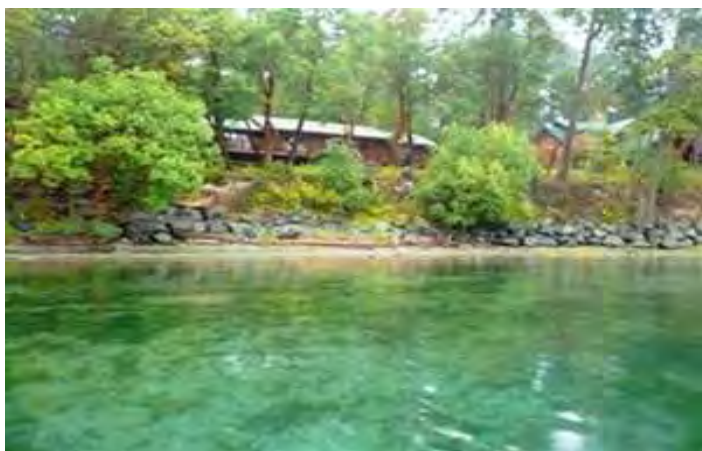
Project name	Table B3. Brown Island Historic Feeder Bluff Restoration		
Location	Southeast shore of Brown Island

Project sponsor	Friends of the San Juans	
	Project status	Completed December 2015	
	Target habitat	Upper beach habitat and nearshore	
	Current ownership	Private	
	Zoning	Single Family Residential	
	Hydrogeomorphic classification	Feeder Bluff	
	Project size	4,000 sq. ft.	
	Strategy	Restoration	
Existing conditions	Along the southeast shore of Brown Island near Friday Harbor, is a small drift cell with a historic feeder bluff that is currently armored across multiple private properties. The wave energy is limited making it an excellent site for full bulkhead removal. The historic feeder bluff is 14 to 18 ft high. Dense high strength till deposits in the lower bank are very resistant to erosion. The upper bank deposits consist of glaciomarine drift composed of pebbly, sandy, silt and clay. The area is mostly forested with native, second growth species.

Project description	The primary goals of the Brown Island Historic Feeder Bluff Restoration project are to restore nearshore processes, improve upper beach habitat and provide a demonstration project for shoreline managers and landowners through removal of unnecessary shoreline armoring. Short-term objectives: Restore sediment supply from a historic feeder bluff within a small drift cell. Restore potential forage fish spawning habitat. Improve habitat conditions for juvenile salmon and salmon prey. Demonstrate that removal of hard armoring can be compatible with private, residential development. Demonstrate the role of upland vegetation and surface water management in controlling shoreline erosion. Educate decision-makers, managers and planners about alternatives to hard armoring through site visits and landowner testimonials. Educate shoreline property owners and land use professionals (builders, realtors) about alternatives to hard armoring through site visits and landowner testimonials.

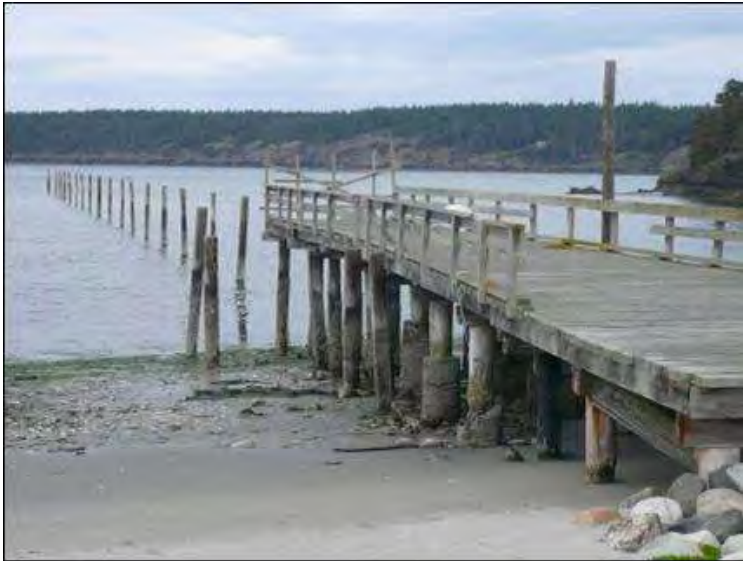
Project name		Table B6. Barlow Bay Nearshore Ecosystem Restoration	
Location		Barlow Bay, Lopez Island

Project sponsor		Friends of the San Juans
	Project status		Completed February 2014
	Target habitat		Forage fish spawning, juvenile salmon migration
	Current ownership		San Juan County Public Works, Tulalip Tribes
	Zoning		Rural farm forest
	Hydrogeomorphic classification		Nearshore estuarine
	Project size		150 sq ft + piling removal
		Strategy	Restoration
Existing conditions		A derelict dock, creosote pilings, and other shoreline debris were located on the beach of Barlow Bay. Rock armoring was also placed alongside a roadway bulkhead; approximately 150 square feet of intertidal beach had been covered by the degraded rock armoring.	
Project description		The derelict dock, creosote pilings, and degraded rock armoring in Barlow Bay were removed, improving water quality, intertidal, and beach conditions in the bay. Improvements in water quality will benefit juvenile salmon, salmon prey, and shellfish. Removal of rock armoring on beach restores forage fish spawning habitat.

Future threats		Development, additional rock armoring along adjacent road.	
Project rationale		MacKaye Harbor (including Barlow Bay) is identified as priority nearshore habitat due to the presence of juvenile salmon and forage fish spawning habitat documented in the area, including surf smelt and pacific sand lance. This project increases forage fish spawning habitat and improves the water quality in Barlow Bay.	
Functions restored		Improved water and sediment quality from the removal of creosote pilings, improved forage fish spawning, shellfish, and juvenile salmon habitat.
