State of Washington Department of Ecology
Cruise Ship Memorandum of Understanding, Cruise Operations in Washington State Inspection Report

Name and Location of Site Inspected: CARNIVAL LUMINOSA, Carnival Cruise Line Pier 91, Seattle, Washington	Additional Participants/Inspectors: Cody Ennis, Ecology
On-Site Representative(s): Name/Title/Phone/e-mail Adrian Racovitan, Environmental Officer e: Imenvoff@carnival.com	
Responsible Official(s): Name/Title/Address/Phone/e-mail Benton Lobo, Vice President, Compliance, ISM Designated Person Ashore Carnival Cruise Lines 3655 NW 87 th Ave, Miami, FL 33178 e: BLoBo2@carnival.com	Other Facility Data: Notification made to Benton Lobo on June 14, 2023 Flag: Bahamas

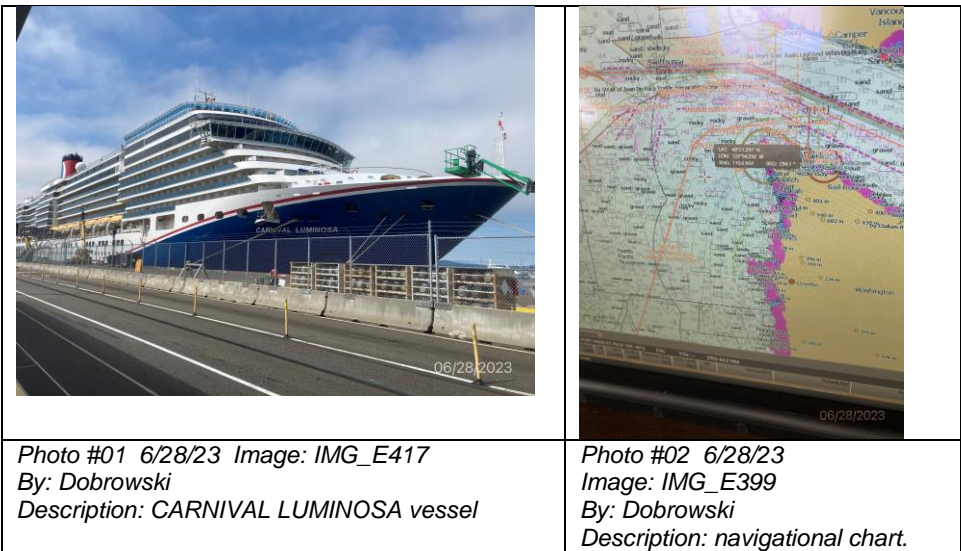
We arrived and boarded the ship (photo #01) at 8:30 am and began with introductions and a plan for the day with Adrian Racovitan, EO. We headed to the Engine Control Room and discussed the vessel itinerary and locations where discharges and fuel transitions occur. We reviewed electronic logs for various waste streams, saw the fuel transfer operations occurring, and went over the plan for the day with CARNIVAL LUMINOSA engineering staff. After this we discussed various waste streams and discharge protocols as well as fuel transfer protocols. We then toured the blackwater marine sanitation devices, the oily bilge treatment, and the Exhaust Gas Cleaning Systems with the engineering staff and the environmental officer. We then headed to the incinerator room and then to the garbage room.

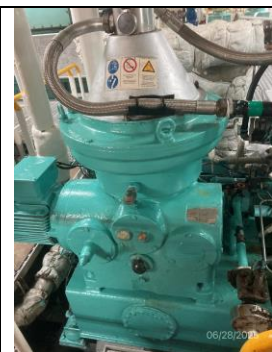
Photo #06 6/28/23
Image: IMG_E413 By: Dobrowski
Description: OWS White Box

route is outside the MOU related waters. The white box (photo #06). The Chief Engineer and the EO have the two separate keys and both need to be present to open the white box. There is a record each time the white box door is opened and a video camera on OWS equipment. The chief Engineer and the EO have the ability to review camera recordings. All portable pumps are logged and only used for certain equipment. The EO confirmed that he is not aware of any rerouting of oily bilge. The OWS was off and recirculating during the inspection and not discharging. If graywater tanks overflow or come in contact with oily bilge, the content is considered as oily bilge and treated through the OWS and the Captain and Chief Engineer are notified.

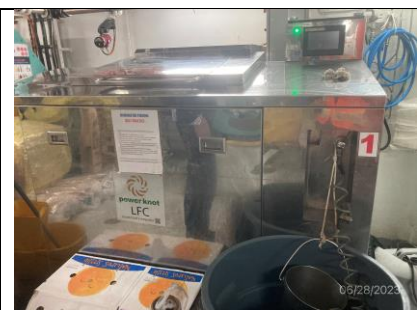
Photo #07 6/28/23 Image: IMG_E389 By: Dobrowski
Description: Food biodigester

Food waste is segregated into soft and hard foods. Soft foods are fed into 8 food waste biodigesters. The effluent from the food waste biodigesters is deposited into the grey water tanks and is discharged outside of MOU related waters. Hard foods are either

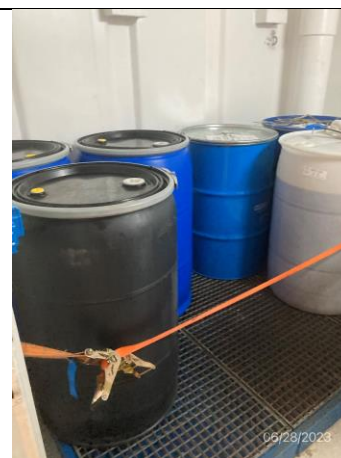
Photo #09 6/28/23
Image: IMG_E394 By: Dobrowski
Description: barrel storage with used cooking oil and various other waste chemicals.

incinerated or landed ashore as USDA waste in Seattle. Used cooking oil (photo #09) is sent ashore for recycling. The EO and Food Operations staff inspect the biodigesters typically daily. There is no food chute on board.
